## Oldbury to Meriden, Warwickshire

# Ground Level Tree Assessment Report

**Prepared For: Severn Trent Water**

Document Reference: 10408.04.001

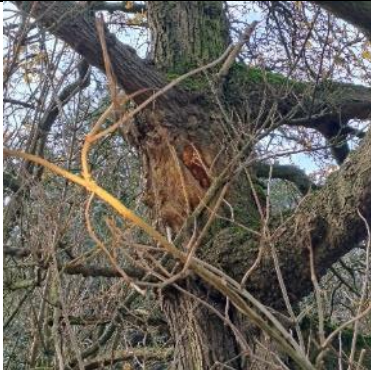
| | BT3 | Tree Description: | <p>Field maple <i>Acer campestre</i></p> <p>PRF 1: Trunk cavity located on a stem orientated north. The cavity faced north and was at a height of 4m. There was no evidence of bat use. There was potential for maternity/satellite/night/mating/swarming bat roost use. H&amp;S Considerations: Barbed wire fence. Further Survey Requirements: PRF inspection survey – ladders. Two surveyors.</p> <p>PRF 2: Multiple butt-rot features present as PRF-I but were too numerous to record all features.</p> | |

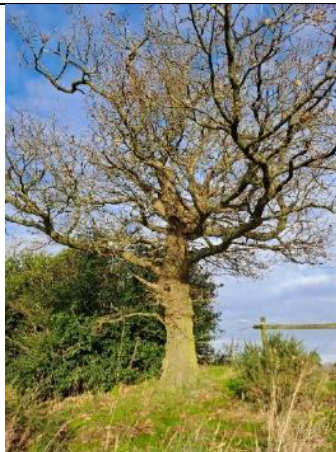
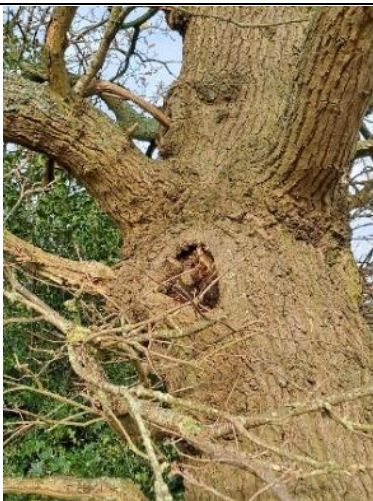
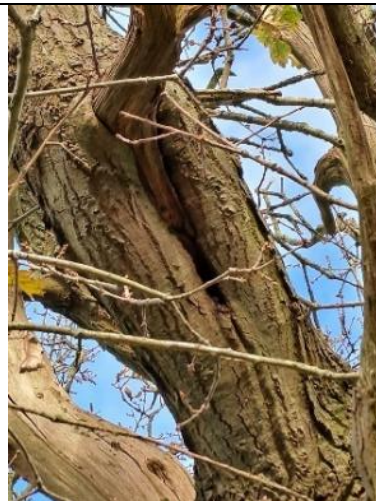
| BT5 | Tree Description: | <p>Pedunculate oak <i>Quercus robur</i><br/>H&amp;S Considerations: None.</p> <p>PRF 1: knot-hole located on a stem orientated south. The hole faced south and was at a height of 2m. There was no evidence of bat use. There was potential for maternity/satellite/night/mating/swarming bat roost use.<br/>Potential Bat Roost Suitability: PRF-M<br/>Further Survey Requirements: PRF inspection survey – ladders.</p> <p>PRF 2: Knot-hole located on a major limb orientated south. The hole faced south and was at a height of 3-4m. There was no evidence of bat use. There was potential for maternity/satellite/night/mating/swarming bat roost use.<br/>Potential Bat Roost Suitability: PRF-M<br/>Further Survey Requirements: PRF inspection survey – ladders/ropes.</p> | | | |

| | | <p>PRF 3: Deadwood located on a minor limb orientated in all directions. The cracked limb faced all aspects and was at a height of 6m.</p> <p>There was no evidence of bat use. There was potential for day/night/feeding/transitional occasional bat roost use.</p> <p>Potential Bat Roost Suitability: PRF-I</p> <p>Further Survey Requirements: PRF inspection survey – ladders.</p> | | |

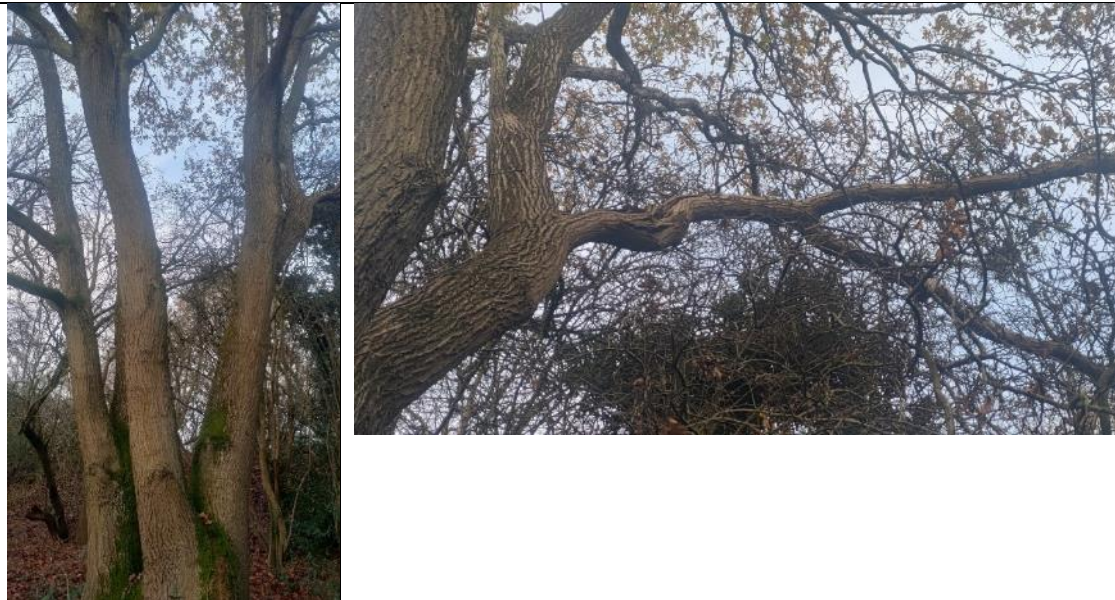
| | BT7 | Tree Description: | <p>Pedunculate oak</p> <p>PRF 1: Hazard-beam located on a minor limb orientated east. The hazard-beam faced south and was at a height of 6m. There was no evidence of bat use. There was potential for day/night/feeding/transitional occasional bat roost use.</p> <p>H&amp;S Considerations: None.</p> <p>Further Survey Requirements: PRF inspection survey – Ropes.</p> | | |

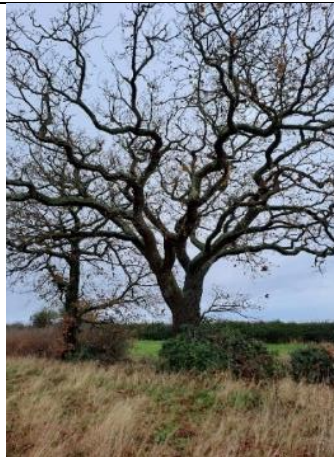
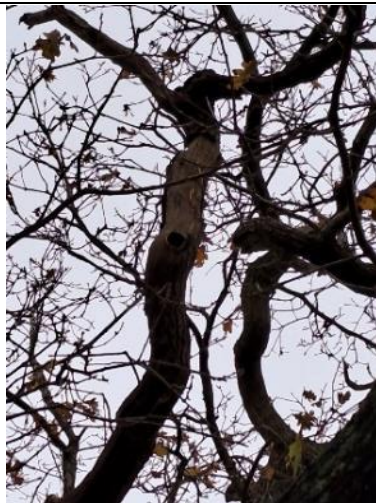
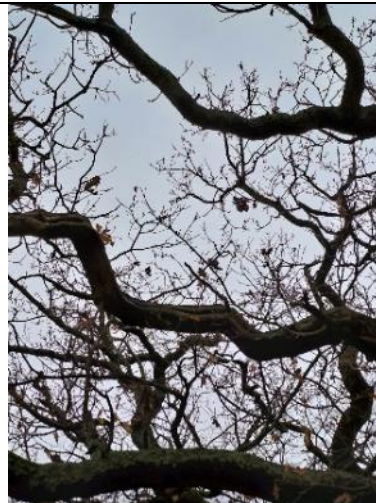
| BT19 | Tree Description: | <p>Pedunculate oak</p> <p>PRF 1: Woodpecker-hole located on a minor limb orientated south-west. The hole faced south-west and was at a height of 6m. There was no evidence of bat use. There was potential for maternity/satellite/night/mating/swarming bat roost use.</p> <p>Potential Bat Roost Suitability: PRF-M</p> <p>H&amp;S Considerations: None.</p> <p>Further Survey Requirements: PRF inspection survey – ropes.</p> | | | |

| | | <p>PRF 2: Crack along branch located on a minor limb orientated south-west. The crack faced south-west and was at a height of 7.5m. There was no evidence of bat use. There was potential for maternity/satellite/night/mating/swarming bat roost use.</p> <p>Potential Bat Roost Suitability: PRF-M</p> <p>H&amp;S Considerations: None.</p> <p>Further Survey Requirements: PRF inspection survey – ropes.</p> | | |

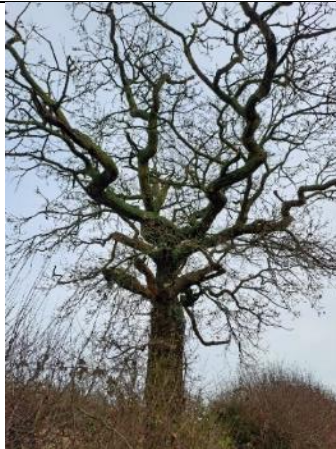
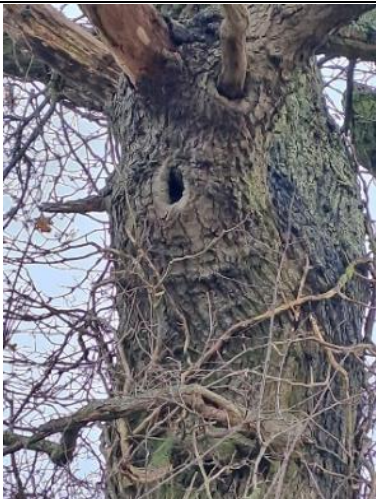
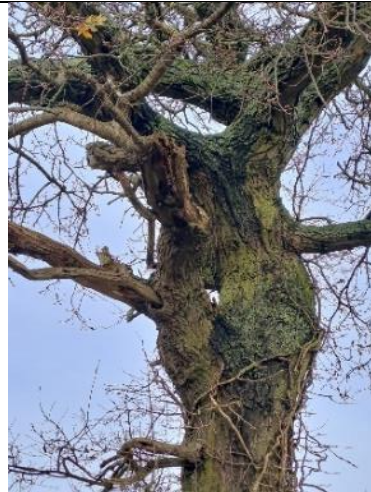
| BT21 | Tree Description: | <p>Pedunculate oak</p> <p>PRF 1: Knot-hole located on a stem orientated south. The hole faced south and was at a height of 2.5m. There was no evidence of bat use. There was potential for maternity/satellite/night/mating/swarming bat roost use.</p> <p>Potential Bat Roost Suitability: PRF-M</p> <p>H&amp;S Considerations: None.</p> <p>Further Survey Requirements: PRF inspection survey – ropes.</p> <p>PRF 2: Various other small PRFs around the tree in the form of cracks, small holes and splits located on a stem orientated south. The PRFs faced all aspects and were at a height of 3-5m. There was no evidence of bat use. There was potential for day/night/feeding/transitional occasional bat roost use.</p> | | | |

| | <p>Potential Bat Roost Suitability: PRF-I<br/>H&amp;S Considerations: None.<br/>Further Survey Requirements: PRF inspection survey – ropes.</p> | | | |

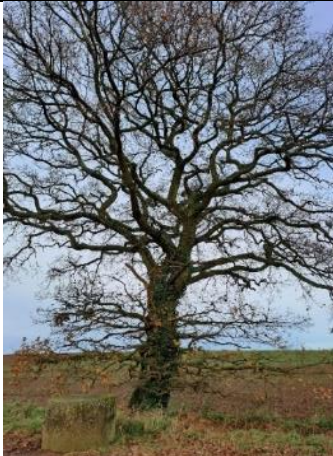
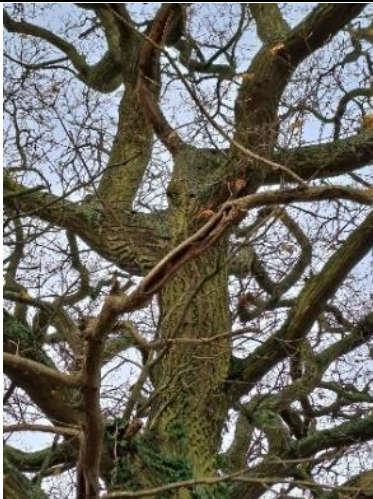
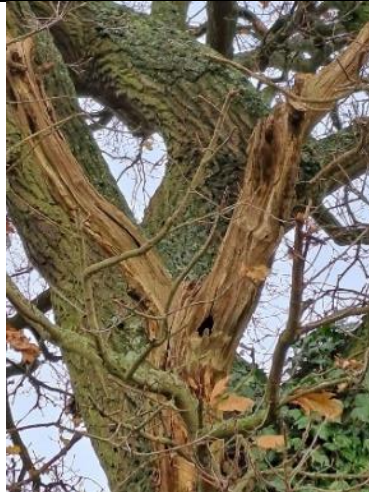
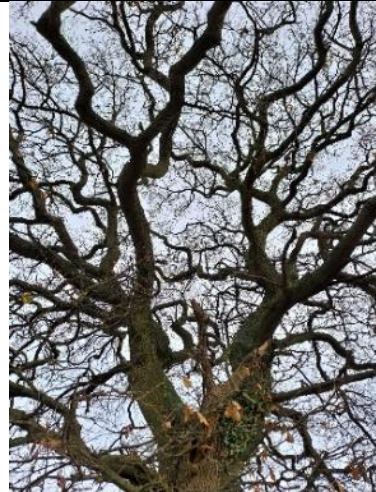
| | <p>Further Survey Requirements: PRF inspection survey – ropes.</p> <p>PRF 2: Hole in dead branch located on a minor limb orientated south. The hole faced south and was at a height of 3m. There was no evidence of bat use. There was potential for maternity/satellite/night/mating/swarming bat roost use.</p> <p>Potential Bat Roost Suitability: PRF-M</p> <p>H&amp;S Considerations: Proximity to water.</p> <p>Further Survey Requirements: PRF inspection survey – ropes.</p> <p>PRF 3: Various cracks and tears located on a major limb orientated all aspects. The cracks and tears faced all aspects and were at a height of 1-6m. There was no evidence of bat use. There was potential for maternity/satellite/night/mating/swarming bat roost use.</p> <p>Potential Bat Roost Suitability: PRF-M</p> <p>H&amp;S Considerations: Proximity to water.</p> <p>Further Survey Requirements: PRF inspection survey – ropes.</p> <p>Notes: If PRF inspection by ropes is not possible because of water, nocturnal emergence surveys will be required instead (2 NVAs and 2 surveyors).</p> |

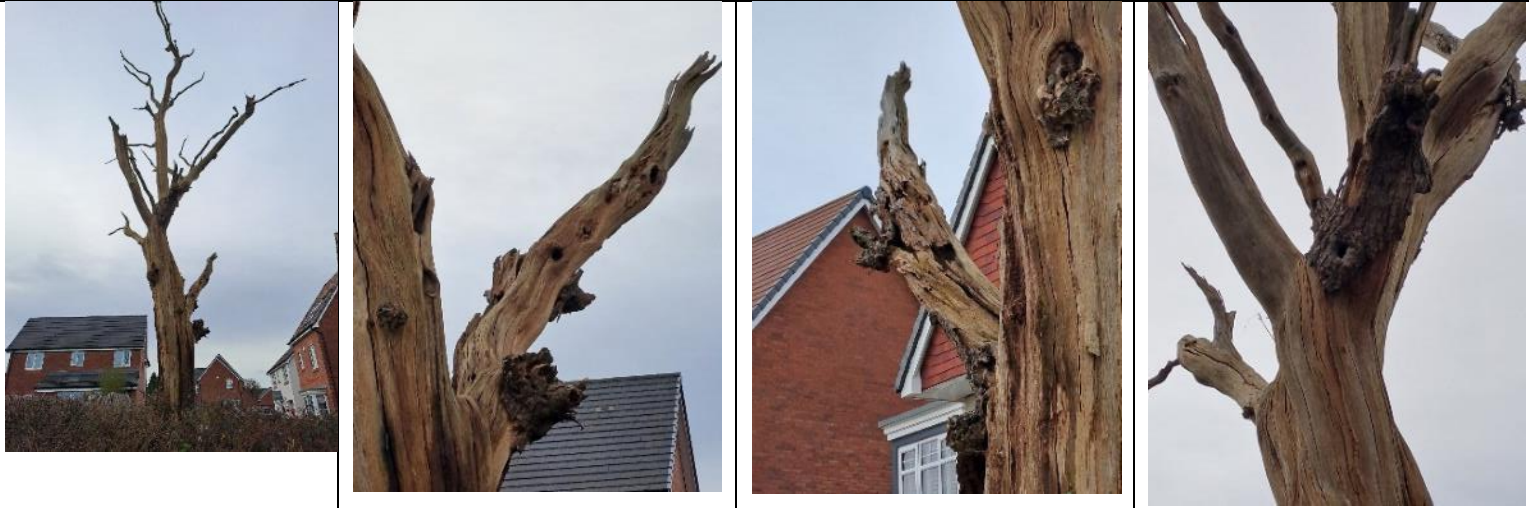
| | BT26 | Tree Description: | <p>Dead tree</p> <p>PRF 1: Numerous holes, cracks and splits located on all aspects of the stem which could lead to cavities. The PRFs faced all aspects and were at a height of 2-6m. There was no evidence of bat use. There was potential for maternity/satellite/night/mating/swarming bat roost use.</p> <p>H&amp;S Considerations: Unstable dead/diseased wood throughout.</p> <p>Further Survey Requirements: Presence/likely absence surveys – dusk emergence.</p> | | |

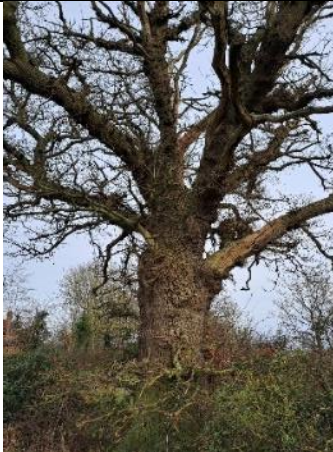
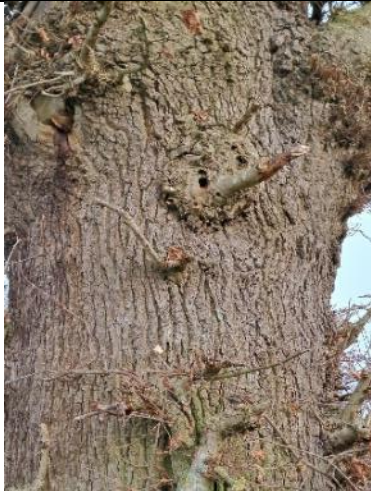
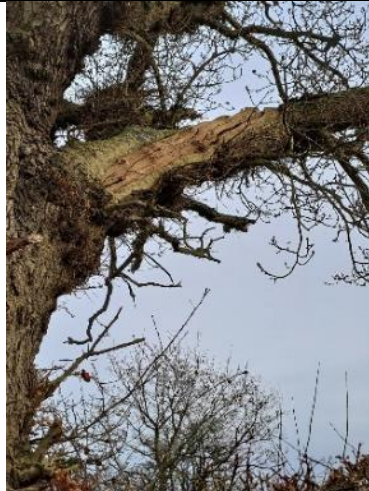
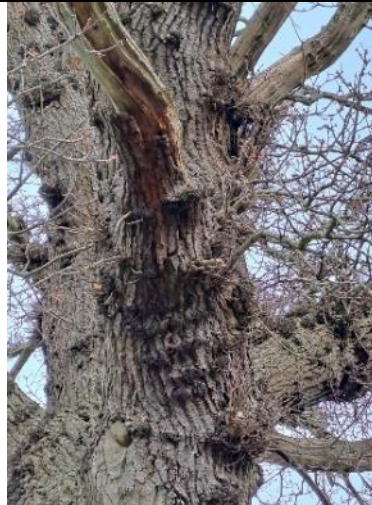
| Arb Reference | | T156 |
|---|---|---|
| BT45 | <p>Tree Description:</p> <p>Pedunculate oak</p> <p>PRF 1: Knot-hole located on the stem orientated south-west. The hole faced south-west and was at a height of 2m. There was no evidence of bat use. There was potential for maternity/satellite/night/mating/swarming bat roost use.<br/>Potential Bat Roost Suitability: PRF-M<br/>H&amp;S Considerations: Uneven ground surrounding.<br/>Further Survey Requirements: PRF inspection survey – ladders.</p> <p>PRF 2: Shearing-crack located on a major limb orientated south. The crack faced south and was at a height of 2-4m. There was no evidence of bat use. There was potential for day/night/feeding/transitional occasional bat roost use.<br/>Potential Bat Roost Suitability: PRF-I<br/>H&amp;S Considerations: Uneven ground surrounding.<br/>Further Survey Requirements: PRF inspection survey – ropes</p> <p>PRF 3: Lifting-bark located on a minor limb orientated south. The bark faced south and was at a height of 3m. There was no evidence of bat use. There was potential for day/night/feeding/transitional occasional bat roost use.<br/>Potential Bat Roost Suitability: PRF-I<br/>H&amp;S Considerations: uneven ground surrounding.<br/>Further Survey Requirements: PRF inspection survey – ropes</p> <p>PRF 4: Shearing-crack located on a minor limb orientated south-west. The crack faced south-west and was at a height of 3-4m. There was no evidence of bat use. There was potential for day/night/feeding/transitional occasional bat roost use.<br/>Potential Bat Roost Suitability: PRF-I<br/>H&amp;S Considerations: Uneven ground surrounding.<br/>Further Survey Requirements: PRF inspection survey – ropes</p> | |

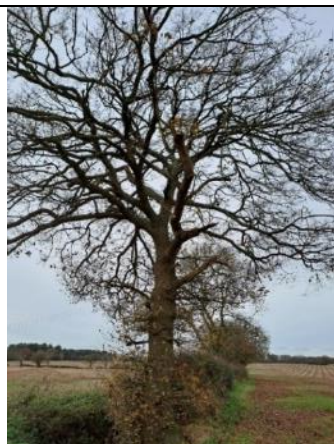
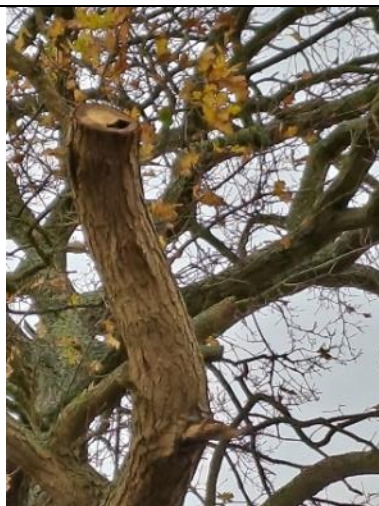
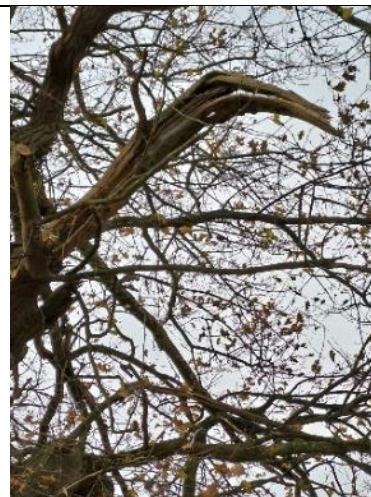
| BT48 | Tree Description: | <p>Pedunculate oak</p> <p>PRF 1: Pruning-cut located on a major limb orientated south. The cut faced south and was at a height of 6m. There was no evidence of bat use. There was potential for maternity/satellite/night/mating/swarming bat roost use.<br/>Potential Bat Roost Suitability: PRF-M<br/>H&amp;S Considerations: Uneven ground surrounding.<br/>Further Survey Requirements: PRF inspection survey – ropes.</p> <p>PRF 2: Shearing-crack located on a major limb orientated east. The crack faced east and was at a height of 3m. There was no evidence of bat use. There was potential for day/night/feeding/transitional occasional bat roost use.<br/>Potential Bat Roost Suitability: PRF-I<br/>H&amp;S Considerations: Uneven ground surrounding.</p> | | |

| | | Further Survey Requirements: PRF inspection survey – ropes. | | | |

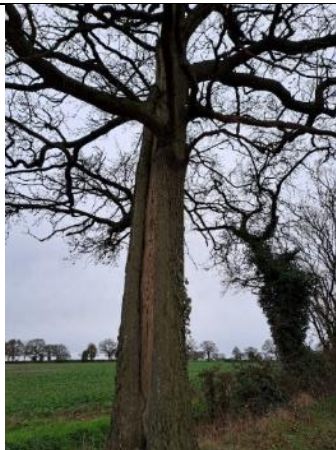
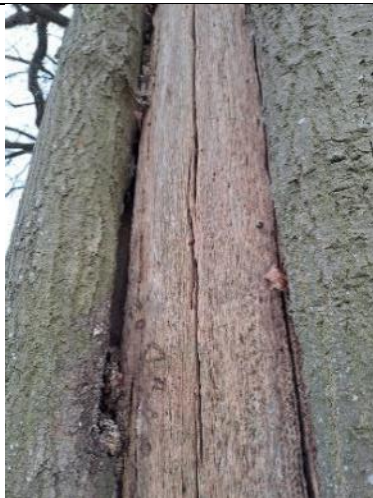
| | | <p>PRF 1: Desiccation-fissure located on the stem orientated east. The fissure faced east and was at a height of 0-8m. There was no evidence of bat use. There was potential for maternity/satellite/night/mating/swarming bat roost use.</p> <p>Potential Bat Roost Suitability: PRF-M</p> <p>H&amp;S Considerations: Uneven ground surrounding.</p> <p>Further Survey Requirements: PRF inspection survey – ladders.</p> | | |

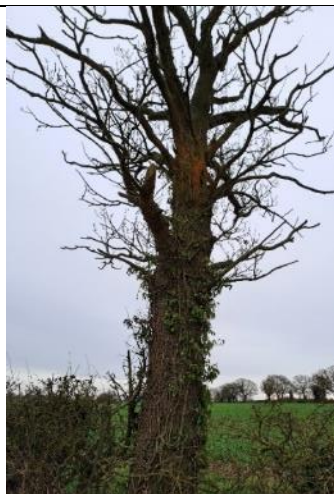
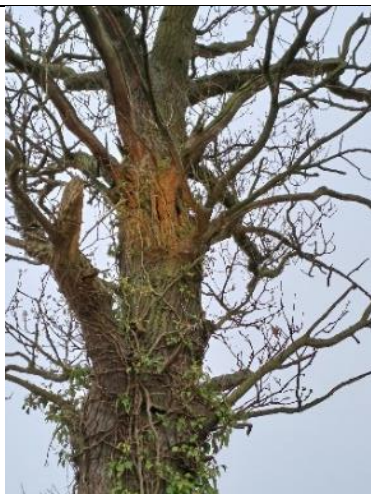
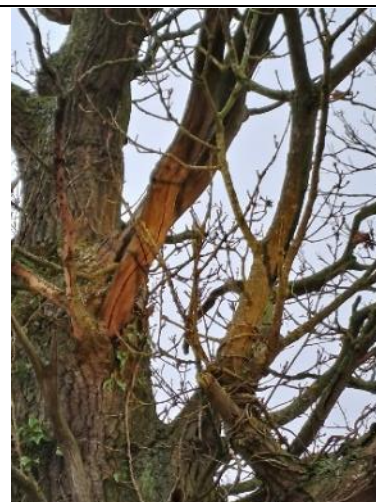
| BT52 | Tree<br>Description: | <p>Pedunculate oak</p> <p>PRF 1: Lifting-bark located on a major limb orientated west. The bark faced west and was at a height of 3m. There was no evidence of bat use. There was potential for day/night/feeding/transitional occasional bat roost use.<br/>Potential Bat Roost Suitability: PRF-I<br/>H&amp;S Considerations: Uneven ground surrounding.<br/>Further Survey Requirements: PRF inspection survey – ropes.</p> <p>PRF 2: Shearing-crack located on a minor limb orientated north. The crack faced north and was at a height of 3m. There was no evidence of bat use. There was potential for day/night/feeding/transitional occasional bat roost use.<br/>Potential Bat Roost Suitability: PRF-I<br/>H&amp;S Considerations: Uneven ground surrounding.</p> | | | |

| | | Further Survey Requirements: PRF inspection survey – ropes. | | |

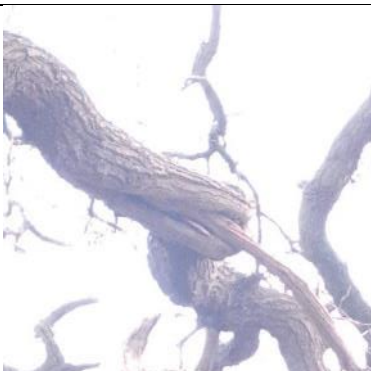
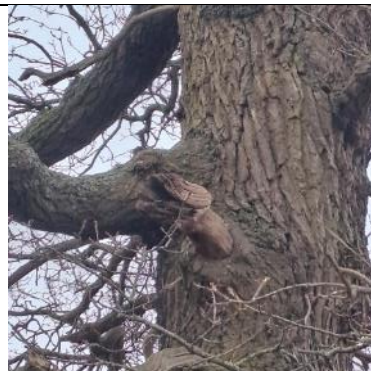
| BT58 | Tree Description: | <p>Pedunculate oak</p> <p>PRF 1: Fluting located on a major limb orientated east. The fluting faced east and was at a height of 4m. There was no evidence of bat use. There was potential for day/night/feeding/transitional occasional bat roost use.<br/>Potential Bat Roost Suitability: PRF-I<br/>H&amp;S Considerations: Proximity to water and uneven ground from the sloped banks of the ditch.<br/>Further Survey Requirements: PRF inspection survey – ropes.</p> <p>PRF 2: Subsidence-crack located on a minor limb orientated west. The crack faced all aspects and was at a height of 4m. There was no evidence of bat use. There was potential for day/night/feeding/transitional occasional bat roost use.<br/>Potential Bat Roost Suitability: PRF-I</p> | | | |

| | | H&S Considerations: Near a ditch with sloped banks.<br>Further Survey Requirements: PRF inspection survey – ladders. | | |

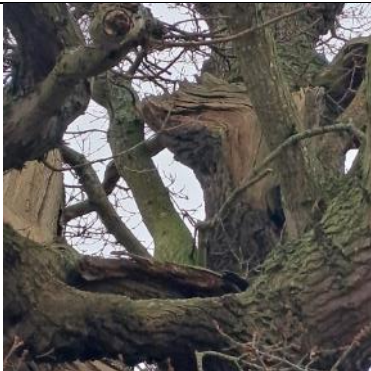
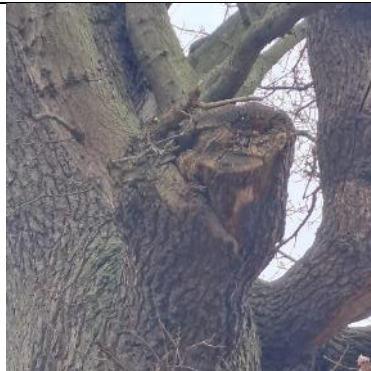
| BT59 | Tree Description: | <p>Pedunculate oak</p> <p>PRF 1: Subsidence-crack located on a major limb orientated south-west. The crack faced south-west and was at a height of 3-4m. There was no evidence of bat use. There was potential for day/night/feeding/transitional occasional bat roost use.</p> <p>Potential Bat Roost Suitability: PRF-I</p> <p>H&amp;S Considerations: Proximity to water and uneven ground from the sloped banks of the ditch.</p> <p>Further Survey Requirements: PRF inspection survey – ropes.</p> <p>PRF 2: Subsidence-crack located on a major limb orientated south. The crack faced south-west and was at a height of 4-5m. There was no evidence of bat use. There was potential for day/night/feeding/transitional occasional bat roost use.</p> <p>Potential Bat Roost Suitability: PRF-I</p> | | |

| | <p>H&amp;S Considerations: Proximity to water and near a ditch with sloped banks.<br/>Further Survey Requirements: PRF inspection survey – ropes.</p> <p>PRF 3: Pruning-cut located on a major limb orientated west. The cut faced north-west and was at a height of 3m. There was no evidence of bat use. There was potential for day/night/feeding/transitional occasional bat roost use.<br/>Potential Bat Roost Suitability: PRF-I<br/>H&amp;S Considerations: Proximity to water.<br/>Further Survey Requirements: PRF inspection survey – ladders/ropes.</p> | | | |

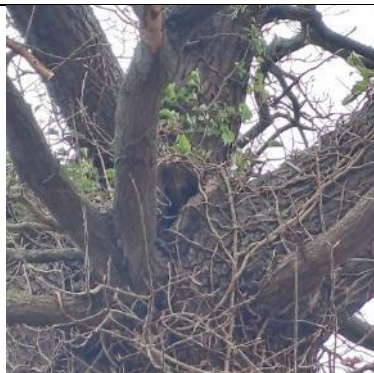
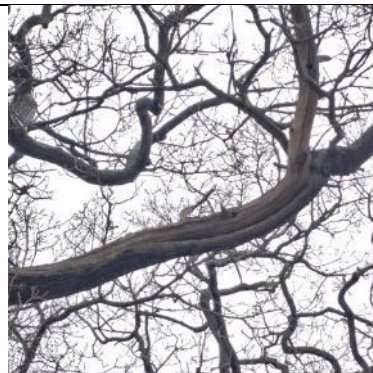
| | <p>H&amp;S Considerations: Proximity to water.<br/>Further Survey Requirements: PRF inspection survey – ladders.</p> <p>PRF 2: Branch cavity located on a minor limb orientated north-east. The cavity faced north-east and was at a height of 6m. There was no evidence of bat use. There was potential for day/night/feeding/transitional occasional bat roost use.</p> <p>Potential Bat Roost Suitability: PRF-I</p> <p>H&amp;S Considerations: PRF damage/disturbance likely.<br/>Further Survey Requirements: PRF inspection survey – ropes.</p> <p>PRF 3: Subsidence-crack located on a major limb orientated south-east. The crack faced south-east and was at a height of 5m. There was no evidence of bat use. There was potential for day/night/feeding/transitional occasional bat roost use.</p> <p>Potential Bat Roost Suitability: PRF-I</p> <p>H&amp;S Considerations: None.<br/>Further Survey Requirements: PRF inspection survey – ropes/ladders.</p> | | | |

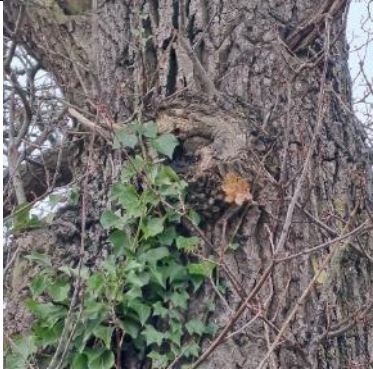
| | | PRF 2: Butt-rot located on the stem orientated north-west. The rot faced north-west and was at a height of 2m. There was no evidence of bat use. There was potential for day/night/feeding/transitional occasional bat roost use. Potential Bat Roost Suitability: PRF-I<br>H&S Considerations: Proximity to road.<br>Further Survey Requirements: PRF inspection survey – ladders. | | |

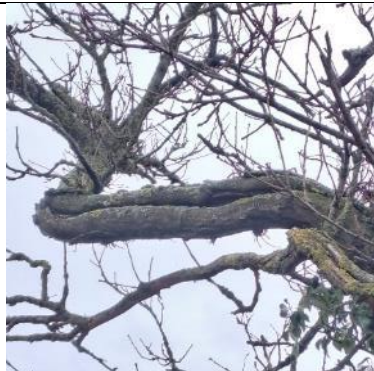
| BT72 | Tree Description: | <p>Pedunculate oak</p> <p>PRF 1: Desiccation-fissure located on a minor limb orientated north-west. The fissure faced north-west and was at a height of 2-3m. There was no evidence of bat use. There was potential for day/night/feeding/transitional occasional bat roost use.</p> <p>H&amp;S Considerations: Proximity to road and water.</p> <p>Further Survey Requirements: PRF inspection survey – ladders.</p> | | | |

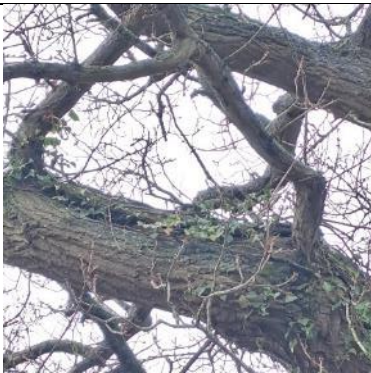
| | | <p>PRF 1: Desiccation-fissure located on a major limb orientated south. The fissure faced east and was at a height of 3.5m. There was no evidence of bat use. There was potential for maternity/satellite/night/mating/swarming bat roost use.</p> <p>H&amp;S Considerations: Proximity to water and steep ground.</p> <p>Further Survey Requirements: PRF inspection survey – ropes.</p> | | |

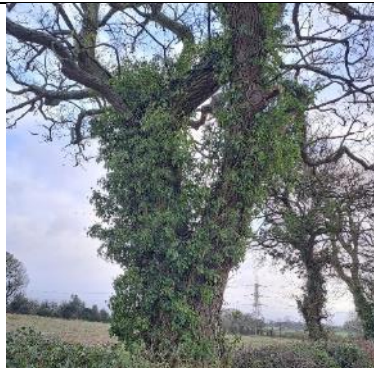
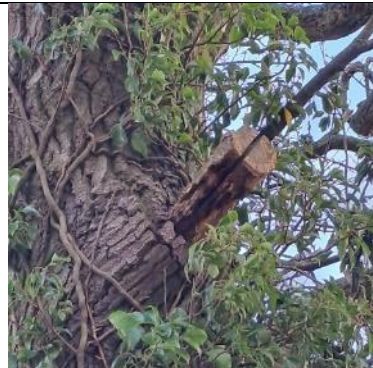
| | <p>PRF 1: Ivy cover (no PRF but may obscure other features) located on the stem oriented all aspects. The ivy faced all aspects and was at a height of 1-4m. There was no evidence of bat use. There was potential for maternity/satellite/night/mating/swarming bat roost use.</p> <p>Potential Bat Roost Suitability: PRF-M</p> <p>H&amp;S Considerations: Overhanging metal/spiked rails, steep ground and excessively boggy ground.</p> <p>Further Survey Requirements: PRF inspection survey – ropes.</p> <p>PRF 2: Desiccation-fissure located on a minor limb orientated west. The fissure faced west and was at a height of 3m. There was no evidence of bat use. There was potential for maternity/satellite/night/mating/swarming bat roost use.</p> <p>Potential Bat Roost Suitability: PRF-M</p> <p>H&amp;S Considerations: Overhanging metal/spiked rails and steep ground.</p> <p>Further Survey Requirements: PRF inspection survey – ladders.</p> | |

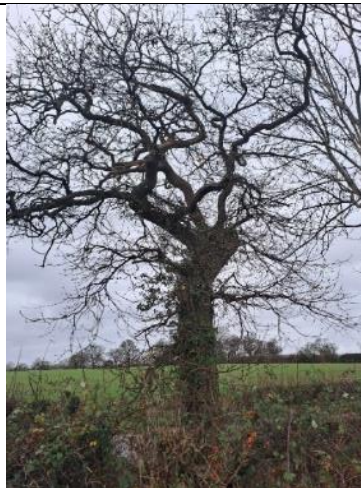
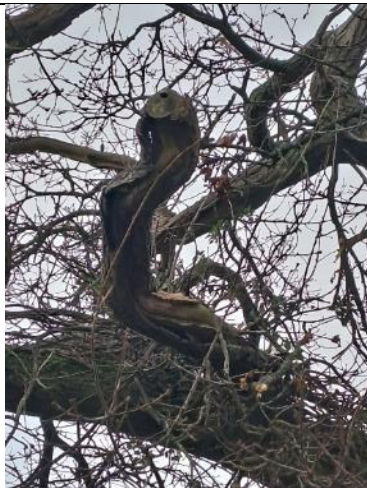
| BT115 | Tree Description: | <p>Pedunculate oak</p> <p>PRF 1: Lifted bark around a broken limb, and small hole in the end of a major limb oriented north-west. The PRFs faced north-west and were at a height of 3m. There was no evidence of bat use. There was potential for day/night/feeding/transitional occasional bat roost use.</p> <p>H&amp;S Considerations: Proximity to road and water.</p> | | |

| | Further Survey Requirements: Soft fell under supervision. | | | |

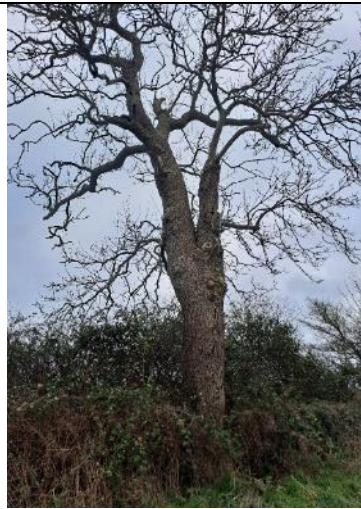
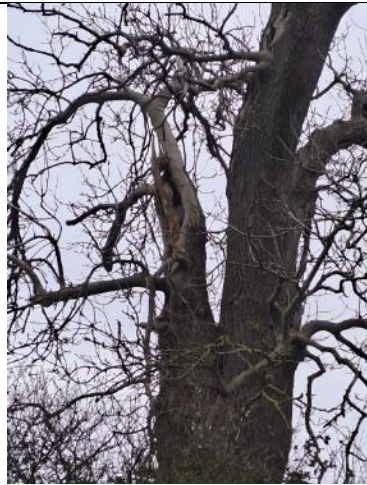
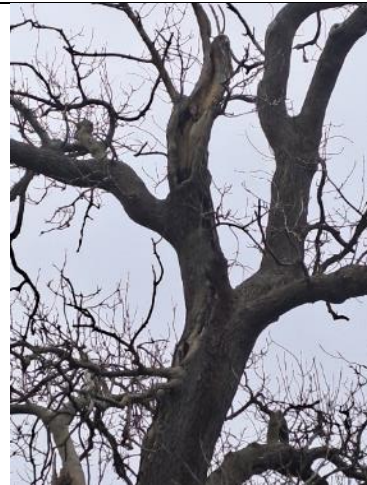
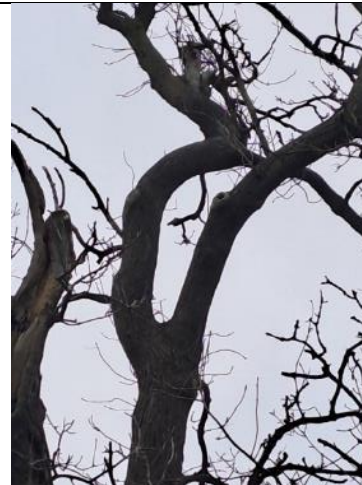
| BT118 | Tree Description: | <p>Ash</p> <p>PRF 1: Wound on the stem oriented south. The wound faced south and was at a height of 3-4m. There was no evidence of bat use. There was potential for maternity/satellite/night/mating/swarming bat roost use.</p> <p>Potential Bat Roost Suitability: PRF-M</p> <p>H&amp;S Considerations: Proximity to road and PRF damage/disturbance likely.</p> | | |

| | <p>Further Survey Requirements: PRF inspection survey – ropes.</p> <p>PRF 2: Wound on the stem oriented south. The wound faced south and was at a height of 5-6m. There was no evidence of bat use. There was potential for maternity/satellite/night/mating/swarming bat roost use.<br/>Potential Bat Roost Suitability: PRF-M<br/>H&amp;S Considerations: Proximity to road.<br/>Further Survey Requirements: PRF inspection survey – ropes.</p> <p>PRF 3: Knot-hole on a major limb oriented north-east. The hole faced south and was at a height of 6.5m. There was no evidence of bat use. There was potential for maternity/satellite/night/mating/swarming bat roost use.<br/>Potential Bat Roost Suitability: PRF-M<br/>H&amp;S Considerations: Proximity to road.<br/>Further Survey Requirements: PRF inspection survey – ropes.</p> <p>PRF 4: Trunk cavity on the stem oriented north-west. The cavity faced north-west and was at a height of 3-6m. There was no evidence of bat use. There was potential for maternity/satellite/night/mating/swarming bat roost use.<br/>Potential Bat Roost Suitability: PRF-M<br/>H&amp;S Considerations: Proximity to road.<br/>Further Survey Requirements: PRF inspection survey – ropes.</p> |

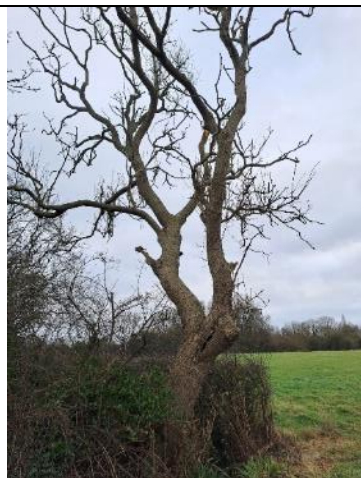
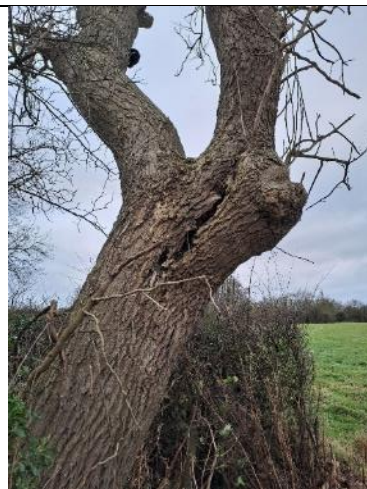
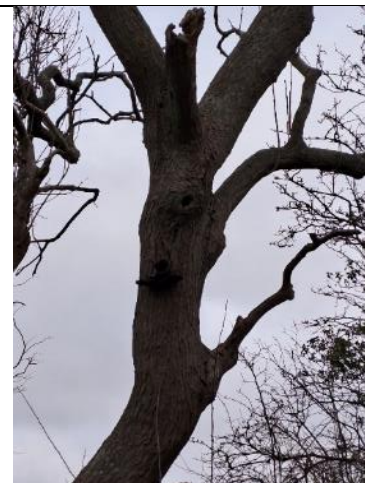
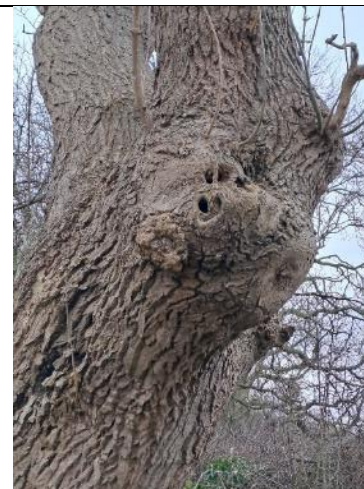
| | BT138 | Tree Description: | <p>Ash</p> <p>PRF 1: Wound on the stem oriented north. The wound faced north and was at a height of 2m. There was no evidence of bat use. There was potential for maternity/satellite/night/mating/swarming bat roost use.<br/>Potential Bat Roost Suitability: PRF-M<br/>H&amp;S Considerations: Proximity to water.<br/>Further Survey Requirements: PRF inspection survey – ropes.</p> <p>PRF 2: Various knot-holes and broken limbs on the stem oriented all aspects. The PRFs faced all aspects and were at a height of 2-6m. There was no evidence of bat use. There was potential for maternity/satellite/night/mating/swarming bat roost use.<br/>Potential Bat Roost Suitability: PRF-M<br/>H&amp;S Considerations: Proximity to water.</p> | | |

| | | Further Survey Requirements: PRF inspection survey – ropes. | | | |

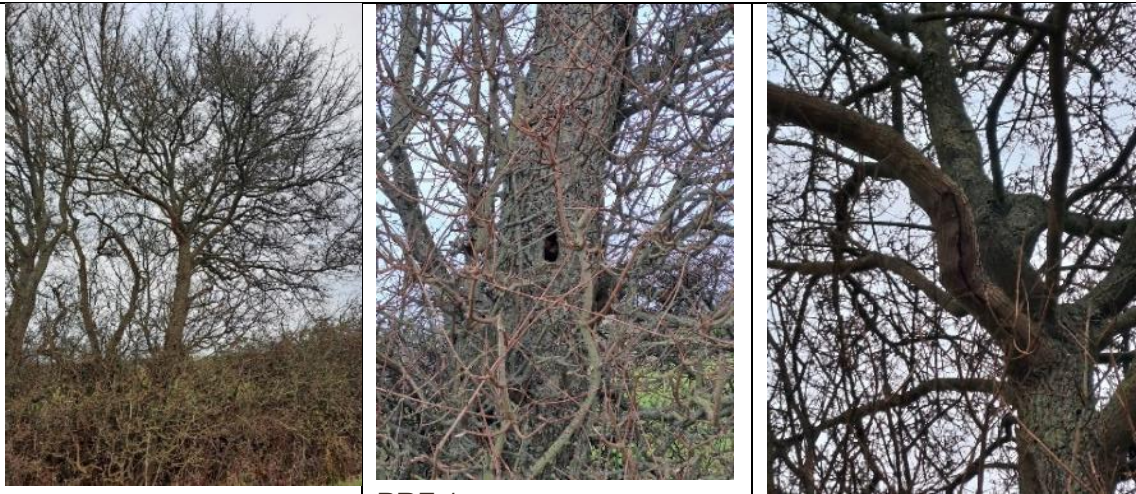
| Arb Reference | | T240 |
|---|---|---|
| BT140 | Tree Description: | <p>Pedunculate oak</p> <p>PRF 1: Knot-hole on the stem oriented west. The hole faced west and was at a height of 2m. There was no evidence of bat use. There was potential for day/night/feeding/transitional occasional bat roost use.<br/>Potential Bat Roost Suitability: PRF-I<br/>H&amp;S Considerations: Uneven ground surrounding and impenetrable vegetation.<br/>Further Survey Requirements: Soft-fell under bat-licenced supervision</p> <p>PRF 2: Desiccation-fissure on a major limb oriented south-west. The fissure faced south-west and was at a height of 4.5m. There was no evidence of bat use. There was potential for day/night/feeding/transitional occasional bat roost use.<br/>Potential Bat Roost Suitability: PRF-I<br/>H&amp;S Considerations: Uneven ground surrounding.<br/>Further Survey Requirements: Soft-fell under bat-licenced supervision</p> |

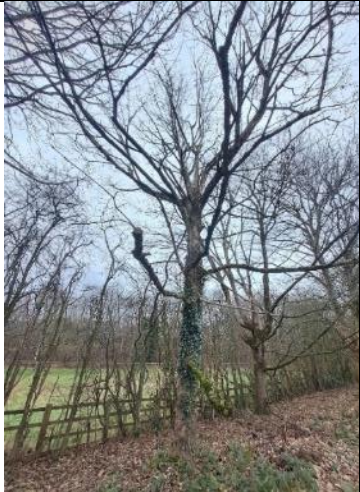
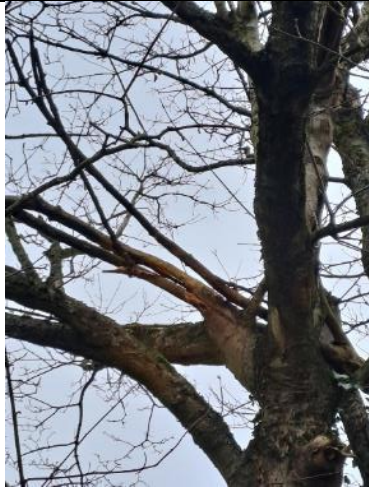
| BT154 | Tree Description: | <p>Sycamore</p> <p>PRF 1: Cracked branch a minor limb oriented north-west. The branch faced north-west and was at a height of 4m. There was no evidence of bat use. There was potential for maternity/satellite/night/mating/swarming bat roost use.</p> <p>H&amp;S Considerations: Proximity to road.</p> <p>Further Survey Requirements: Presence/likely absence surveys - dusk emergence.</p> | | | |

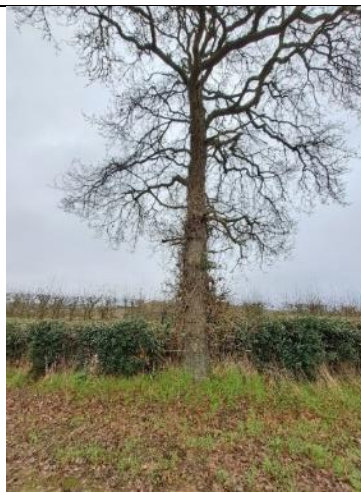
| BT166 | Tree Description: | <p>Pedunculate oak</p> <p>PRF 1: Desiccation-fissure on a minor limb oriented south-east. The fissure faced south-east and was at a height of 6m. There was no evidence of bat use. There was potential for day/night/feeding/transitional occasional bat roost use.</p> <p>H&amp;S Considerations: Proximity to road and steep ground.</p> <p>Further Survey Requirements: PRF inspection survey – ropes.</p> | | |

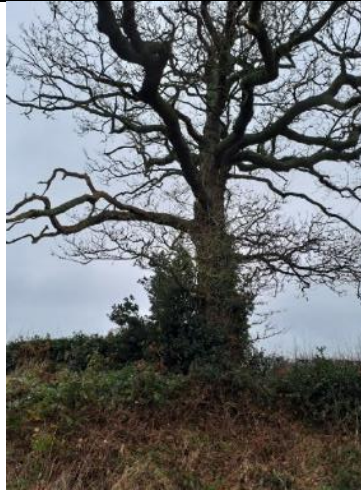
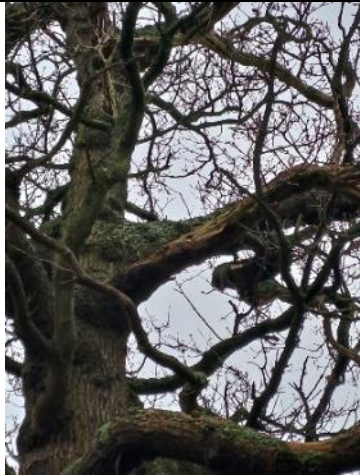
| BT168 | Tree Description: | <p>Pedunculate oak</p> <p>PRF 1: Desiccation-fissure on a major limb oriented all aspects. The fissure faced all aspects and was the height of the tree. There was no evidence of bat use. There was potential for maternity/satellite/night/mating/swarming bat roost use.</p> <p>H&amp;S Considerations: Proximity to road, steep ground and proximity to water.</p> <p>Further Survey Requirements: PRF inspection survey – ropes.</p> <p>Note: Multiple branches with fissures/dead features. There were no obvious cavities, but it was a large oak so likely to be suitable.</p> | | | |

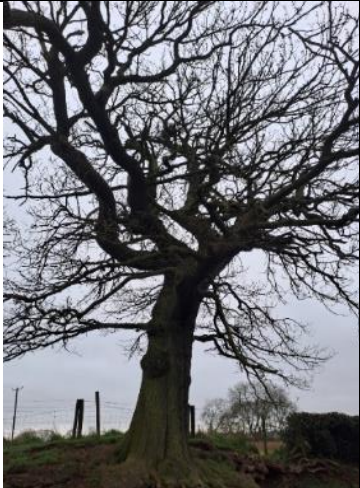
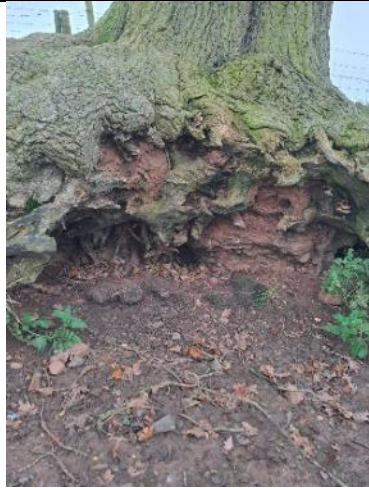
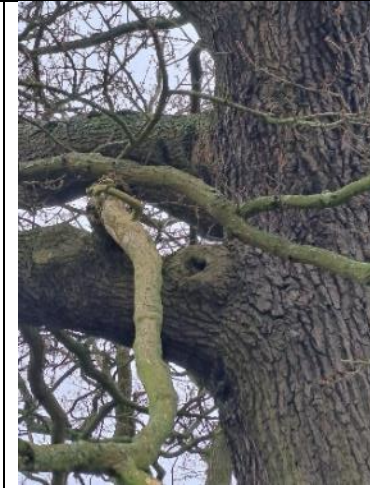
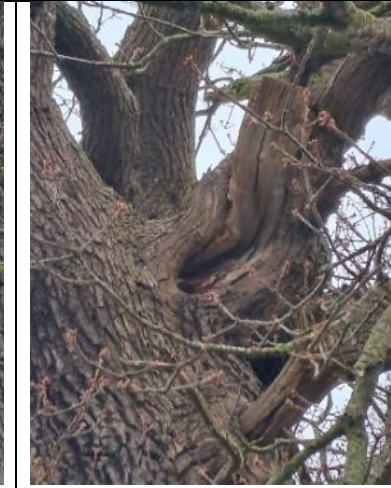
| | BT173 | Tree Description: | <p>Pedunculate oak</p> <p>PRF 1: Butt-rot on the stem oriented south-east. The rot faced south-east and was at a height of 0m. There was no evidence of bat use. There was potential for maternity/satellite/night/mating/swarming bat roost use.<br/>Potential Bat Roost Suitability: PRF-M<br/>H&amp;S Considerations: Barbed wire.<br/>Further Survey Requirements: PRF inspection survey – ground level.</p> <p>PRF 2: Knot-hole on a major limb oriented south-east. The hole faced south-east and was at a height of 2.5m. There was no evidence of bat use. There was potential for maternity/satellite/night/mating/swarming bat roost use.<br/>Potential Bat Roost Suitability: PRF-M<br/>H&amp;S Considerations: Barbed wire.<br/>Further Survey Requirements: PRF inspection survey – ropes.</p> | | |

| | | <p>PRF 3: Branch cavity on the stem oriented east. The cavity faced east and was at a height of 4m. There was no evidence of bat use. There was potential for maternity/satellite/night/mating/swarming bat roost use.<br/>Potential Bat Roost Suitability: PRF-M<br/>H&amp;S Considerations: Barbed wire.<br/>Further Survey Requirements: PRF inspection survey – ropes.</p> <p>PRF 4: Knot-hole on a major limb oriented west. The hole faced west and was at a height of 4m. There was no evidence of bat use. There was potential for maternity/satellite/night/mating/swarming bat roost use.<br/>Potential Bat Roost Suitability: PRF-M<br/>H&amp;S Considerations: Barbed wire.<br/>Further Survey Requirements: PRF inspection survey – ropes.</p> <p>Note: There were a further knot-holes and cavities on the tree not recorded in detail.</p> |

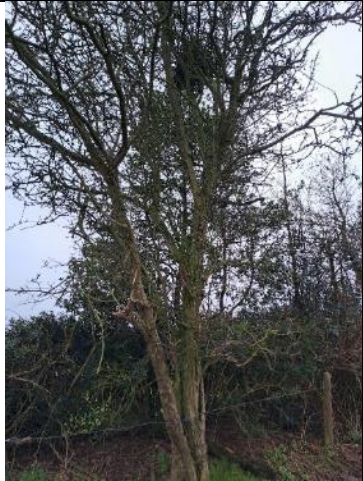
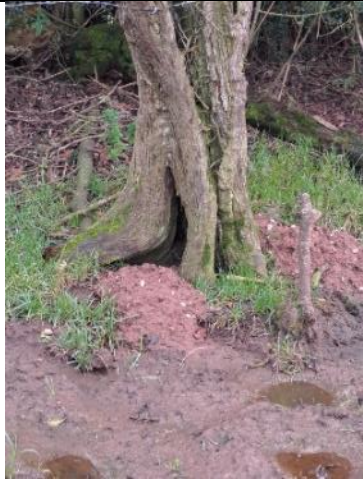
| BT177 | Tree Description: | <p>Hawthorn</p> <p>PRF 1: Butt-rot on the stem oriented west. The rot faced west and was at a height of 0m. There was no evidence of bat use. There was potential for day/night/feeding/transitional occasional bat roost use.</p> <p>H&amp;S Considerations: None.</p> <p>Further Survey Requirements: PRF inspection survey – ground level</p> | | | |

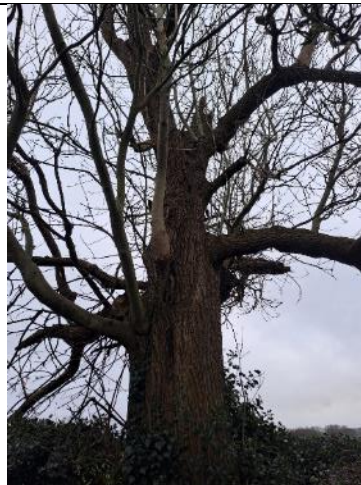
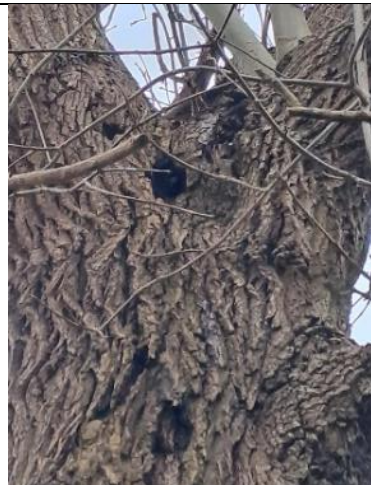
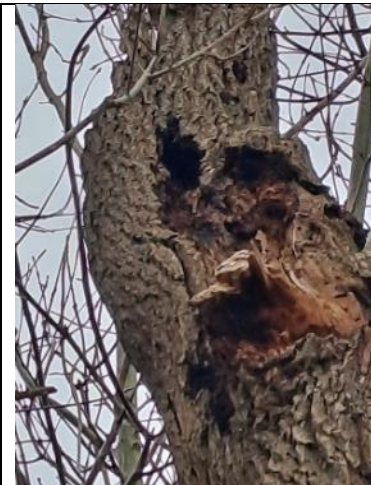
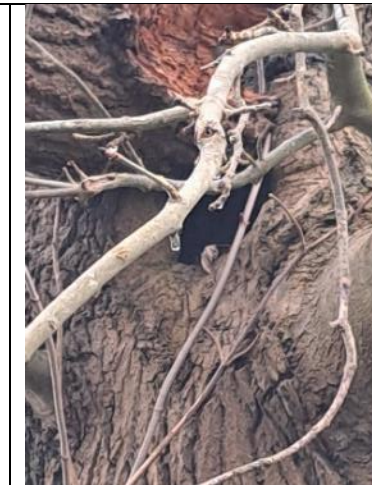
| | | <p>Further Survey Requirements: PRF inspection survey – ropes.</p> <p>PRF 3: Knot-hole on the stem oriented east. The hole faced east and was at a height of 3m. There was no evidence of bat use. There was potential for maternity/satellite/night/mating/swarming bat roost use.</p> <p>Potential Bat Roost Suitability: PRF-M</p> <p>H&amp;S Considerations: None.</p> <p>Further Survey Requirements: PRF inspection survey – ropes.</p> <p>Note: Loose branch hanging in the tree. Could fall and cause harm.</p> | | | | |

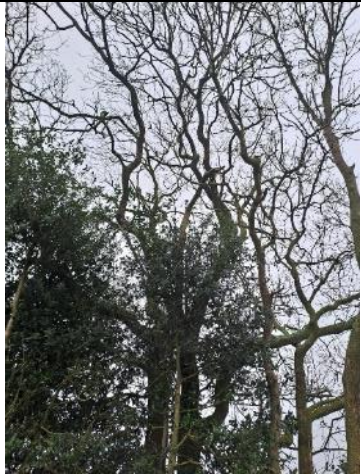
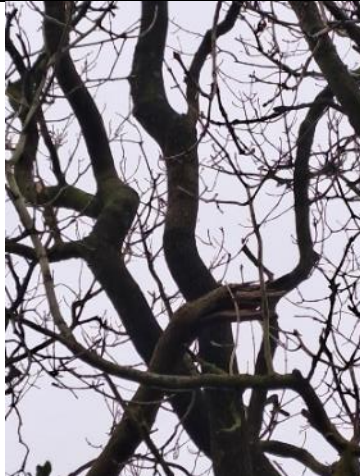
| BT183 | Tree Description: | <p>Ash</p> <p>PRF 1: Subsidence-crack on a minor limb oriented north. The crack faced north-west and was at a height of 4m. There was no evidence of bat use. There was potential for day/night/feeding/transitional occasional bat roost use.</p> <p>H&amp;S Considerations: Proximity to footpaths.</p> <p>Further Survey Requirements: PRF inspection survey – ropes.</p> | | |

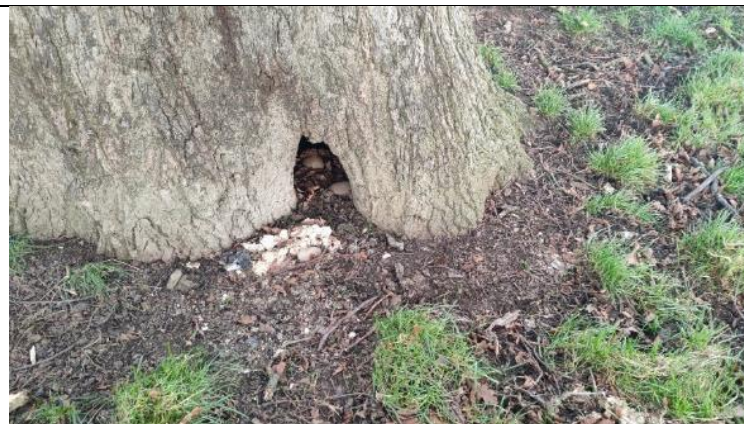
| BT195 | Tree Description: | <p>Pedunculate oak</p> <p>PRF 1: Butt-rot on the stem oriented south. The rot faced south and was at a height of 0m. There was no evidence of bat use. There was potential for maternity/satellite/night/mating/swarming bat roost use.</p> <p>Potential Bat Roost Suitability: PRF-M</p> <p>H&amp;S Considerations: None.</p> <p>Further Survey Requirements: Presence/likely absence surveys - dusk emergence.</p> <p>PRF 2: Dead limb (starting to form knot hole but dead splintered wood has associated cavities too) on the stem oriented south. The limb faced south and was at a height of 6m. There was no evidence of bat use. There was potential for maternity/satellite/night/mating/swarming bat roost use.</p> | | | |

| | <p>Potential Bat Roost Suitability: PRF-M<br/>H&amp;S Considerations: Unstable dead/diseased wood throughout.<br/>Further Survey Requirements: PRF inspection survey – ropes. If the tree is unsafe to climb due to the dead/diseased wood, then nocturnal surveys will be required.</p> <p>PRF 3: A dead limb becoming an upwards facing knot-hole on the stem oriented east. The limb faced east and was at a height of 5m. There was no evidence of bat use. There was potential for day/night/feeding/transitional occasional bat roost use.</p> <p>Potential Bat Roost Suitability: PRF-I<br/>H&amp;S Considerations: Unstable dead/diseased wood throughout.<br/>Further Survey Requirements: PRF inspection survey – ropes. If the tree is unsafe to climb due to the dead/diseased wood, then nocturnal surveys will be required.</p> <p>PRF 4: Tear-out on the stem oriented south. The tear-out faced south and was at a height of 10m. There was no evidence of bat use. There was potential for maternity/satellite/night/mating/swarming bat roost use.</p> <p>Potential Bat Roost Suitability: PRF-M<br/>H&amp;S Considerations: Unstable dead/diseased wood throughout.<br/>Further Survey Requirements: PRF inspection survey – ropes. If the tree is unsafe to climb due to the dead/diseased wood, then nocturnal surveys will be required.</p> |

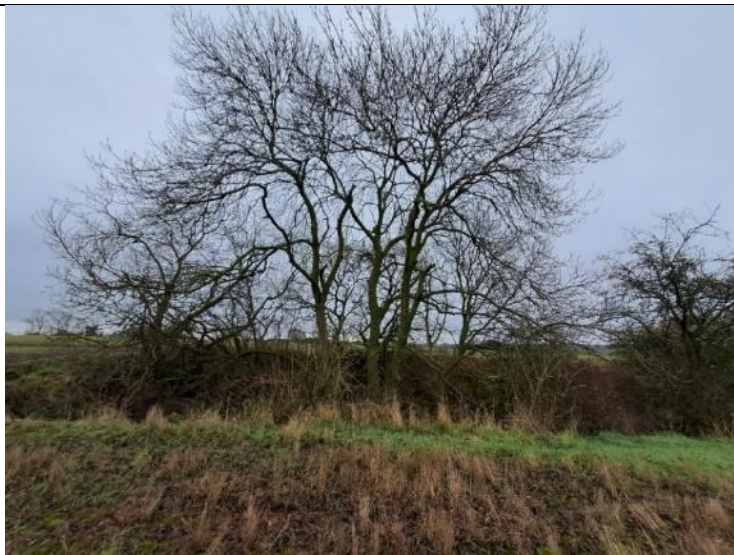
| BG10 | Tree Description: | <p>Ash</p> <p>PRF 1: Subsidence-crack located on a minor limb oriented west. The crack faced south-west and was at a height of 5m. There was no evidence of bat use. There was potential for day/night/feeding/transitional occasional bat roost use.</p> <p>H&amp;S Considerations: Steep ground. There was a dry pond however this may hold water at other times of the year.</p> <p>Further Survey Requirements: If pruning, soft fell under supervision.</p> | |

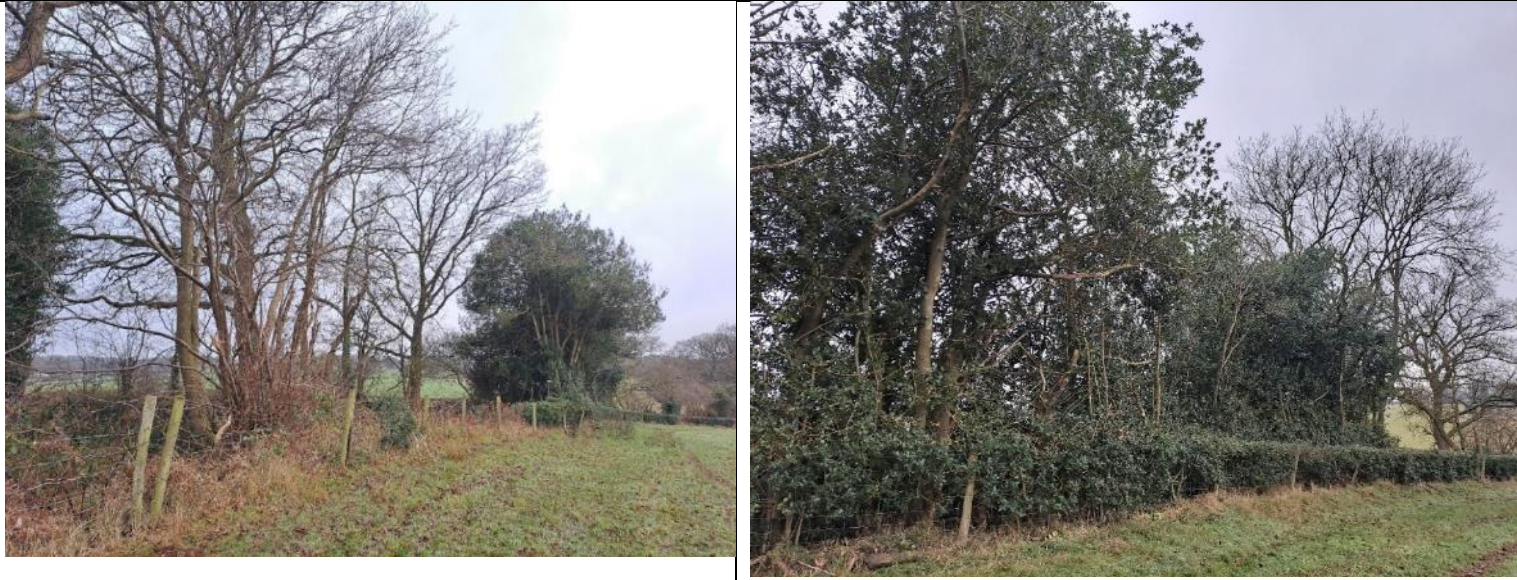
| | BG11 | Tree Description: | <p>Ash</p> <p>PRF 1: Subsidence-crack located on a stem oriented all aspects. The crack faced south-west and was at a height of 2-4m. There was no evidence of bat use. There was potential for day/night/feeding/transitional occasional bat roost use.</p> <p>H&amp;S Considerations: Proximity to footpaths.</p> <p>Further Survey Requirements: PRF inspection survey – ropes.</p> <p>Note: Numerous trees were along the hedgerow on the field side with small PRF-Is grouped together as one. Ropes, endoscope from ground and ladder survey methods all possible.</p> | |
