## Oldbury to Meriden, Warwickshire

# Ground Level Tree Assessment Report

**Prepared For: Severn Trent Water**

Document Reference: 10408.04.001

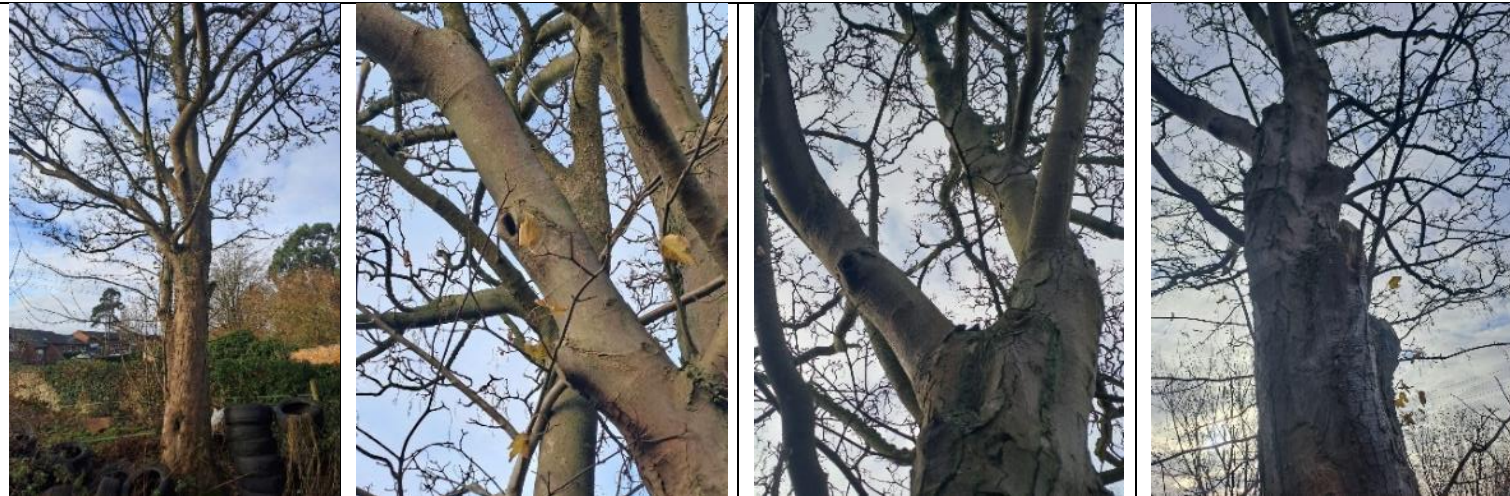
| BT1 | Tree Description: | <p>Sycamore <i>Acer pseudoplatanus</i></p> <p>PRF 1: Multiple knot-holes located on a stem orientated all aspects. The holes were located around the tree and assessed as one PRF. The holes were at a height of 3-4m.</p> <p>There was no evidence of bat use. There was potential for day/night/feeding/transitional occasional bat roost use.</p> <p>H&amp;S Considerations: Proximity to road.</p> <p>Further Survey Requirements: PRF inspection survey – ladders.</p> |

| | Categorisation of Potential Bat Roost Habitat Suitability | | | | | PRF-I |

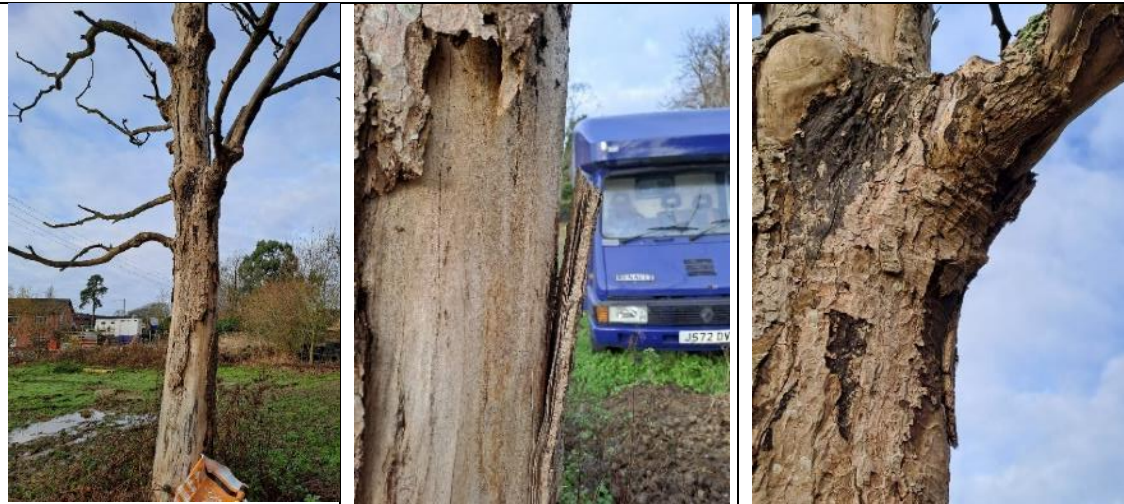
| | BT2 | Tree Description: | Dead tree<br><br>PRF 1: Lifting bark located on entire stem. The lifting bark faced all orientations and was at a height of 0-6m. There was no evidence of bat use. There was potential for day/night/feeding/transitional occasional bat roost use.<br>H&S Considerations: Unstable dead/diseased wood throughout.<br>Further Survey Requirements: PRF inspection from ground level. One surveyor. | | | |

| | Categorisation of Potential Bat Roost Habitat Suitability | | | PRF-I |

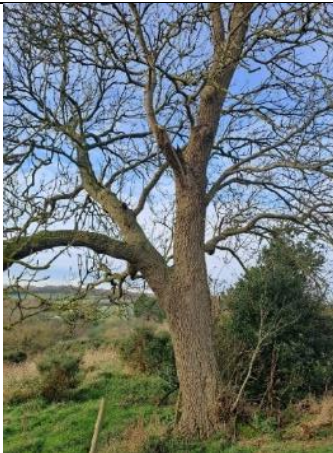
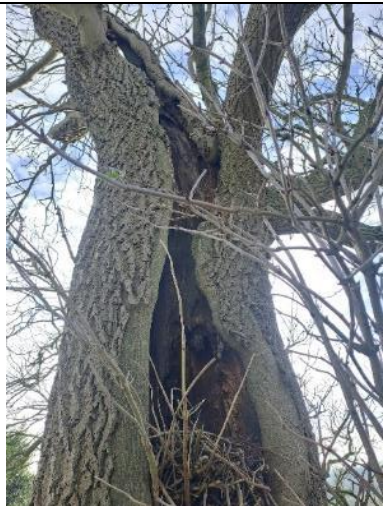
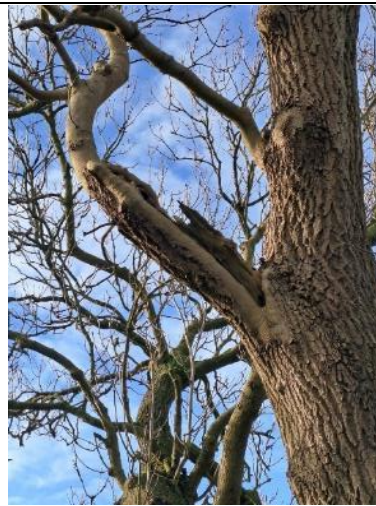
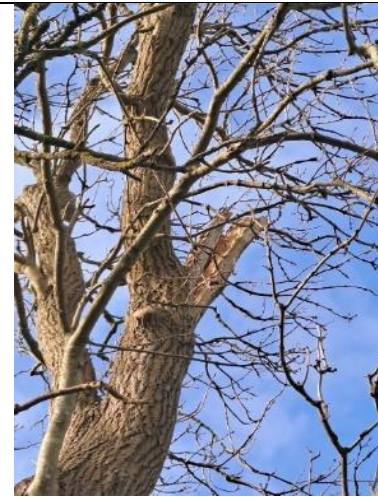
| BT4 | Tree Description: | <p>Ash <i>Fraxinus excelsior</i></p> <p>PRF 1: Wound located on a stem orientated east. The wound faced west and was at a height of 1-3m. There was no evidence of bat use. There was potential for maternity/satellite/night/mating/swarming bat roost use. Potential Bat Roost Suitability: PRF-M</p> <p>H&amp;S Considerations: Uneven ground surrounding and barbed wire fence. Further Survey Requirements: Presence/likely absence surveys – dusk emergence.</p> <p>PRF 2: Wound located on a major limb orientated east. The wound faced east and was at a height of 5-6m. There was no evidence of bat use. There was potential for maternity/satellite/night/mating/swarming bat roost use. Potential Bat Roost Suitability: PRF-M</p> <p>H&amp;S Considerations: Uneven ground surrounding and barbed wire fence. Further Survey Requirements: Presence/likely absence surveys – dusk emergence.</p> <p>PRF 3: Cracked limb located on a stem orientated east. The cracked limb faced north and was at a height of 7m.</p> | | | |

| | | <p>There was no evidence of bat use. There was potential for maternity/satellite/night/mating/swarming bat roost use.<br/>Potential Bat Roost Suitability: PRF-M<br/>H&amp;S Considerations: Uneven ground surrounding and barbed wire fence.<br/>Further Survey Requirements: Presence/likely absence surveys – dusk emergence.</p> <p>PRF 4: Knot-hole located on a stem orientated east. The hole faced south and was at a height of 3m.<br/>There was no evidence of bat use. There was potential for maternity/satellite/night/mating/swarming bat roost use.<br/>Potential Bat Roost Suitability: PRF-M<br/>H&amp;S Considerations: Uneven ground surrounding and barbed wire fence.<br/>Further Survey Requirements: Presence/likely absence surveys – dusk emergence.</p> |

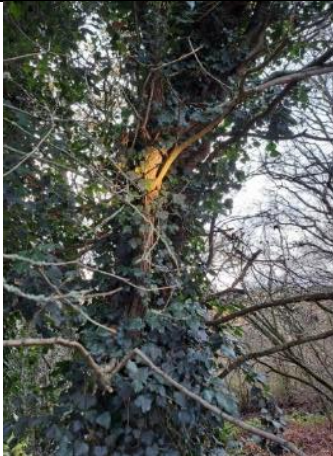
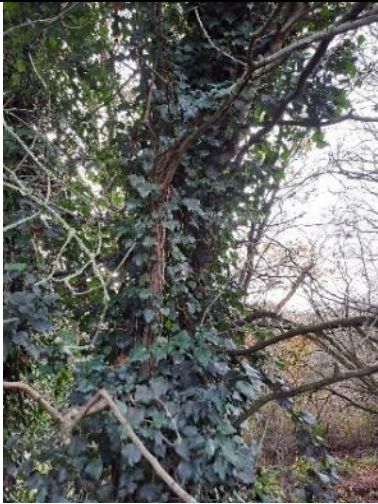
| BT6 | Tree Description: | <p>Hawthorn <i>Crataegus monogyna</i></p> <p>PRF 1: Ivy cover mature (&gt;50mm diameter, lattice forming) located on a stem orientated all aspects. The ivy faced all aspects and was at a height of 1-12m. The ivy creates a PRF and could potentially be hiding other PRFs.</p> <p>There was no evidence of bat use. There was potential for day/night/feeding/transitional occasional bat roost use.</p> <p>H&amp;S Considerations: Steep ground.</p> <p>Further Survey Requirements: PRF inspection survey – Ropes.</p> | | |

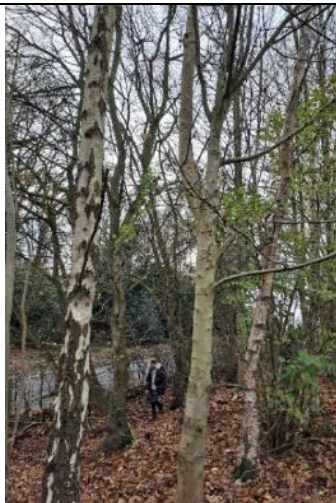
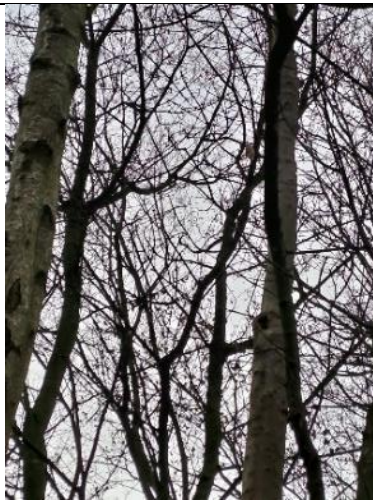
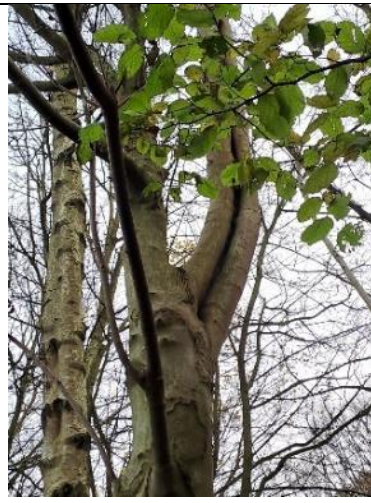
| | BT8 | Tree Description: | <p>Sycamore</p> <p>PRF 1: Knot-hole located on a stem orientated north-east. The hole faced north-east and was at a height of 4-5m. There was no evidence of bat use. There was potential for day/night/feeding/transitional occasional bat roost use. Potential Bat Roost Suitability: PRF-I</p> <p>H&amp;S Considerations: None.</p> <p>Further Survey Requirements: Soft fell rather than close inspection survey. Difficult to climb and there are no anchor points.</p> |

| | | <p>PRF 2: Split stem orientated north-west. The split stem faced north-west and was at a height of 4m. There was no evidence of bat use. There was potential for day/night/feeding/transitional occasional bat roost use.</p> <p>Potential Bat Roost Suitability: PRF-I</p> <p>H&amp;S Considerations: None.</p> <p>Further Survey Requirements: Soft fell.</p> | | |

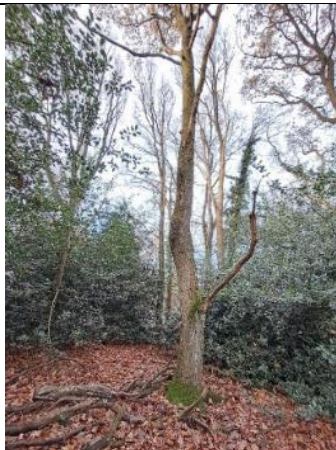
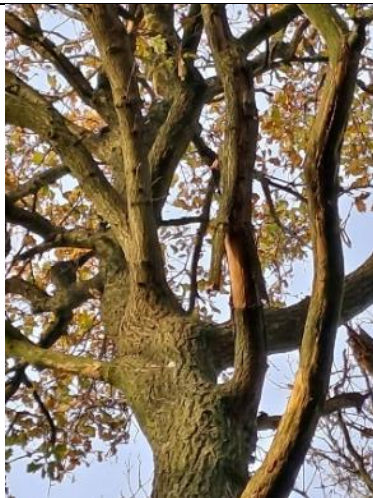
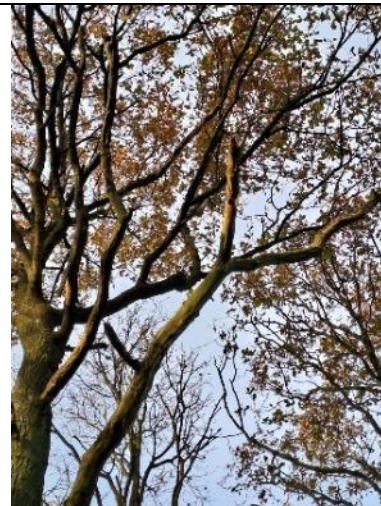
| BT9 | Tree Description: | <p>Pedunculate oak</p> <p>PRF 1: Lifting-bark located on a major limb orientated south-east. The bark faced south-east and was at a height of 6-8m. There was no evidence of bat use. There was potential for day/night/feeding/transitional occasional bat roost use.</p> <p>H&amp;S Considerations: None.</p> <p>Further Survey Requirements: PRF inspection survey – MEWP/scaffold; PRK inspection survey – ropes</p> | | |

| | | Notes: x2 split limbs/lifting bark on south-west elevation both PRF-I | | |

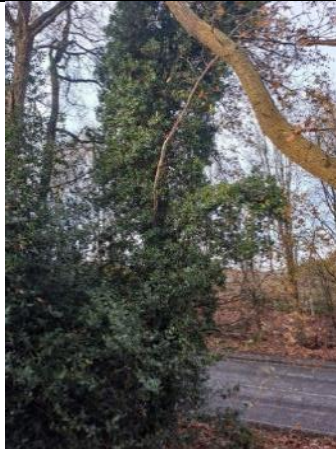
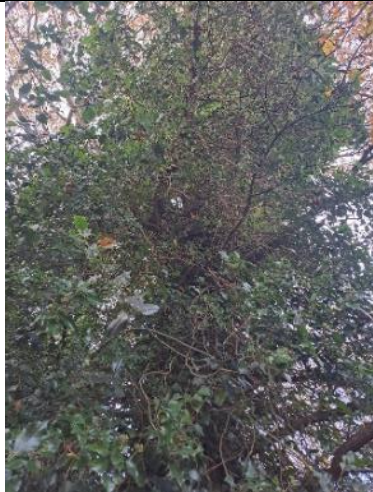
| | BT11 | Tree Description: | <p>Pedunculate oak</p> <p>PRF 1: Ivy cover mature (&gt;50mm diameter, lattice forming) located on a stem orientated all aspects. The ivy faced all aspects and was at a height of 0-15m. The ivy creates a PRF and could potentially be hiding other PRFs. There was no evidence of bat use. There was potential for day/night/feeding/transitional occasional bat roost use.</p> <p>H&amp;S Considerations: Proximity to road.</p> <p>Further Survey Requirements: Soft fell</p> | | |

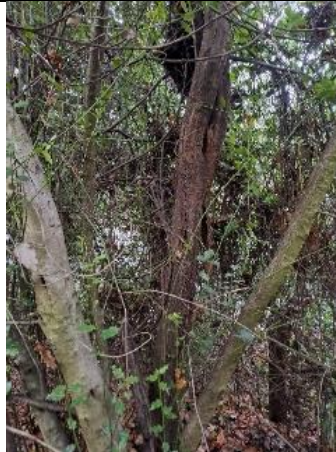
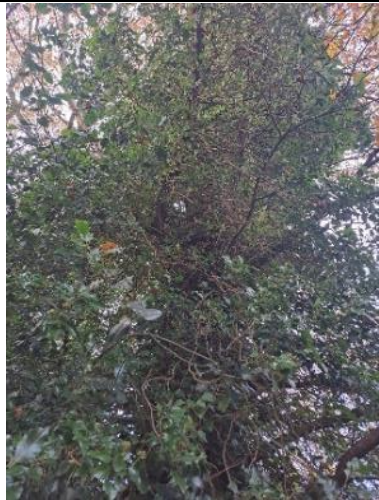
| BT12 | Tree Description: | <p>Holly <i>Ilex aquifolium</i></p> <p>PRF 1: Lifting-bark located on a stem orientated north-east. The bark faced north-east and was at a height of 1.5m. There was no evidence of bat use. There was potential for day/night/feeding/transitional occasional bat roost use.</p> <p>H&amp;S Considerations: Proximity to road.</p> <p>Further Survey Requirements: PRF inspection from ground.</p> | | | |

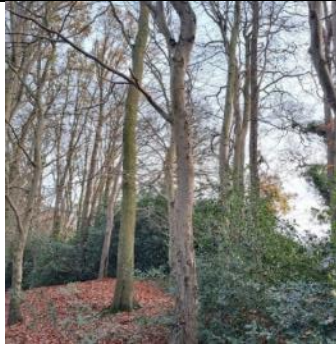
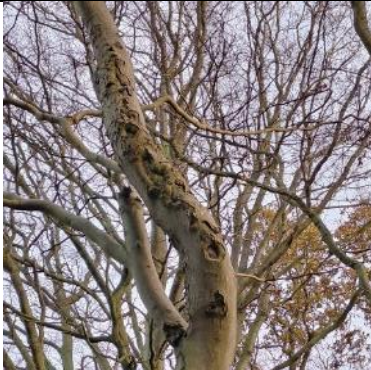
| | BT13 | Tree Description: | <p>Beech species <i>Fagus sp.</i></p> <p>PRF 1: Canker located on a stem orientated south-west. The canker faced south-west and was at a height of 6-7m. There was no evidence of bat use. There was potential for day/night/feeding/transitional occasional bat roost use.</p> <p>H&amp;S Considerations: Proximity to road.</p> <p>Further Survey Requirements: PRF inspection survey – ropes.</p> | | |

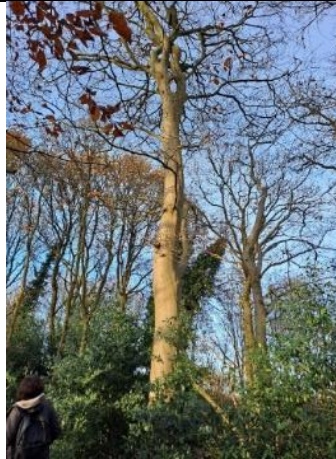
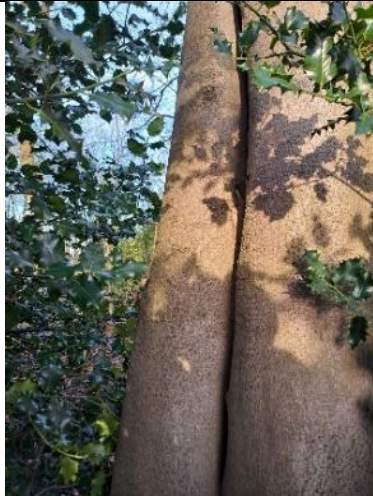
| BT14 | Tree Description: | <p>Beech species</p> <p>PRF 1: Trunk cavity located on a stem orientated south-west. The cavity faced south-west and was at a height of 1-4m. There was no evidence of bat use. There was potential for maternity/satellite/night/mating/swarming bat roost use.</p> <p>H&amp;S Considerations: None.</p> <p>Further Survey Requirements: PRF inspection survey – ladders.</p> | | | |

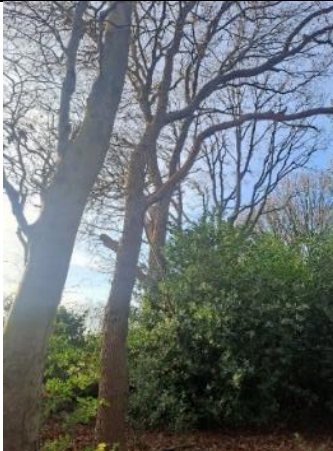
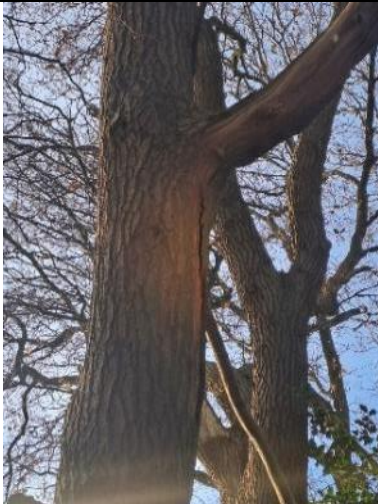
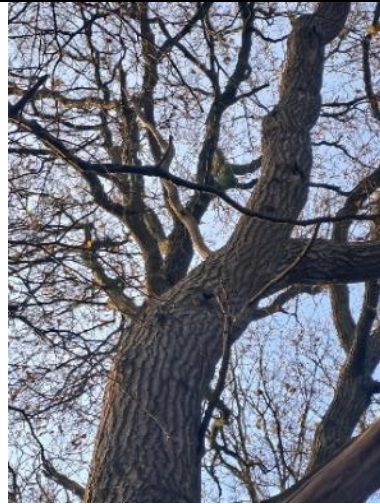
| | BT15 | Tree Description: | <p>Pedunculate oak</p> <p>PRF 1: Lifting-bark located on a stem orientated north. The bark faced east and was at a height of 3m. There was no evidence of bat use. There was potential for day/night/feeding/transitional occasional bat roost use.<br/>Potential Bat Roost Suitability: PRF-I<br/>H&amp;S Considerations: None.<br/>Further Survey Requirements: PRF inspection survey – ropes.</p> <p>PRF 2: knot-hole located on a stem orientated east. The hole faced east and was at a height of 4m. There was no evidence of bat use. There was potential for day/night/feeding/transitional occasional bat roost use.<br/>Potential Bat Roost Suitability: PRF-I<br/>H&amp;S Considerations: None.<br/>Further Survey Requirements: PRF inspection survey – ropes.</p> | | |

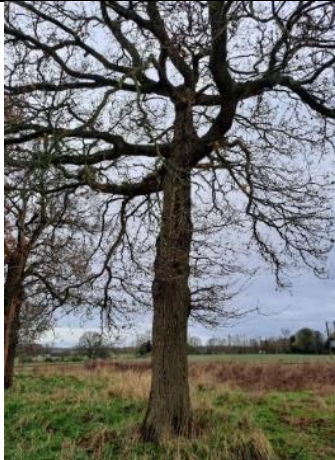
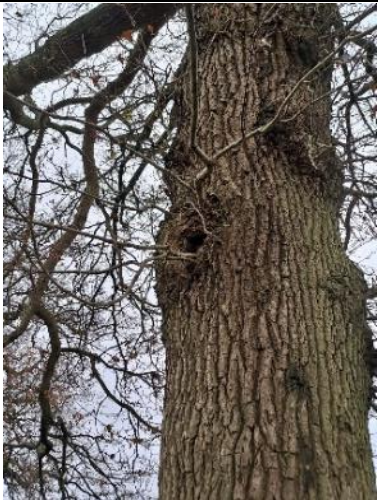
| BT16 | Tree Description: | Pedunculate oak<br><br>PRF 1: Knot-hole located on a stem orientated north-east. The hole faced north-east and was at a height of 2.5. There was no evidence of bat use. There was potential for day/night/feeding/transitional occasional bat roost use.<br>H&S Considerations: None.<br>Further Survey Requirements: PRF inspection survey – ladders. | | | |

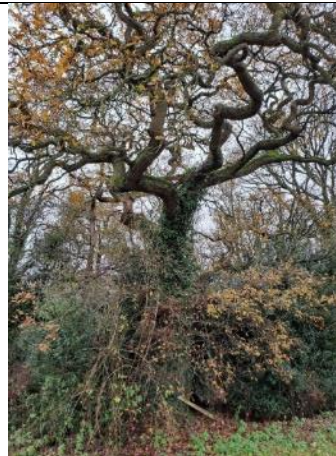
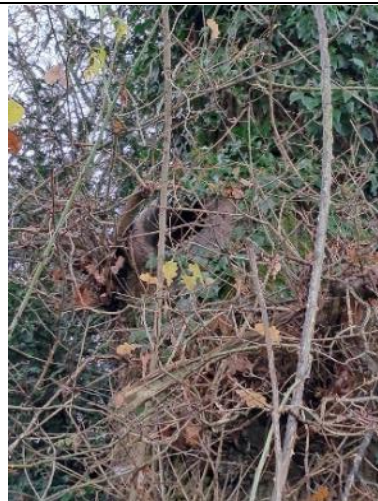
| BT17 | Tree Description: | <p>Pedunculate oak</p> <p>PRF 1: knot-hole located on a stem orientated east. The hole faced east and was at a height of 3m. There was no evidence of bat use. There was potential for day/night/feeding/transitional occasional bat roost use.</p> <p>H&amp;S Considerations: None.</p> <p>Further Survey Requirements: PRF inspection survey – ropes/ladders</p> | | | |

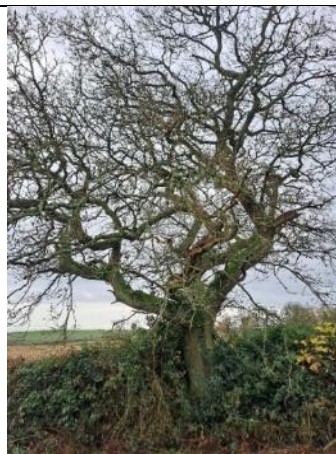
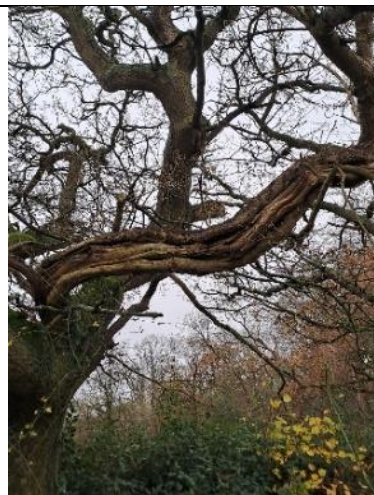
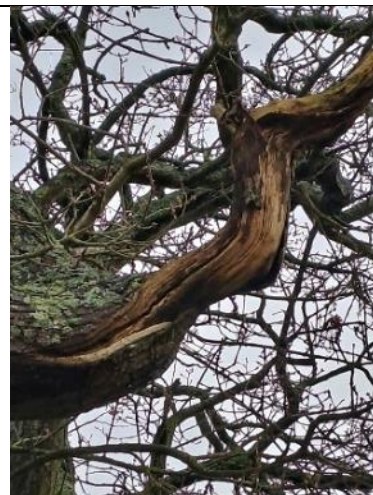
| | BT18 | Tree Description: | Pedunculate oak<br><br>PRF 1: Splits/crevices in branch located on a major limb orientated north. The splits/crevices faced north and were at a height of 2m. There was no evidence of bat use. There was potential for day/night/feeding/transitional occasional bat roost use.<br>Potential Bat Roost Suitability: PRF-I<br>H&S Considerations: None.<br>Further Survey Requirements: PRF inspection survey – ladders.<br><br>PRF 2: Split in branch located on a major limb orientated south. The split faced south and was at a height of 3m. There was no evidence of bat use. There was potential for day/night/feeding/transitional occasional bat roost use.<br>Potential Bat Roost Suitability: PRF-I<br>H&S Considerations: None. | | | |

| | | Further Survey Requirements: PRF inspection survey – ropes. | | | |

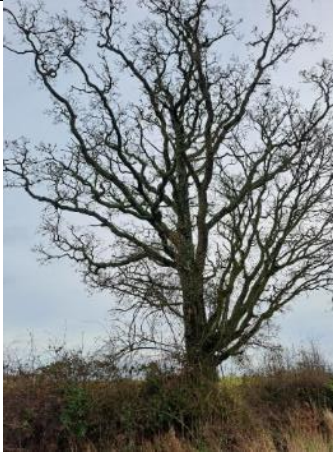
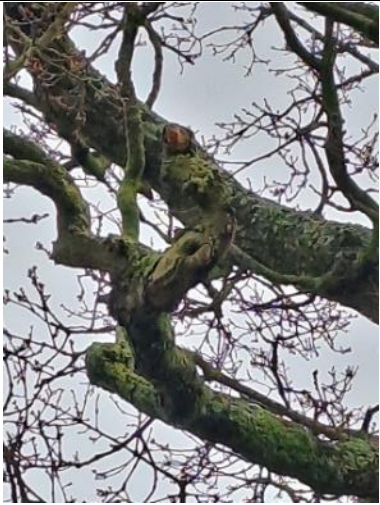
| BT20 | Tree Description: | <p>Pedunculate oak</p> <p>PRF 1: Knot-hole located on a minor limb orientated south-west. The hole faced south-west and was at a height of 4m. There was no evidence of bat use. There was potential for day/night/feeding/transitional occasional bat roost use.</p> <p>H&amp;S Considerations: None.</p> | | |

| | | Further Survey Requirements: Unlikely to be able to inspect using a ladder or ropes due to being located at the end of a small branch. Soft fell under supervision. | | | |

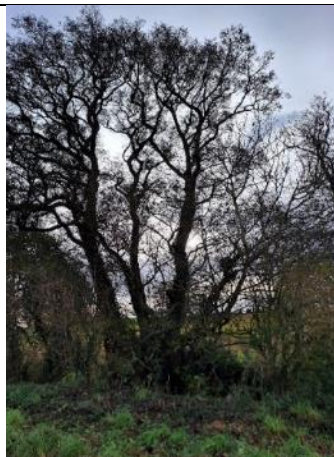
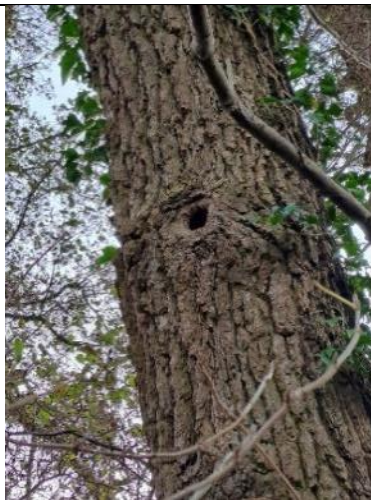
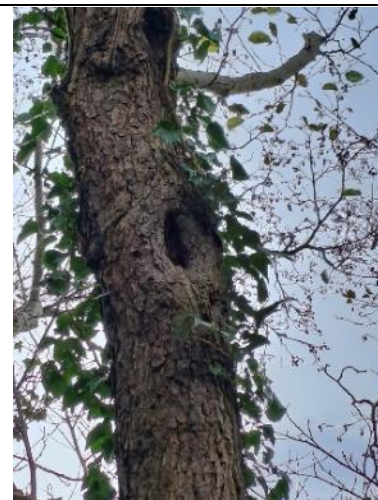
| BT22 | Tree Description: | <p>Alder <i>Alnus glutinosa</i></p> <p>PRF 1: Knot-hole located on a stem orientated north-west. The hole faced north-west and was at a height of 3m. There was no evidence of bat use. There was potential for maternity/satellite/night/mating/swarming bat roost use.</p> <p>Potential Bat Roost Suitability: PRF-M<br/>H&amp;S Considerations: None.<br/>Further Survey Requirements: PRF inspection survey – ropes.</p> | | |

| | | <p>PRF 2: Knot-hole located on a major limb orientated north-west. The hole faced north-west and was at a height of 3m. There was no evidence of bat use. There was potential for maternity/satellite/night/mating/swarming bat roost use.</p> <p>Potential Bat Roost Suitability: PRF-M</p> <p>H&amp;S Considerations: None.</p> <p>Further Survey Requirements: PRF inspection survey – ladders.</p> | | | |

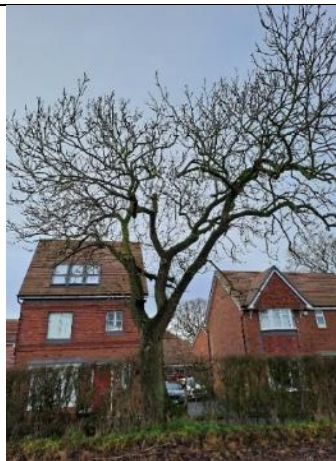
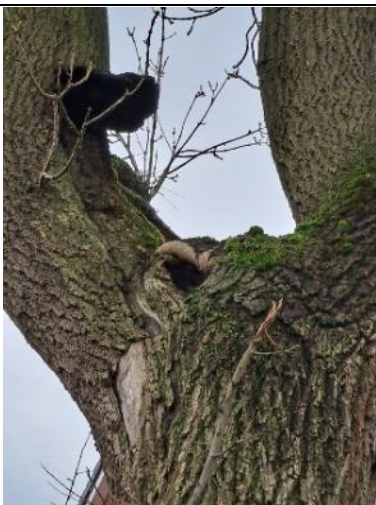
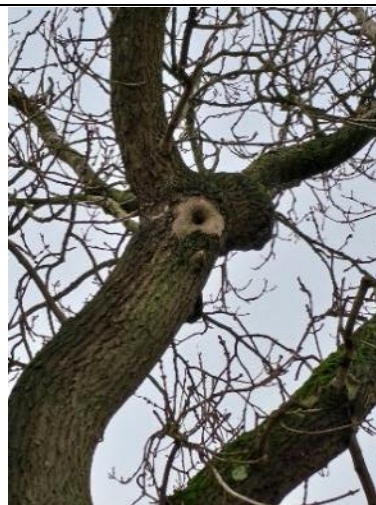
| BT24 | Tree Description: | <p>Pedunculate oak</p> <p>PRF 1: Knot-hole located on a stem orientated north-east. The hole faced north-east and was at a height of 2m. There was no evidence of bat use. There was potential for maternity/satellite/night/mating/swarming bat roost use. Potential Bat Roost Suitability: PRF-M<br/>H&amp;S Considerations: None.<br/>Further Survey Requirements: PRF inspection survey – ladders.</p> <p>PRF 2: Knot-hole located on a major limb orientated north-east. The hole faced north-east and was at a height of 3m. There was no evidence of bat use. There was potential for maternity/satellite/night/mating/swarming bat roost use.<br/>Potential Bat Roost Suitability: PRF-M</p> | | | | |

| | H&S Considerations: None.<br>Further Survey Requirements: PRF inspection survey – ladders. | |

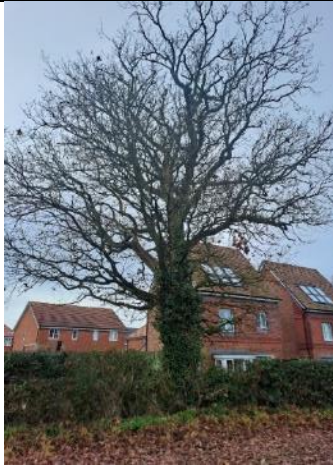
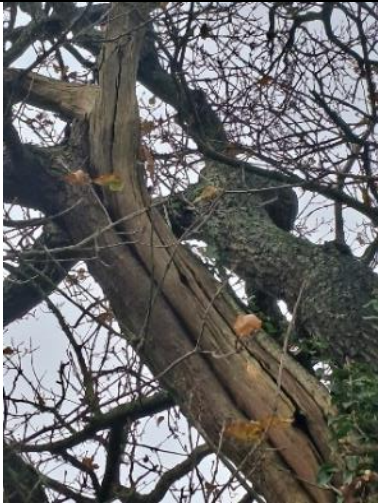
| BT25 | Tree Description: | <p>Pedunculate oak</p> <p>PRF 1: Several holes and a cavity located along the same major limb orientated north-east. The holes faced north-east and were at a height of 3-4m. There was no evidence of bat use. There was potential for maternity/satellite/night/mating/swarming bat roost use.</p> <p>H&amp;S Considerations: None.</p> <p>Further Survey Requirements: PRF inspection survey – ladders/ropes</p> |

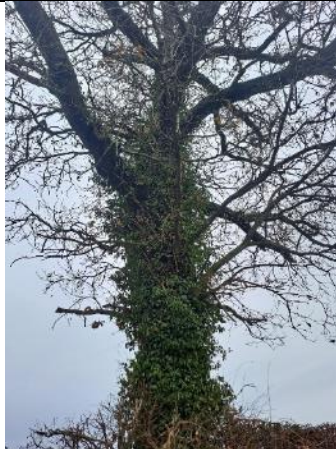
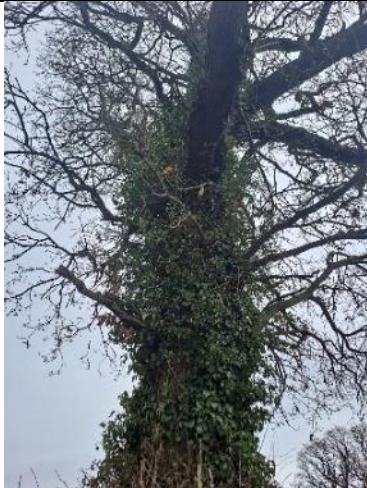
| | BT27 | Tree Description: | <p>Pedunculate oak</p> <p>PRF 1: Ivy cover (no PRF but may obscure other features) located along a minor limb orientated all aspects. The ivy faced all aspects and were at a height of 0-8m. There was no evidence of bat use. There was potential for day/night/feeding/transitional occasional bat roost use.</p> <p>H&amp;S Considerations: Proximity to road.</p> <p>Further Survey Requirements: Likely not possible to climb due to the proximity to the road. Soft fell under supervision.</p> | | |

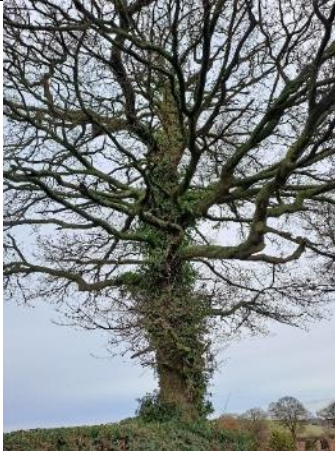
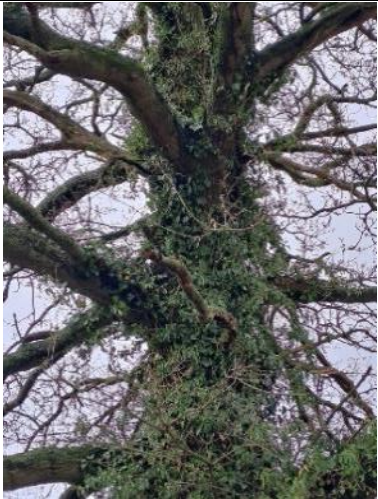
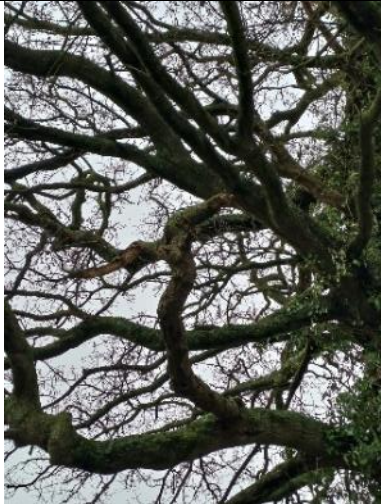
| | BT28 | Tree Description: | <p>Pedunculate oak</p> <p>PRF 1: Various split branches along a minor limb orientated all aspects. The split branches faced all aspects and were at a height of 2-5m. There was no evidence of bat use. There was potential for day/night/feeding/transitional occasional bat roost use.</p> <p>H&amp;S Considerations: Proximity to road.</p> <p>Further Survey Requirements: Likely not possible to climb due to the proximity to the road. Suggested soft felling under supervision.</p> | | |

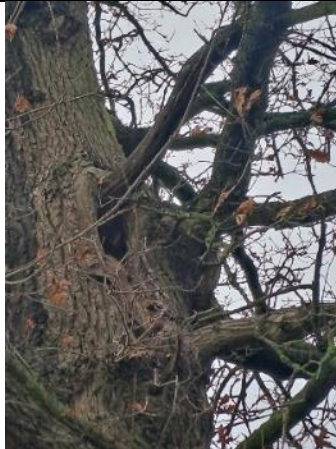
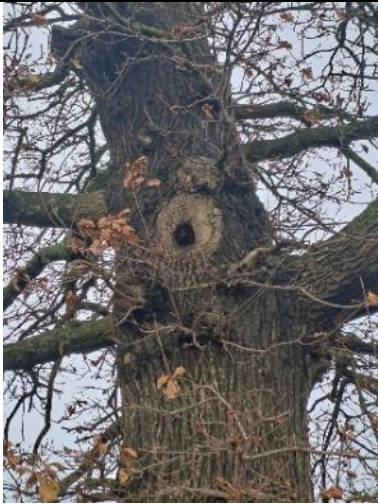
| BT29 | Tree<br>Description: | <p>Pedunculate oak</p> <p>PRF 1: Knot-hole located on a stem orientated east. The hole faced east and was at a height of 4m. There was no evidence of bat use. There was potential for maternity/satellite/night/mating/swarming bat roost use.<br/>Potential Bat Roost Suitability: PRF-M<br/>H&amp;S Considerations: Proximity to road.<br/>Further Survey Requirements: PRF inspection survey – ropes.</p> <p>PRF 2: Knot-hole located on the stem orientated south. The hole faced south and was at a height of 3m. There was no evidence of bat use. There was potential for maternity/satellite/night/mating/swarming bat roost use.<br/>Potential Bat Roost Suitability: PRF-M<br/>H&amp;S Considerations: Proximity to road.<br/>Further Survey Requirements: PRF inspection survey – ropes.</p> <p>Notes: Likely not possible to climb due to the proximity to the road. If climbing is not possible, then further surveys will be nocturnal surveys (2 surveyors, 3 NVAs).</p> |

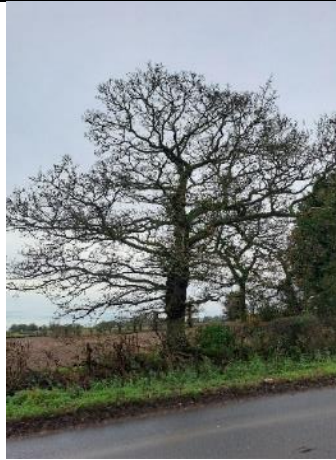
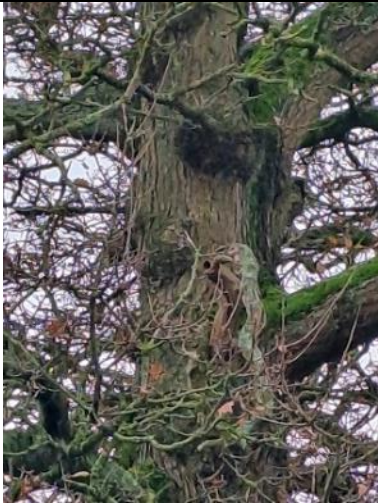
| BT30 | Tree Description: | <p>Pedunculate oak</p> <p>PRF 1: Hole located on a minor limb orientated north. The hole faced north and was at a height of 3m. There was no evidence of bat use. There was potential for day/night/feeding/transitional occasional bat roost use.</p> <p>H&amp;S Considerations: Proximity to road.</p> <p>Further Survey Requirements: PRF inspection survey – ropes.</p> <p>Notes: Likely not possible to climb due to the proximity to the road. If climbing is not possible, then soft felling under supervision.</p> | | | |

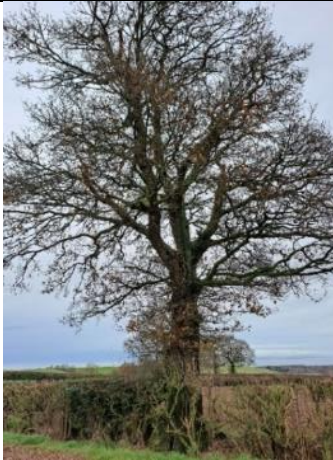
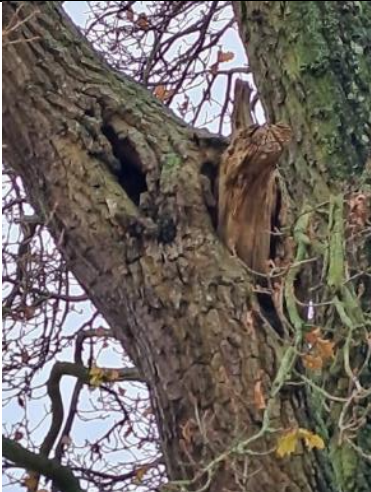
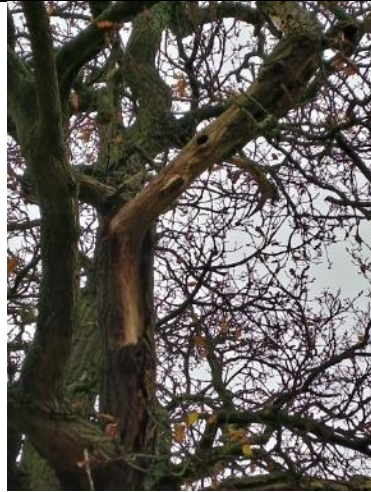
| | BT31 | Tree Description: | <p>Pedunculate oak</p> <p>PRF 1: Wound located on a major limb orientated west. The wound faced south-west and was at a height of 2.5m. There was no evidence of bat use. There was potential for maternity/satellite/night/mating/swarming bat roost use. Potential Bat Roost Suitability: PRF-M<br/>H&amp;S Considerations: Barbed wire.<br/>Further Survey Requirements: PRF inspection survey – ropes.</p> <p>PRF 2: Knot-hole located on a minor limb orientated west. The hole faced north and was at a height of 3.5m. There was no evidence of bat use. There was potential for day/night/feeding/transitional occasional bat roost use. Potential Bat Roost Suitability: PRF-I<br/>H&amp;S Considerations: Barbed wire.<br/>Further Survey Requirements: PRF inspection survey – ropes.</p> | | |

| | | Notes: If ropes are not possible due to the barbed wire, nocturnal surveys will be required. | | |

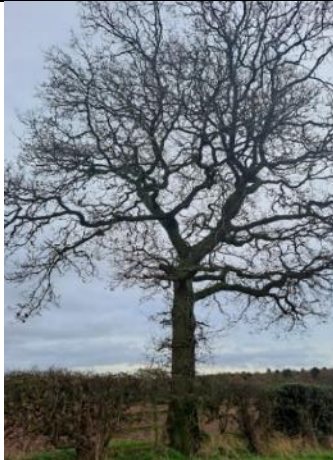
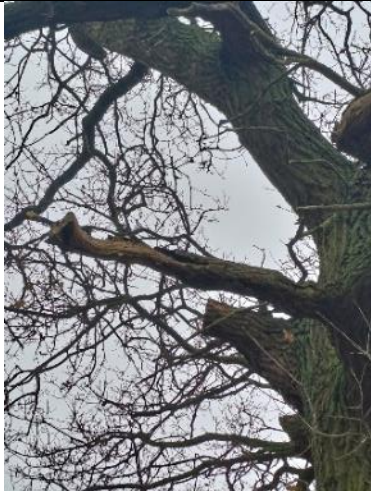
| BT32 | Tree Description: | <p>Pedunculate oak</p> <p>PRF 1: Lifting-bark located on a dead minor limb orientated west. The bark faced west and was at a height of 4m. There was no evidence of bat use. There was potential for maternity/satellite/night/mating/swarming occasional bat roost use.</p> <p>H&amp;S Considerations: None.</p> <p>Further Survey Requirements: PRF inspection survey – ladders/ropes.</p> | | |

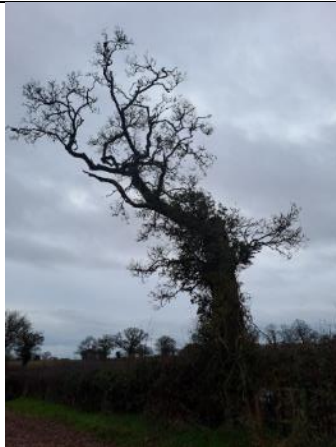
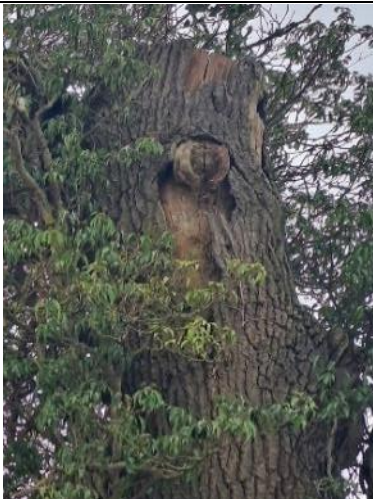
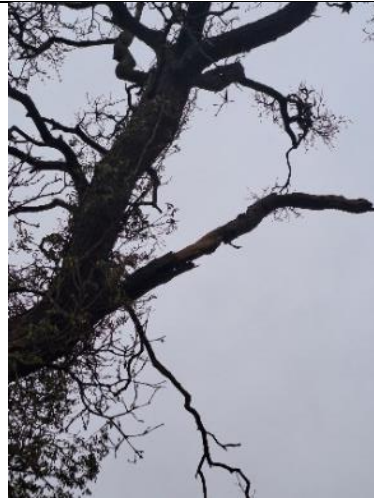
| | BT33 | Tree Description: | <p>Pedunculate oak</p> <p>PRF 1: Lifting-bark located on a stem orientated north-west. The bark faced north-west and was at a height of 4m. There was no evidence of bat use. There was potential for maternity/satellite/night/mating/swarming bat roost use.<br/>Potential Bat Roost Suitability: PRF-M<br/>H&amp;S Considerations: Proximity to road.<br/>Further Survey Requirements: PRF inspection survey – ropes.</p> <p>PRF 2: Lifting-bark located on a minor limb orientated east. The bark faced east and was at a height of 6m. There was no evidence of bat use. There was potential for maternity/satellite/night/mating/swarming bat roost use.<br/>Potential Bat Roost Suitability: PRF-M<br/>H&amp;S Considerations: Proximity to road.<br/>Further Survey Requirements: PRF inspection survey – ropes.</p> | | |

| | | Note: Likely not possible to climb due to the proximity to the road. If climbing is not possible, then nocturnal surveys will be required. | | | |

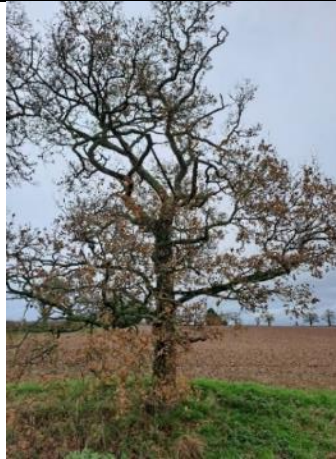
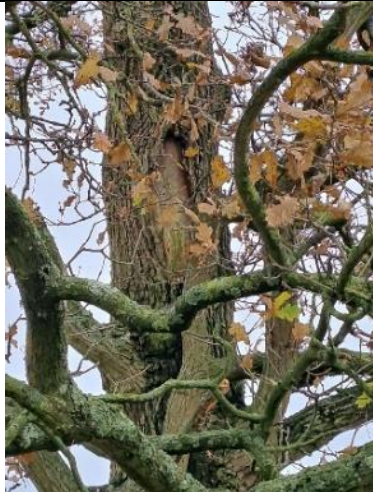
| BT34 | Tree Description: | <p>Pedunculate oak</p> <p>PRF 1: Wound located on a stem orientated south. The hole faced south and was at a height of 2.5m. There was no evidence of bat use. There was potential for day/night/feeding/transitional occasional bat roost use.</p> <p>H&amp;S Considerations: Proximity to water.</p> <p>Further Survey Requirements: Soft fell under supervision.</p> | | | |

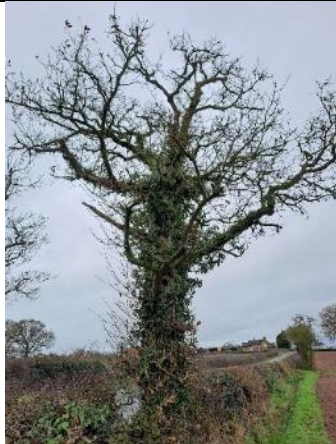
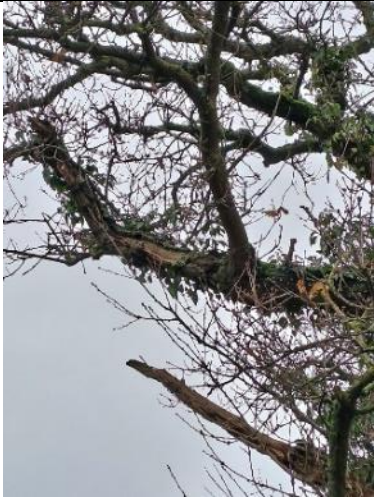
| BT35 | Tree Description: | <p>Pedunculate oak</p> <p>PRF 1: Ivy cover (no PRF but may obscure other features) located on a stem orientated all aspects. The ivy faced all aspects and was at a height of 1-5m. There was no evidence of bat use. There was potential for day/night/feeding/transitional occasional bat roost use.</p> <p>H&amp;S Considerations: Proximity to road.</p> <p>Further Survey Requirements: Soft fell under supervision.</p> | | | |

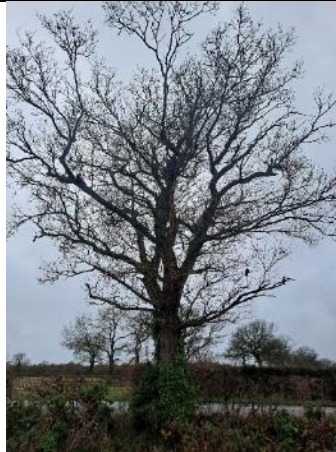
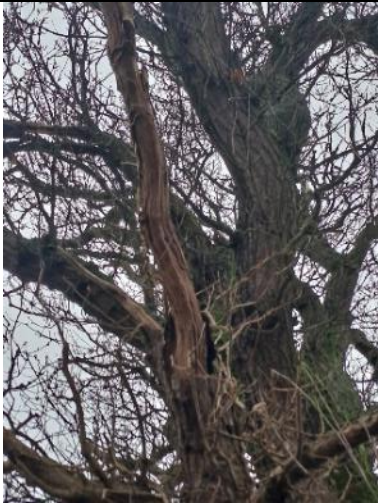
| BT36 | Tree Description: | <p>Pedunculate oak</p> <p>PRF 1: Lifting-bark located on a minor limb orientated east. The bark faced east and was at a height of 2.5m. There was no evidence of bat use. There was potential for day/night/feeding/transitional occasional bat roost use.</p> <p>H&amp;S Considerations: Proximity to road.</p> <p>Further Survey Requirements: PRF inspection – ropes.</p> <p>Note: Likely not possible to climb due to the proximity to the road. If climbing is not possible, soft fell under supervision.</p> | | | |

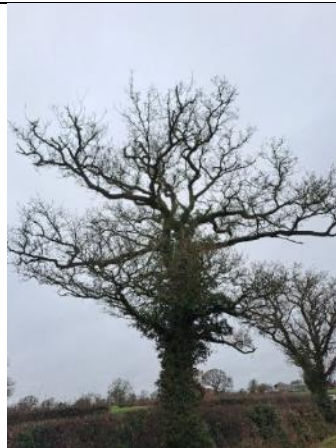
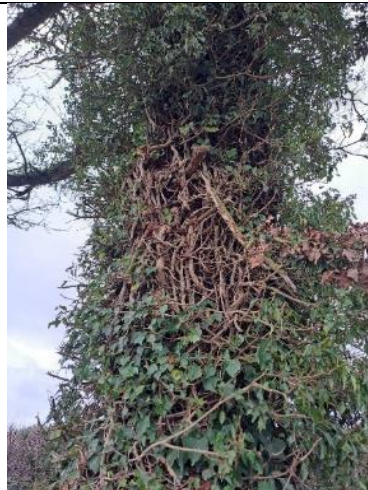
| BT37 | Tree Description: | <p>Pedunculate oak</p> <p>PRF 1: Ivy cover mature (&gt;50mm diameter, lattice forming) located on a stem orientated all aspects. The ivy creates a PRF but may also obscure other PRFs. The ivy faced all aspects and was at a height of 0-6m. There was no evidence of bat use. There was potential for day/night/feeding/transitional occasional bat roost use.</p> <p>H&amp;S Considerations: Proximity to road.</p> <p>Further Survey Requirements: Soft fell under supervision.</p> | | | |

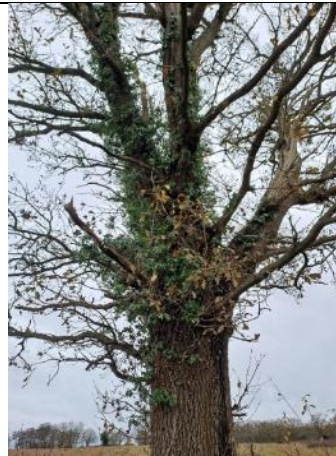
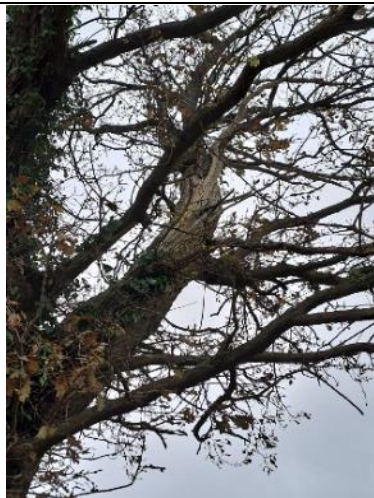
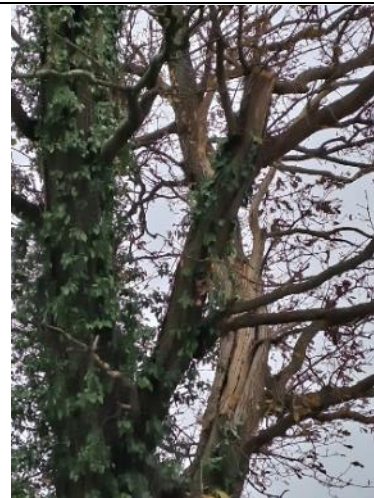
| | BT38 | Tree Description: | Pedunculate oak<br><br>PRF 1: Wound located on a major limb orientated west. The wound faced west and was at a height of 3-5m. There was no evidence of bat use. There was potential for day/night/feeding/transitional occasional bat roost use.<br>Potential Bat Roost Suitability: PRF-I<br>H&S Considerations: Proximity to road.<br>Further Survey Requirements: Soft fell under supervision.<br><br>PRF 2: Split in branch located on a major limb orientated east. The split faced east and was at a height of 4-5m. There was no evidence of bat use. There was potential for day/night/feeding/transitional occasional bat roost use.<br>Potential Bat Roost Suitability: PRF-I<br>H&S Considerations: Proximity to road.<br>Further Survey Requirements: Soft fell under supervision. | | | |

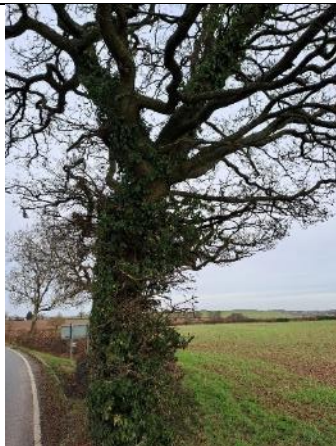
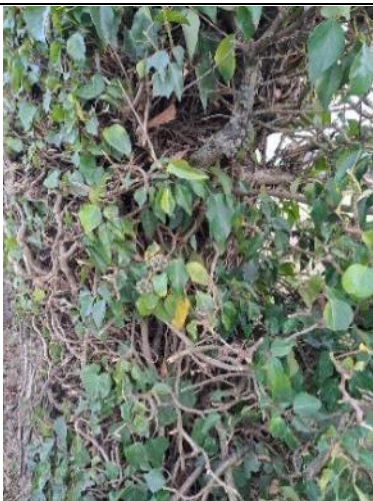
| BT40 | Tree<br>Description: | <p>Pedunculate oak</p> <p>PRF 1: Ivy cover mature (&gt;50mm diameter, lattice forming) located on a stem orientated all aspects. The ivy creates a PRF but may also obscure other PRFs. The ivy faced all aspects and was at a height of 0-4m. There was no evidence of bat use. There was potential for day/night/feeding/transitional occasional bat roost use.</p> <p>H&amp;S Considerations: Proximity to road.</p> <p>Further Survey Requirements: Soft fell under supervision.</p> | | | |

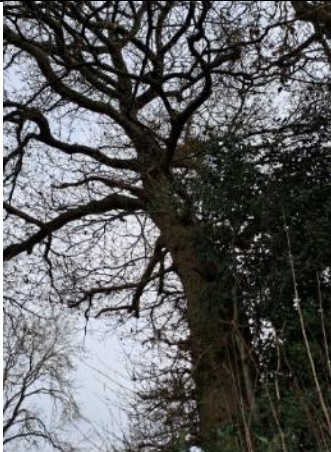
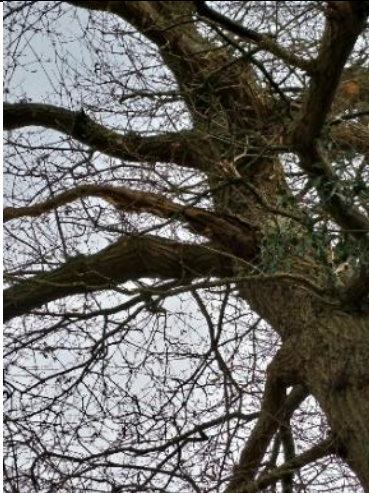
| BT41 | Tree<br>Description: | <p>Pedunculate oak</p> <p>PRF 1: Lifting-bark located on a minor limb orientated west. The bark faced west and was at a height of 5m. There was no evidence of bat use. There was potential for day/night/feeding/transitional occasional bat roost use.</p> <p>H&amp;S Considerations: Proximity to road.</p> | | | |

| | | Further Survey Requirements: Soft fell under supervision. | | | |

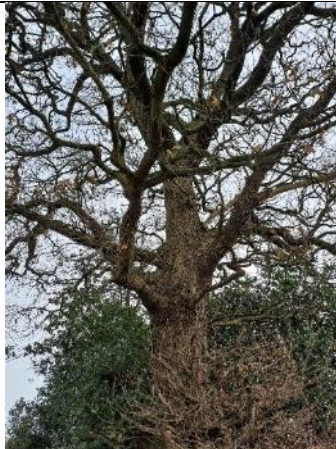
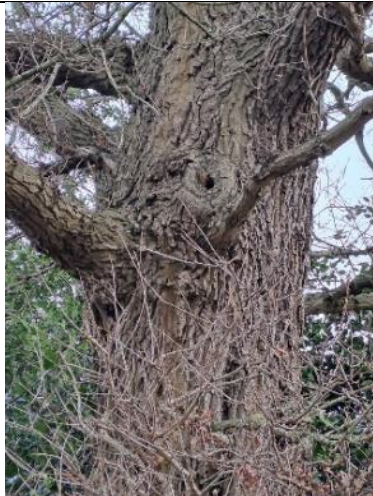
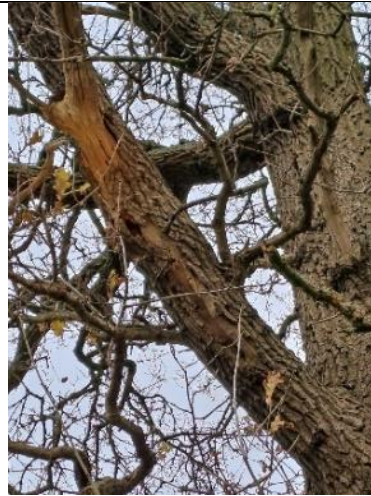
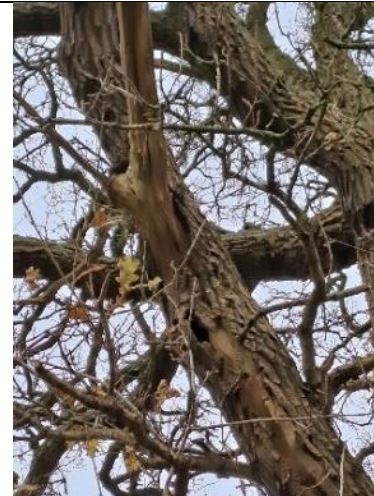
| BT42 | Tree Description: | <p>Pedunculate oak</p> <p>PRF 1: Knot-hole located on a stem orientated west. The hole faced west and was at a height of 4m. There was no evidence of bat use. There was potential for maternity/satellite/night/mating/swarming bat roost use.<br/>Potential Bat Roost Suitability: PRF-M<br/>H&amp;S Considerations: None.<br/>Further Survey Requirements: PRF inspection survey – ladders.</p> <p>PRF 2: Branch cavity located on a major limb orientated south-west. The cavity faced south-west and was at a height of 4m. There was no evidence of bat use. There was potential for maternity/satellite/night/mating/swarming bat roost use.<br/>Potential Bat Roost Suitability: PRF-M</p> | | | |

| | <p>H&amp;S Considerations: Uneven ground surrounding.<br/>Further Survey Requirements: PRF inspection survey – ropes.</p> <p>PRF 3: Lifting-bark located on a major limb orientated south-west. The ivy faced all aspects and was at a height of 0-4m. There was no evidence of bat use. There was potential for day/night/feeding/transitional occasional bat roost use.</p> <p>Potential Bat Roost Suitability: PRF-I</p> <p>H&amp;S Considerations: Uneven ground surrounding.<br/>Further Survey Requirements: Soft fell under supervision.</p> | |

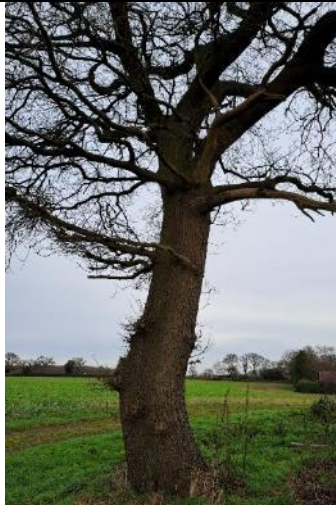
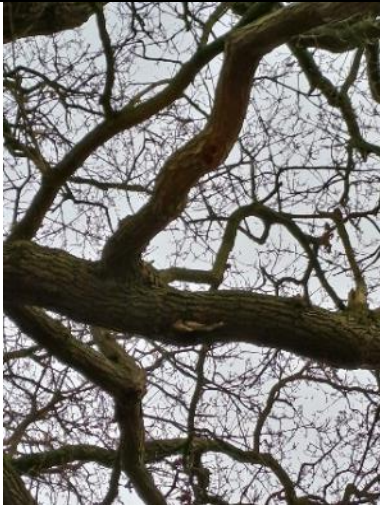
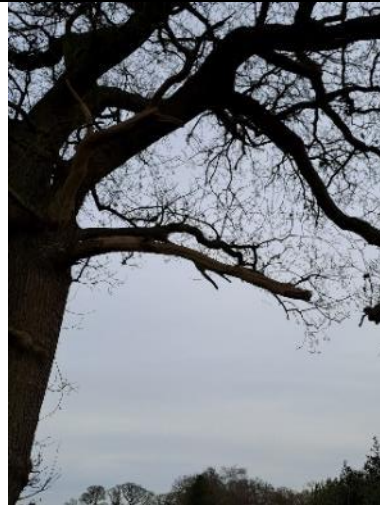
| | <p>PRF 1: Knot-hole located on a minor limb orientated west. The knot-hole faced west and was at a height of 6m. There was no evidence of bat use. There was potential for maternity/satellite/night/mating/swarming bat roost use. Potential Bat Roost Suitability: PRF-M<br/>H&amp;S Considerations: Uneven ground surrounding.<br/>Further Survey Requirements: PRF inspection survey – ropes.</p> <p>PRF 2: Branch cavity located on a major limb orientated south. The cavity faced south and was at a height of 4m. There was no evidence of bat use. There was potential for maternity/satellite/night/mating/swarming bat roost use. Potential Bat Roost Suitability: PRF-M<br/>H&amp;S Considerations: Uneven ground surrounding.<br/>Further Survey Requirements: PRF inspection survey – ropes.<br/>Note: Hollow dead branch.</p> | | |

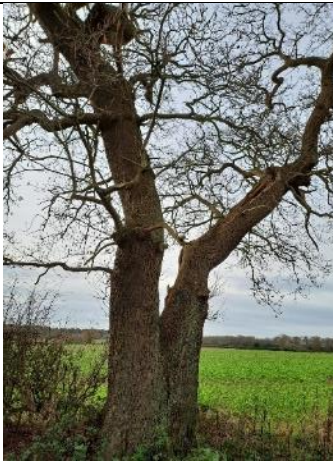
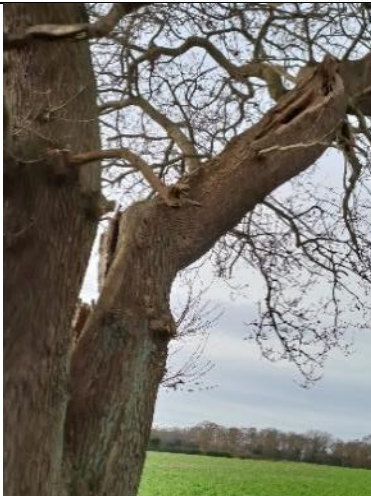
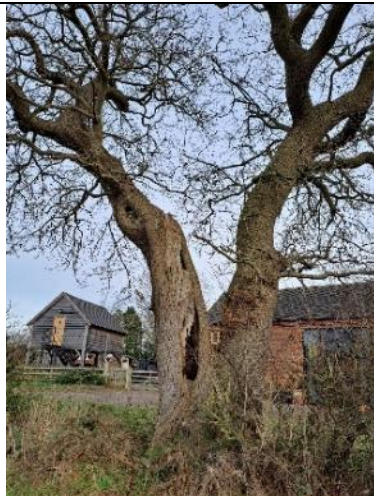
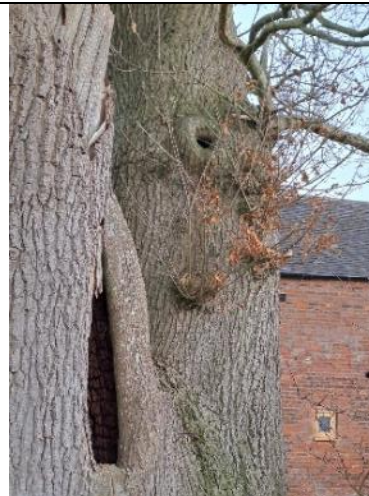
| | | <p>PRF 1: Branch cavity located on the stem orientated north. The cavity faced north and was at a height of 0.5-4m. There was no evidence of bat use. There was potential for maternity/satellite/night/mating/swarming bat roost use. Potential Bat Roost Suitability: PRF-M</p> <p>H&amp;S Considerations: None.</p> <p>Further Survey Requirements: PRF inspection survey – ropes.</p> <p>PRF 2: Knot-hole located on the stem orientated west. The hole faced west and was at a height of 2m. There was no evidence of bat use. There was potential for maternity/satellite/night/mating/swarming bat roost use. Potential Bat Roost Suitability: PRF-M</p> <p>H&amp;S Considerations: Uneven ground surrounding.</p> <p>Further Survey Requirements: PRF inspection survey – ladders/ropes.</p> | | | |
| | | Categorisation of Potential Bat Roost Habitat Suitability | | | PRF-M |
