## Oldbury to Meriden, Warwickshire

# Ground Level Tree Assessment Report

**Prepared For: Severn Trent Water**

Document Reference: 10408.04.001

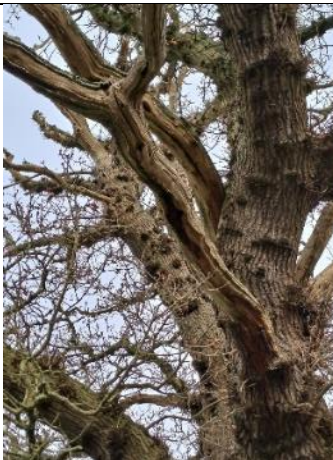
| Arb Reference | | T156 |
|---|---|---|
| BT45 | <p>Tree Description:</p> <p>Pedunculate oak</p> <p>PRF 1: Knot-hole located on the stem orientated south-west. The hole faced south-west and was at a height of 2m. There was no evidence of bat use. There was potential for maternity/satellite/night/mating/swarming bat roost use.<br/>Potential Bat Roost Suitability: PRF-M<br/>H&amp;S Considerations: Uneven ground surrounding.<br/>Further Survey Requirements: PRF inspection survey – ladders.</p> <p>PRF 2: Shearing-crack located on a major limb orientated south. The crack faced south and was at a height of 2-4m. There was no evidence of bat use. There was potential for day/night/feeding/transitional occasional bat roost use.<br/>Potential Bat Roost Suitability: PRF-I<br/>H&amp;S Considerations: Uneven ground surrounding.<br/>Further Survey Requirements: PRF inspection survey – ropes</p> <p>PRF 3: Lifting-bark located on a minor limb orientated south. The bark faced south and was at a height of 3m. There was no evidence of bat use. There was potential for day/night/feeding/transitional occasional bat roost use.<br/>Potential Bat Roost Suitability: PRF-I<br/>H&amp;S Considerations: uneven ground surrounding.<br/>Further Survey Requirements: PRF inspection survey – ropes</p> <p>PRF 4: Shearing-crack located on a minor limb orientated south-west. The crack faced south-west and was at a height of 3-4m. There was no evidence of bat use. There was potential for day/night/feeding/transitional occasional bat roost use.<br/>Potential Bat Roost Suitability: PRF-I<br/>H&amp;S Considerations: Uneven ground surrounding.<br/>Further Survey Requirements: PRF inspection survey – ropes</p> | |

| Categorisation of Potential Bat Roost Habitat Suitability | | | | | PRF-M |

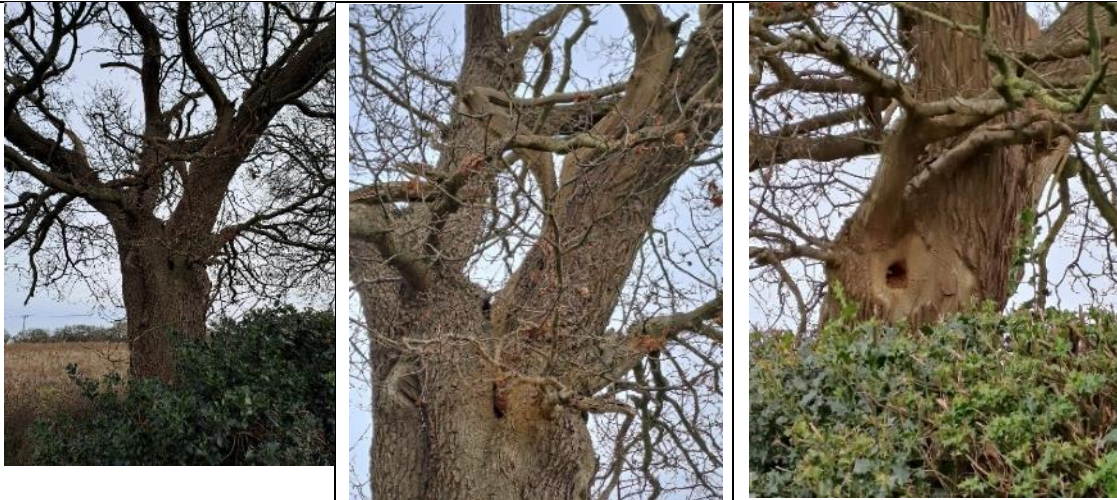
| Arb Reference | | | T164 |
|---|---|---|---|
| BT46 | Tree Description: | <p>Pedunculate oak</p> <p>PRF 1: Trunk cavity located on the stem orientated west. The cavity faced west and was at a height of 3m. There was no evidence of bat use. There was potential for maternity/satellite/night/mating/swarming bat roost use.</p> <p>H&amp;S Considerations: Uneven ground surrounding.</p> <p>Further Survey Requirements: PRF inspection survey – ropes</p> | |
| Categorisation of Potential Bat Roost Habitat Suitability | | | PRF-M |

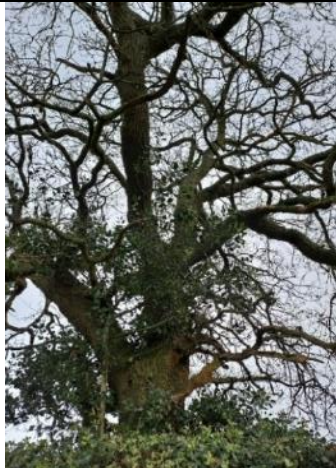
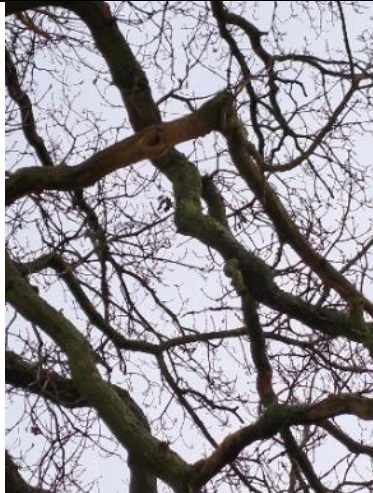
| Arb Reference | | | T164 |
|---|---|---|---|
| BT47 | Tree Description: | <p>Pedunculate oak</p> <p>PRF 1: Knot-hole located on a minor limb orientated west. The hole faced west and was at a height of 4m. There was no evidence of bat use. There was potential for day/night/feeding/transitional occasional bat roost use.</p> <p>H&amp;S Considerations: Uneven ground surrounding.</p> | |

| Categorisation of Potential Bat Roost Habitat Suitability | | | | PRF-I |

| | | Further Survey Requirements: Soft fell under bat-licenced supervision. | | |

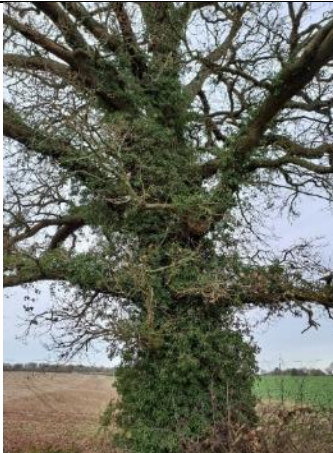
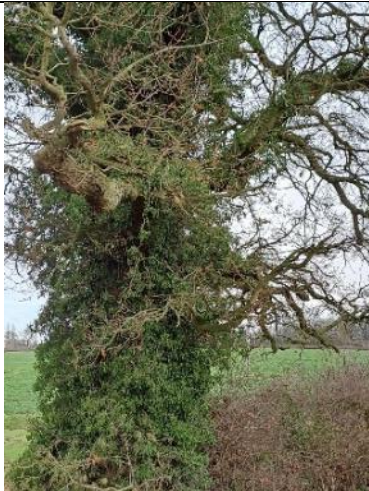
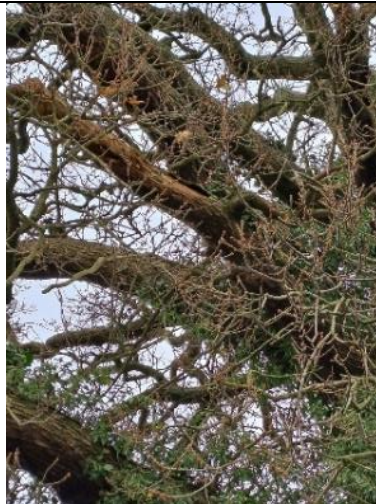
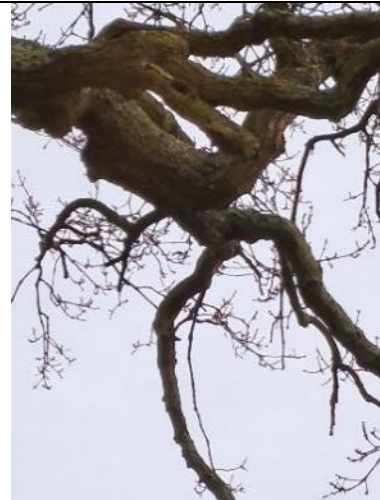
| BT49 | Tree Description: | <p>Pedunculate oak</p> <p>PRF 1: Ivy cover mature (&gt;50mm diameter, lattice forming) located on a stem orientated all aspects. The ivy creates a PRF but may also obscure other PRFs. The ivy faced all aspects and was at a height of 0-8m. There was no evidence of bat use. There was potential for day/night/feeding/transitional occasional bat roost use.</p> <p>Potential Bat Roost Suitability: PRF-I</p> <p>H&amp;S Considerations: Uneven ground surrounding.</p> <p>Further Survey Requirements: PRF inspection survey – ropes.</p> <p>PRF 2: Lifting-bark located on a major limb orientated south. The bark faced south and was at a height of 6m. There was no evidence of bat use. There was potential for day/night/feeding/transitional occasional bat roost use.</p> | | | |

| | <p>Potential Bat Roost Suitability: PRF-I<br/>H&amp;S Considerations: Uneven ground surrounding.<br/>Further Survey Requirements: PRF inspection survey – ropes.</p> <p>PRF 3: Branch cavity located on a minor limb orientated south. The cavity faced south and was at a height of 3m. There was no evidence of bat use. There was potential for day/night/feeding/transitional occasional bat roost use.<br/>Potential Bat Roost Suitability: PRF-I<br/>H&amp;S Considerations: Uneven ground surrounding.<br/>Further Survey Requirements: PRF inspection survey – ropes.</p> | |

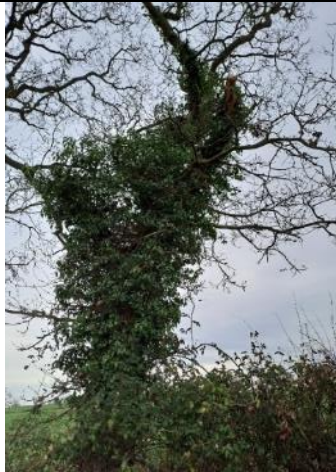
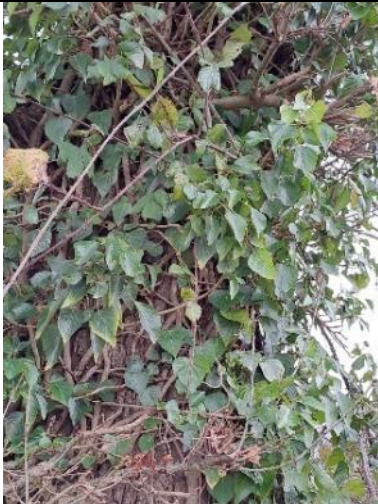
| | Tree Description: | <p>Pedunculate oak</p> <p>PRF 1: Ivy cover mature (&gt;50mm diameter, lattice forming) located on a stem orientated all aspects. The ivy creates a PRF but may also obscure other PRFs. The ivy faced all aspects and was at a height of 0-5m. There was no evidence of bat use. There was potential for day/night/feeding/transitional occasional bat roost use.</p> <p>H&amp;S Considerations: Uneven ground surrounding.</p> <p>Further Survey Requirements: Soft fell under supervision.</p> | | |

| | Categorisation of Potential Bat Roost Habitat Suitability | | | | PRF-I |

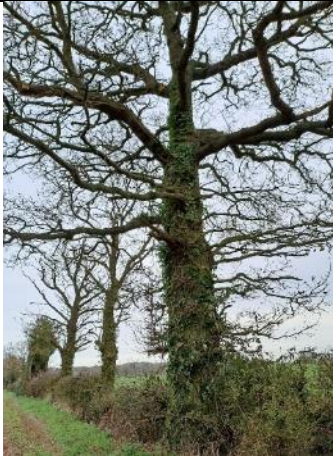
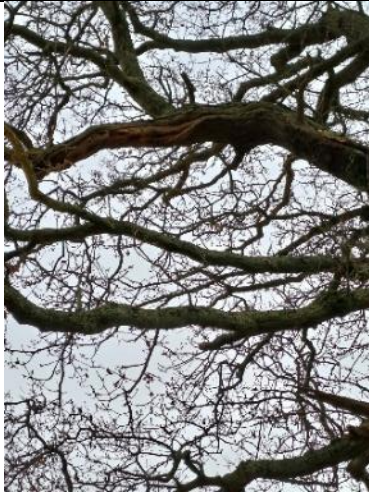
| BT53 | Tree Description: | <p>Pedunculate oak</p> <p>PRF 1: Branch cavity located on a minor limb orientated north. The cavity faced north and was at a height of 5m. There was no evidence of bat use. There was potential for maternity/satellite/night/mating/swarming bat roost use.</p> <p>H&amp;S Considerations: Uneven ground surrounding.</p> <p>Further Survey Requirements: PRF inspection survey – ropes.</p> | | |

| | Categorisation of Potential Bat Roost Habitat Suitability | | | | PRF-M |

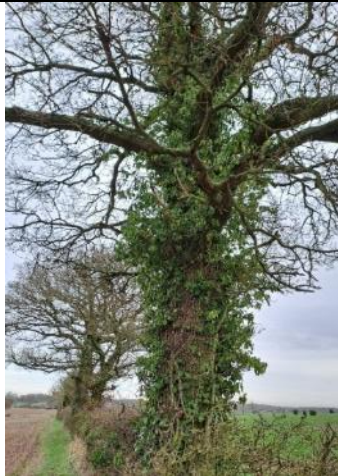
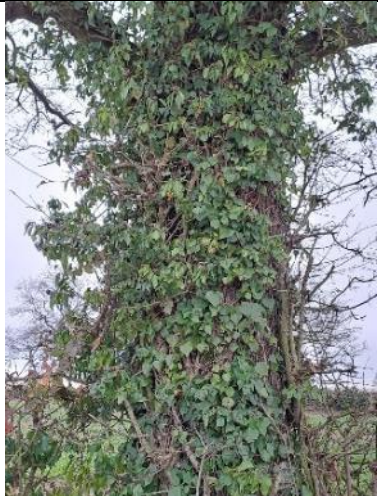
| | BT54 | Tree Description: | <p>Pedunculate oak</p> <p>PRF 1: Ivy cover mature (&gt;50mm diameter, lattice forming) located on a stem orientated all aspects. The ivy creates a PRF but may also obscure other PRFs. The ivy faced all aspects and was at a height of 0-8m. There was no evidence of bat use. There was potential for day/night/feeding/transitional occasional bat roost use.</p> <p>H&amp;S Considerations: Uneven ground surrounding.</p> <p>Further Survey Requirements: PRF inspection survey – ropes.</p> | | |

| | Categorisation of Potential Bat Roost Habitat Suitability | | | | PRF-I |

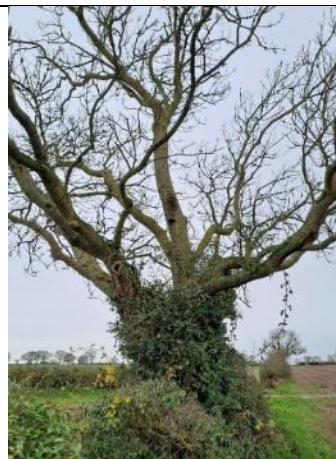
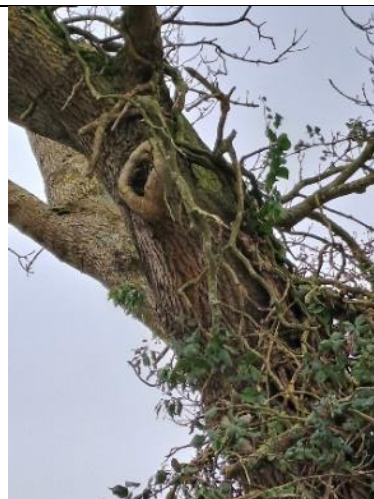
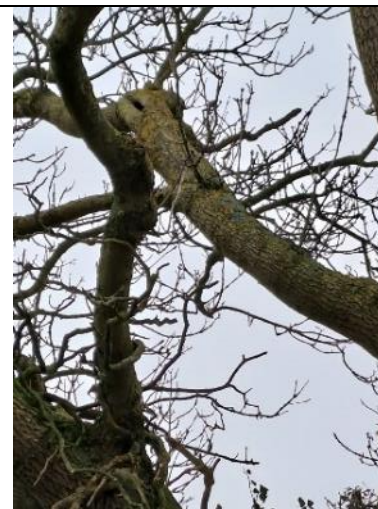
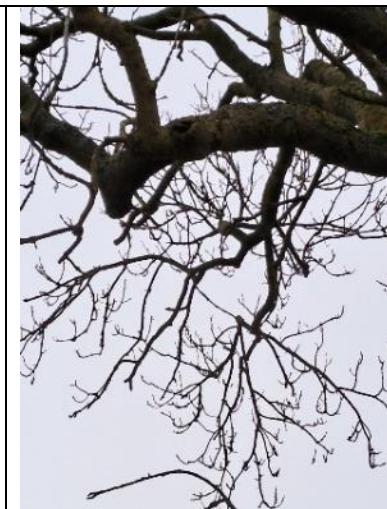
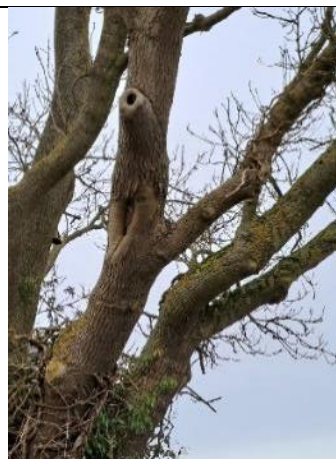
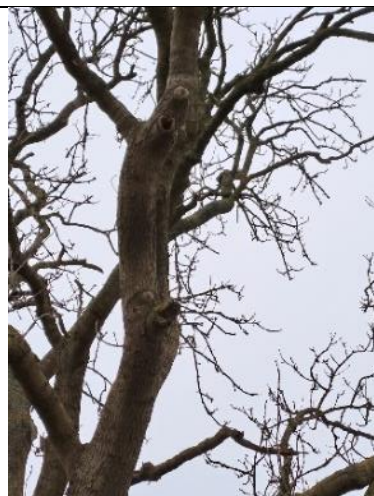
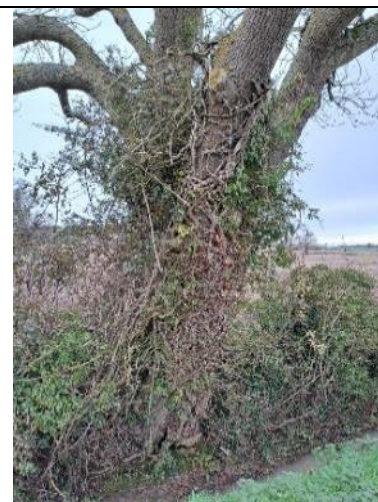
| | <p>PRF 3: Knot-hole located on a minor limb orientated east. The hole faced north and was at a height of 4m. There was no evidence of bat use. There was potential for day/night/feeding/transitional occasional bat roost use.<br/>Potential Bat Roost Suitability: PRF-I<br/>H&amp;S Considerations: Uneven ground surrounding.<br/>Further Survey Requirements: PRF inspection survey – ladders/ropes.</p> <p>PRF 4: Knot-hole located on a major limb orientated south. The hole faced south and was at a height of 5m. There was no evidence of bat use. There was potential for maternity/satellite/night/mating/swarming bat roost use.<br/>Potential Bat Roost Suitability: PRF-M<br/>H&amp;S Considerations: Uneven ground surrounding.<br/>Further Survey Requirements: PRF inspection survey – ropes.</p> <p>PRF 5: Knot-hole located on a major limb orientated south. The hole faced south and was at a height of 7m. There was no evidence of bat use. There was potential for maternity/satellite/night/mating/swarming bat roost use.<br/>Potential Bat Roost Suitability: PRF-M<br/>H&amp;S Considerations: Uneven ground surrounding.<br/>Further Survey Requirements: PRF inspection survey – ropes.</p> <p>PRF 6: Ivy cover mature (&gt;50mm diameter, lattice forming) located on the stem orientated all aspects. The ivy creates a PRF but may also obscure other PRFs. The ivy faced all aspects and was at a height of 0-4m. There was no evidence of bat use. There was potential for day/night/feeding/transitional occasional bat roost use.<br/>Potential Bat Roost Suitability: PRF-I<br/>H&amp;S Considerations: Uneven ground surrounding.<br/>Further Survey Requirements: PRF inspection survey – ladders/ropes.</p> |

| Categorisation of Potential Bat Roost Habitat Suitability | | | PRF-M |

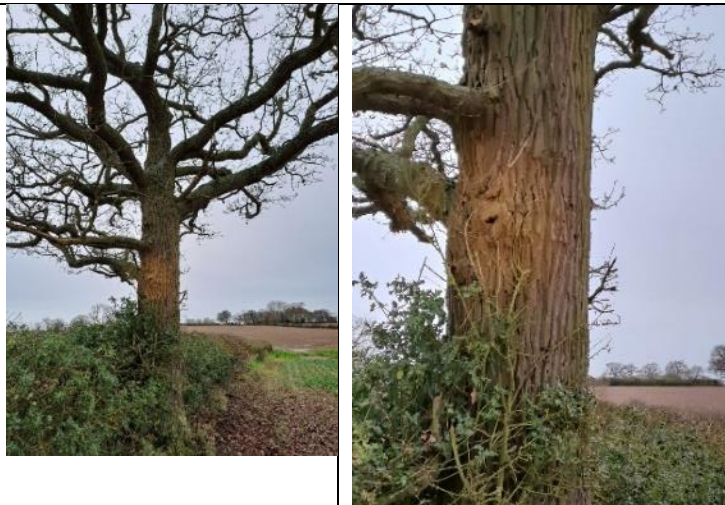
| Categorisation of Potential Bat Roost Habitat Suitability | | | PRF-M |
|---|---|---|---|
| BT56 | Tree Description: | <p>Pedunculate oak</p> <p>PRF 1: Knot-hole located on the stem orientated south. The hole faced south and was at a height of 3m. There was no evidence of bat use. There was potential for day/night/feeding/transitional occasional bat roost use.</p> <p>H&amp;S Considerations: Uneven ground surrounding.</p> <p>Further Survey Requirements: PRF inspection survey – ropes.</p> | |
| Categorisation of Potential Bat Roost Habitat Suitability | | | PRF-I |

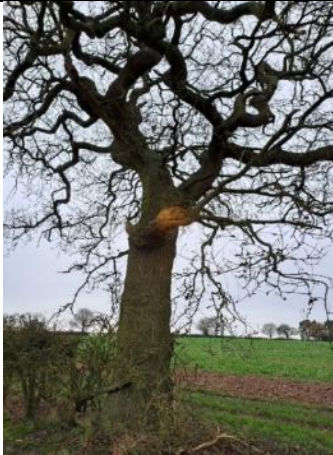
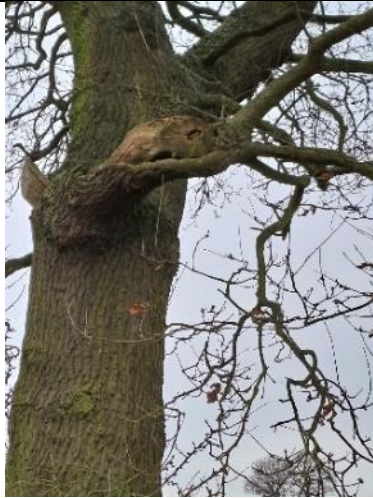
| Categorisation of Potential Bat Roost Habitat Suitability | | | PRF-M |
|---|---|---|---|
| BT57 | Tree Description: | <p>Pedunculate oak</p> <p>PRF 1: Pruning-cut located on the stem orientated east. The cut faced east and was at a height of 3m. There was no evidence of bat use. There was potential for day/night/feeding/transitional occasional bat roost use.</p> <p>H&amp;S Considerations: Uneven ground surrounding.</p> | |

| Categorisation of Potential Bat Roost Habitat Suitability | | | | | PRF-I |

| | | Further Survey Requirements: PRF inspection survey – ropes | | | |

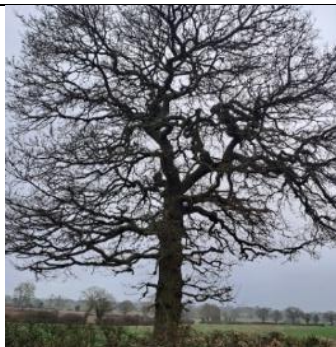
| BT58 | Tree Description: | <p>Pedunculate oak</p> <p>PRF 1: Fluting located on a major limb orientated east. The fluting faced east and was at a height of 4m. There was no evidence of bat use. There was potential for day/night/feeding/transitional occasional bat roost use.<br/>Potential Bat Roost Suitability: PRF-I<br/>H&amp;S Considerations: Proximity to water and uneven ground from the sloped banks of the ditch.<br/>Further Survey Requirements: PRF inspection survey – ropes.</p> <p>PRF 2: Subsidence-crack located on a minor limb orientated west. The crack faced all aspects and was at a height of 4m. There was no evidence of bat use. There was potential for day/night/feeding/transitional occasional bat roost use.<br/>Potential Bat Roost Suitability: PRF-I</p> | | | |

| | | H&S Considerations: Near a ditch with sloped banks.<br>Further Survey Requirements: PRF inspection survey – ladders. | | |

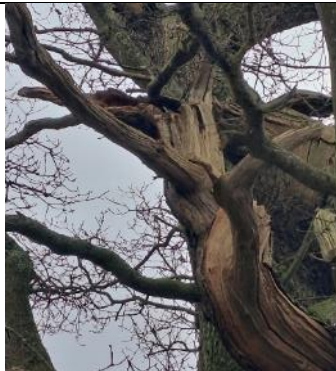
| BT59 | Tree Description: | <p>Pedunculate oak</p> <p>PRF 1: Subsidence-crack located on a major limb orientated south-west. The crack faced south-west and was at a height of 3-4m. There was no evidence of bat use. There was potential for day/night/feeding/transitional occasional bat roost use.</p> <p>Potential Bat Roost Suitability: PRF-I</p> <p>H&amp;S Considerations: Proximity to water and uneven ground from the sloped banks of the ditch.</p> <p>Further Survey Requirements: PRF inspection survey – ropes.</p> <p>PRF 2: Subsidence-crack located on a major limb orientated south. The crack faced south-west and was at a height of 4-5m. There was no evidence of bat use. There was potential for day/night/feeding/transitional occasional bat roost use.</p> <p>Potential Bat Roost Suitability: PRF-I</p> | | |

| | <p>H&amp;S Considerations: Proximity to water and near a ditch with sloped banks.<br/>Further Survey Requirements: PRF inspection survey – ropes.</p> <p>PRF 3: Pruning-cut located on a major limb orientated west. The cut faced north-west and was at a height of 3m. There was no evidence of bat use. There was potential for day/night/feeding/transitional occasional bat roost use.<br/>Potential Bat Roost Suitability: PRF-I<br/>H&amp;S Considerations: Proximity to water.<br/>Further Survey Requirements: PRF inspection survey – ladders/ropes.</p> | | | |

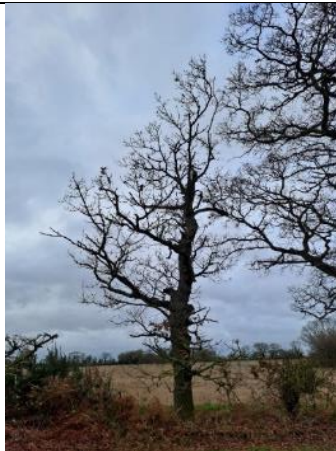
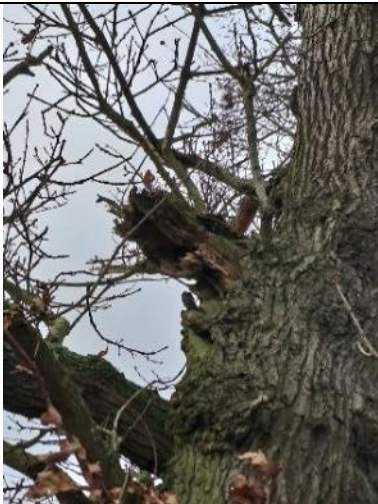
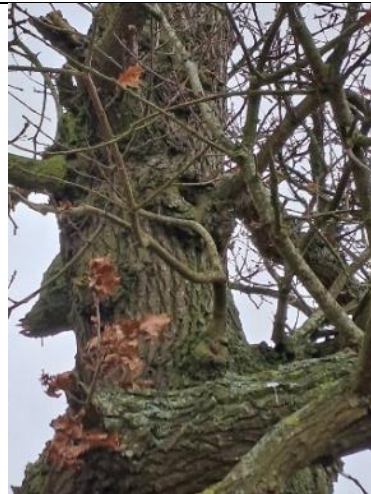
| | Tree Description: | <p>Pedunculate oak</p> <p>PRF 1: Dead, broken branch located on the stem orientated south-east. The branch faced south-east and was at a height of 3.5m. There was no evidence of bat use. There was potential for day/night/feeding/transitional occasional bat roost use.<br/>Potential Bat Roost Suitability: PRF-I<br/>H&amp;S Considerations: Proximity to water.</p> | | |

| | | <p>Further Survey Requirements: PRF inspection survey – ropes.</p> <p>PRF 2: Knot-hole located on the stem orientated south. The hole faced south and was at a height of 4m. There was no evidence of bat use. There was potential for day/night/feeding/transitional occasional bat roost use.</p> <p>Potential Bat Roost Suitability: PRF-I</p> <p>H&amp;S Considerations: Proximity to water.</p> <p>Further Survey Requirements: PRF inspection survey – ropes.</p> | | |

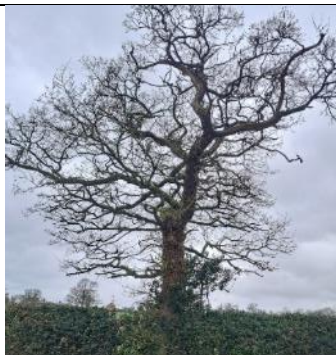
| | <p>H&amp;S Considerations: Proximity to water.<br/>Further Survey Requirements: PRF inspection survey – ladders.</p> <p>PRF 2: Branch cavity located on a minor limb orientated north-east. The cavity faced north-east and was at a height of 6m. There was no evidence of bat use. There was potential for day/night/feeding/transitional occasional bat roost use.</p> <p>Potential Bat Roost Suitability: PRF-I</p> <p>H&amp;S Considerations: PRF damage/disturbance likely.<br/>Further Survey Requirements: PRF inspection survey – ropes.</p> <p>PRF 3: Subsidence-crack located on a major limb orientated south-east. The crack faced south-east and was at a height of 5m. There was no evidence of bat use. There was potential for day/night/feeding/transitional occasional bat roost use.</p> <p>Potential Bat Roost Suitability: PRF-I</p> <p>H&amp;S Considerations: None.<br/>Further Survey Requirements: PRF inspection survey – ropes/ladders.</p> | | | |
| Categorisation of Potential Bat Roost Habitat Suitability | | | | PRF-I |

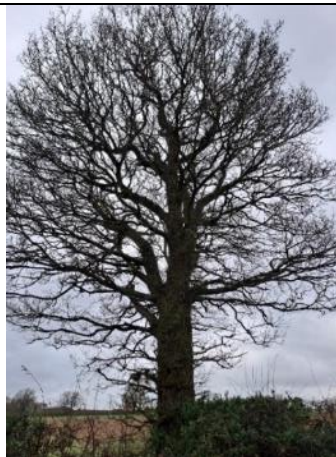
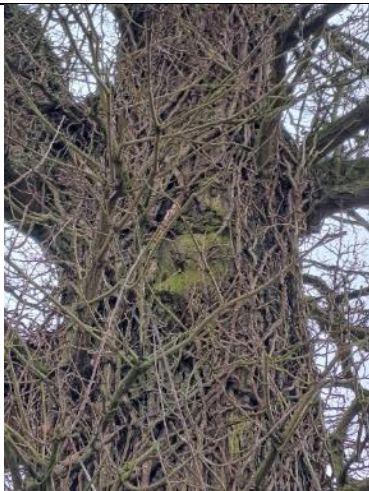
| Arb Reference | | | | N/A |
|---|---|---|---|---|
| BT62 | Tree Description: | <p>Pedunculate oak</p> <p>PRF 1: Knot-hole located on the stem orientated east. The hole faced east and was at a height of 3m. There was no evidence of bat use. There was potential for maternity/satellite/night/mating/swarming bat roost use.</p> <p>H&amp;S Considerations: None.</p> <p>Further Survey Requirements: PRF inspection survey – ropes.</p> <p>Note: Dead ivy could be hiding PRFs.</p> | | |
| Categorisation of Potential Bat Roost Habitat Suitability | | | | PRF-M |

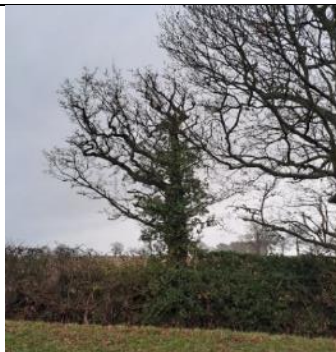
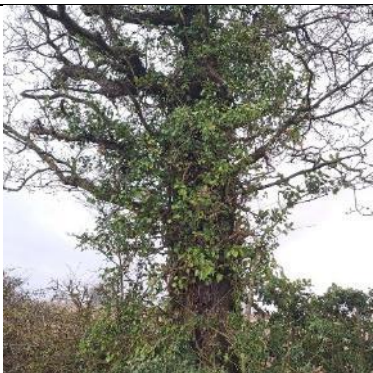
| Arb Reference | | | | N/A |
|---|---|---|---|---|
| BT63 | Tree Description: | <p>Pedunculate oak</p> <p>PRF 1: Ivy cover (no PRF but may obscure other features) located on the stem orientated all aspects. The ivy faced all aspects and was at a height of 1-3m. There was no evidence of bat use. There was potential for day/night/feeding/transitional occasional bat roost use.</p> | | |

| | | H&S Considerations: Proximity to water and near the sloped banks of a ditch.<br>Further Survey Requirements: PRF inspection survey – ladders. | | |
| Categorisation of Potential Bat Roost Habitat Suitability | | | | PRF-I |

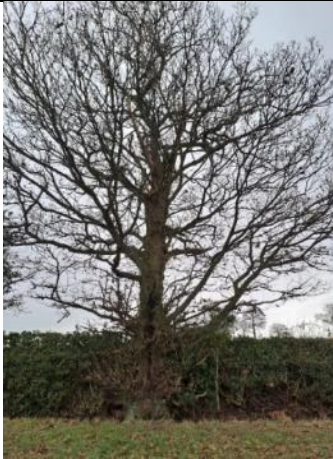
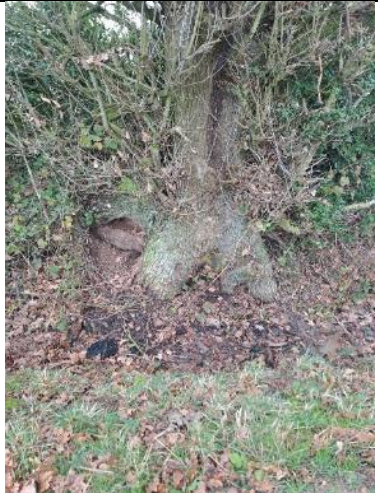
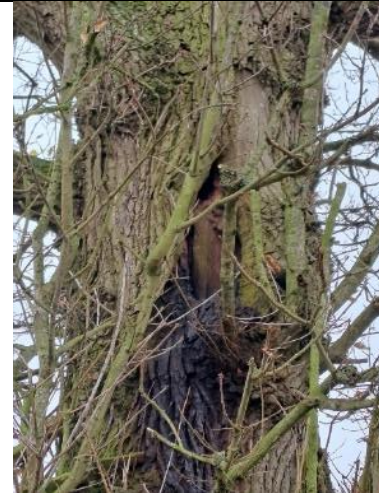
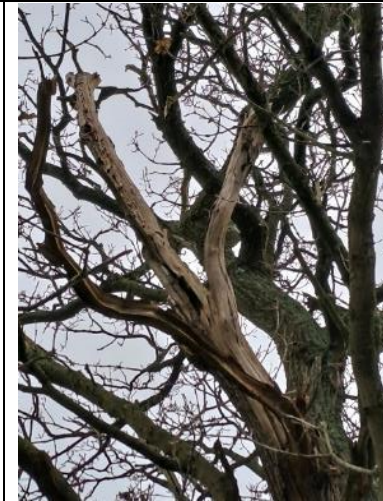
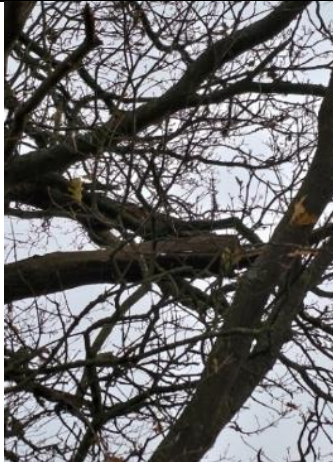
| BT64 | Tree Description: | <p>Pedunculate oak</p> <p>PRF 1: A number of holes at the base of the tree located on the stem orientated east. The holes faced east and were at a height of 0m. There was no evidence of bat use. There was potential for maternity/satellite/night/mating/swarming bat roost use.<br/>Potential Bat Roost Suitability: PRF-M<br/>H&amp;S Considerations: Proximity to water.<br/>Further Survey Requirements: Can survey from the ground.</p> <p>PRF 2: Knot-hole located on the stem orientated east. The hole faced east and was at a height of 2m. There was no evidence of bat use. There was potential for maternity/satellite/night/mating/swarming bat roost use.<br/>Potential Bat Roost Suitability: PRF-M<br/>H&amp;S Considerations: Proximity to water.<br/>Further Survey Requirements: PRF inspection survey – ropes.</p> | | |

| | | <p>PRF 3: Branch cavity located on a minor limb orientated north-east. The cavity faced north-east and was at a height of 6m. There was no evidence of bat use. There was potential for maternity/satellite/night/mating/swarming bat roost use.</p> <p>Potential Bat Roost Suitability: PRF-M</p> <p>H&amp;S Considerations: Proximity to water.</p> <p>Further Survey Requirements: PRF inspection survey – ropes.</p><br><p>PRF 4: Lifting-bark located on a minor limb orientated south-east. The bark faced south-east and was at a height of 6m. There was no evidence of bat use. There was potential for maternity/satellite/night/mating/swarming bat roost use.</p> <p>Potential Bat Roost Suitability: PRF-M</p> <p>H&amp;S Considerations: Proximity to water.</p> <p>Further Survey Requirements: PRF inspection survey – ropes.</p> | | | |

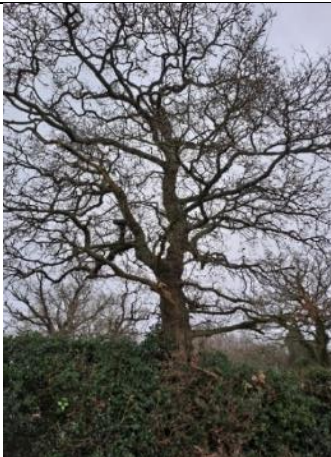
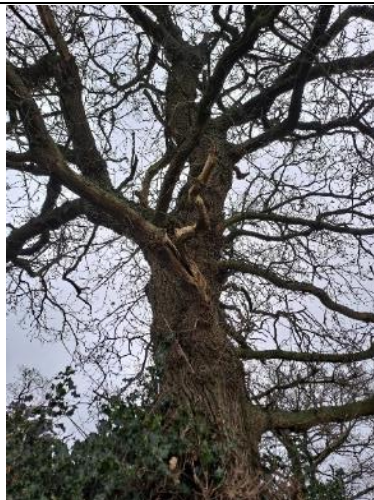
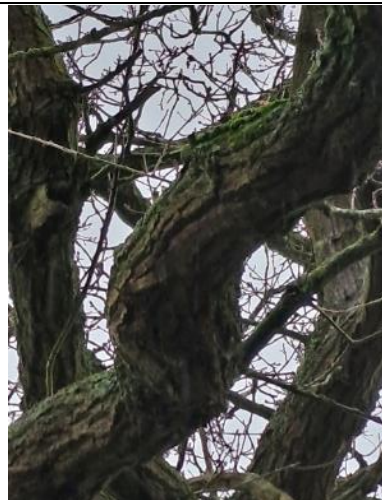
| BT65 | Tree Description: | <p>Pedunculate oak</p> <p>PRF 1: Knot-hole located on the stem orientated north-east. The hole faced north-east and was at a height of 2m. There was no evidence of bat use. There was potential for maternity/satellite/night/mating/swarming bat roost use.<br/>Potential Bat Roost Suitability: PRF-M<br/>H&amp;S Considerations: Proximity to road.<br/>Further Survey Requirements: PRF inspection survey – ropes.</p> <p>PRF 2: Knot-hole located on a minor limb orientated north. The hole faced north and was at a height of 3m. There was no evidence of bat use. There was potential for maternity/satellite/night/mating/swarming bat roost use.<br/>Potential Bat Roost Suitability: PRF-M<br/>H&amp;S Considerations: Proximity to road.<br/>Further Survey Requirements: PRF inspection survey – ropes.</p> | | | |

| | | Note: Due to proximity of road, rope inspection may not be possible, if not, nocturnal surveys will be required. | | | |

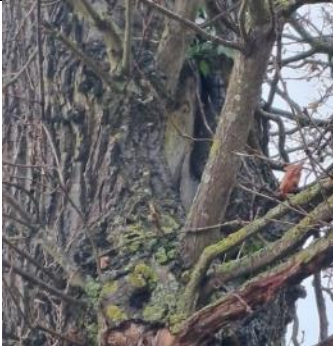
| | | PRF 1: Dead splitting branch located on a major limb orientated south-west. The branch faced south-west and was at a height of 2.5m. There was no evidence of bat use. There was potential for day/night/feeding/transitional occasional bat roost use.<br>Potential Bat Roost Suitability: PRF-I<br>H&S Considerations: Proximity to road and water and impenetrable vegetation.<br>Further Survey Requirements: PRF inspection survey – ladders. | | | T357 |

| | | PRF 2: Butt-rot located on the stem orientated north-west. The rot faced north-west and was at a height of 2m. There was no evidence of bat use. There was potential for day/night/feeding/transitional occasional bat roost use. Potential Bat Roost Suitability: PRF-I<br>H&S Considerations: Proximity to road.<br>Further Survey Requirements: PRF inspection survey – ladders. | | |

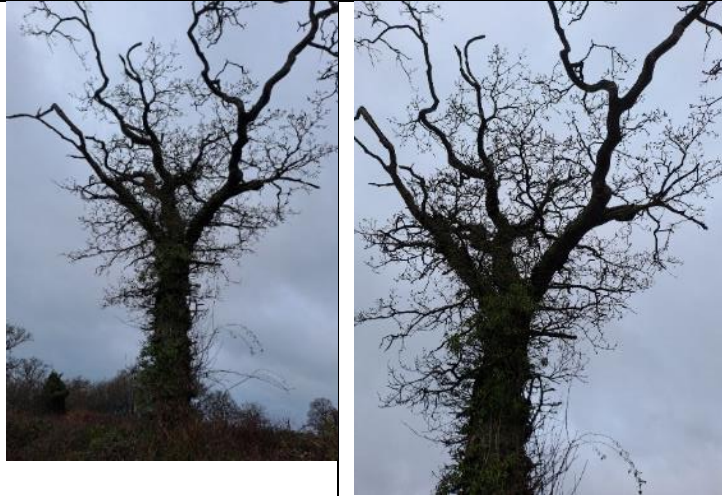
| | Tree Description: | Pedunculate oak<br><br>PRF 1: Branch cavity located on the stem orientated all aspects. The cavity faced all aspects and was at a height of 3-5m. There was no evidence of bat use. There was potential for day/night/feeding/transitional occasional bat roost use.<br>H&S Considerations: Proximity to road.<br>Further Survey Requirements: PRF inspection survey – ropes. | | |

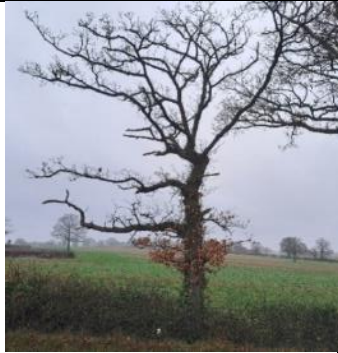
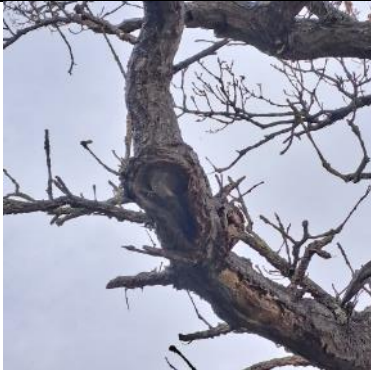
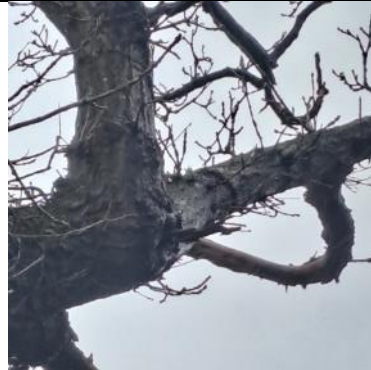
| BT68 | Tree Description: | <p>Pedunculate oak</p> <p>PRF 1: Branch cavity located on a major limb orientated west. The cavity faced west and was at a height of 1.5m. There was no evidence of bat use. There was potential for day/night/feeding/transitional occasional bat roost use. Potential Bat Roost Suitability: PRF-I<br/>H&amp;S Considerations: Proximity to road.<br/>Further Survey Requirements: PRF inspection survey – ladders.</p> <p>PRF 2: Hole located on a major limb orientated north-east. The hole faced north-east and was at a height of 2-3m. There was no evidence of bat use. There was potential for day/night/feeding/transitional occasional bat roost use. Potential Bat Roost Suitability: PRF-I<br/>H&amp;S Considerations: Proximity to road.<br/>Further Survey Requirements: PRF inspection survey – ladders.</p> | | |

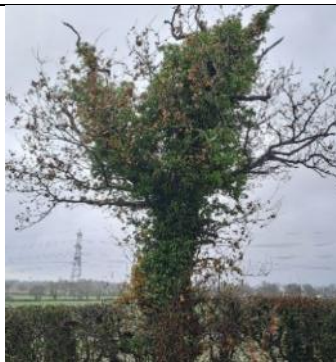
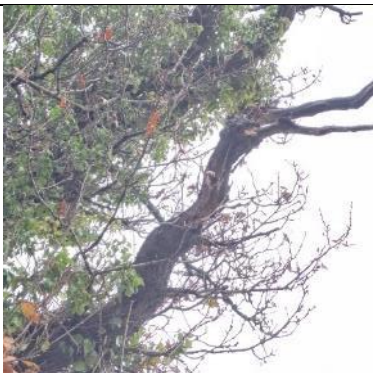
| | BT70 | Tree Description: | <p>Pedunculate oak</p> <p>PRF 1: Ivy cover (no PRF but may obscure other features) located on the stem orientated all aspects. The ivy faced all aspects and was at a height of 1-4m. There was no evidence of bat use. There was potential for day/night/feeding/transitional occasional bat roost use.</p> <p>Potential Bat Roost Suitability: PRF-I</p> <p>H&amp;S Considerations: Proximity to road and water.</p> <p>Further Survey Requirements: PRF inspection survey – ladders.</p> <p>PRF 2: Lifting-bark located on a major limb orientated south-west. The bark faced south-west and was at a height of 3-4m. There was no evidence of bat use. There was potential for day/night/feeding/transitional occasional bat roost use.</p> <p>Potential Bat Roost Suitability: PRF-I</p> <p>H&amp;S Considerations: Proximity to road and water.</p> <p>Further Survey Requirements: PRF inspection survey – ropes.</p> | | |

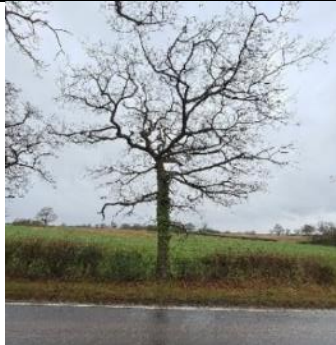
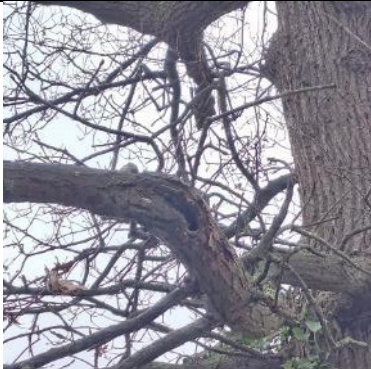
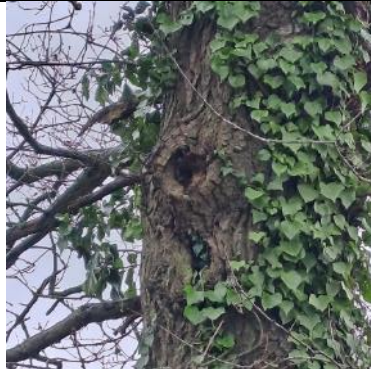
| BT71 | Tree Description: | <p>Pedunculate oak</p> <p>PRF 1: Branch cavity located on a minor limb orientated west. The cavity faced west and was at a height of 2m. There was no evidence of bat use. There was potential for day/night/feeding/transitional occasional bat roost use. Potential Bat Roost Suitability: PRF-I<br/>H&amp;S Considerations: Proximity to road and water.<br/>Further Survey Requirements: PRF inspection survey – ropes.</p> <p>PRF 2: Knot-hole located on a stem orientated west. The hole faced west and was at a height of 2-3m. There was no evidence of bat use. There was potential for day/night/feeding/transitional occasional bat roost use. Potential Bat Roost Suitability: PRF-I<br/>H&amp;S Considerations: Proximity to road and water.<br/>Further Survey Requirements: PRF inspection survey – ladders.</p> | | | |

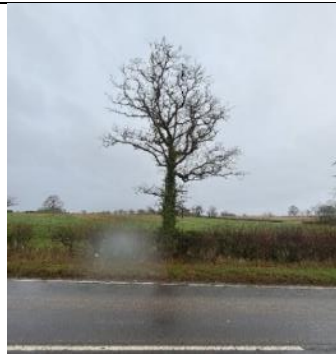
| BT72 | Tree Description: | <p>Pedunculate oak</p> <p>PRF 1: Desiccation-fissure located on a minor limb orientated north-west. The fissure faced north-west and was at a height of 2-3m. There was no evidence of bat use. There was potential for day/night/feeding/transitional occasional bat roost use.</p> <p>H&amp;S Considerations: Proximity to road and water.</p> <p>Further Survey Requirements: PRF inspection survey – ladders.</p> | | | |

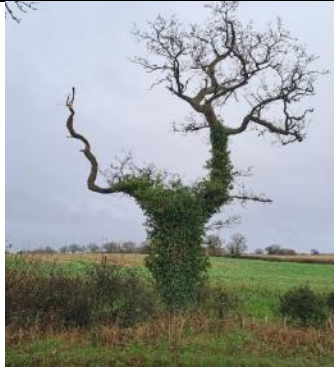
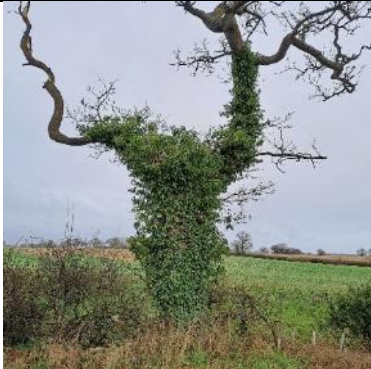
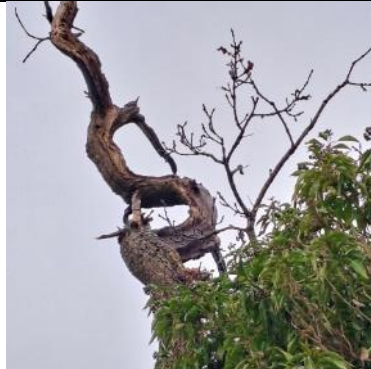
| | BT73 | Tree Description: | Pedunculate oak<br><br>PRF 1: Ivy cover (no PRF but may obscure other features) located on the stem orientated all aspects. The ivy faced all aspects and was at a height of 1-3m. There was no evidence of bat use. There was potential for day/night/feeding/transitional occasional bat roost use.<br>Potential Bat Roost Suitability: PRF-I<br>H&S Considerations: Proximity to road and water.<br>Further Survey Requirements: PRF inspection survey – ladders.<br><br>PRF 2: Branch cavity located on a major limb orientated west. The cavity faced west and was at a height of 4m. There was no evidence of bat use. There was potential for day/night/feeding/transitional occasional bat roost use.<br>Potential Bat Roost Suitability: PRF-I<br>H&S Considerations: Proximity to road and water.<br>Further Survey Requirements: PRF inspection survey – ropes. | | | |

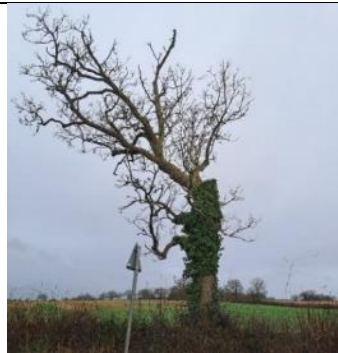
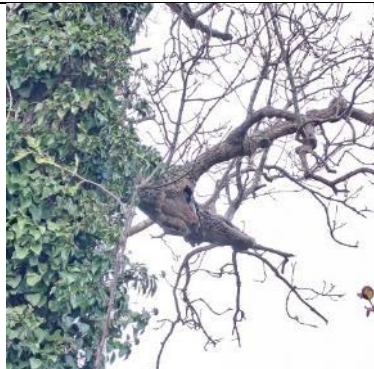
| BT74 | Tree Description: | <p>Ash</p> <p>PRF 1: Unknown feature type located on a major limb orientated north. The cavity faced north and was at a height of 3-4m. There was no evidence of bat use. There was potential for day/night/feeding/transitional occasional bat roost use.</p> <p>H&amp;S Considerations: Proximity to road and water.</p> <p>Further Survey Requirements: PRF inspection survey – ropes.</p> | | | |

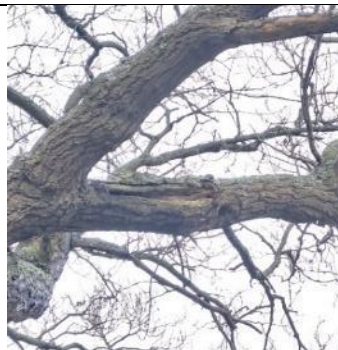
| | BT75 | Tree Description: | Pedunculate oak<br><br>PRF 1: Branch cavity located on a major limb orientated north-west. The cavity faced north-west and was at a height of 3m. There was no evidence of bat use. There was potential for day/night/feeding/transitional occasional bat roost use.<br>H&S Considerations: Proximity to road and water.<br>Further Survey Requirements: PRF inspection survey – ropes. | | | |

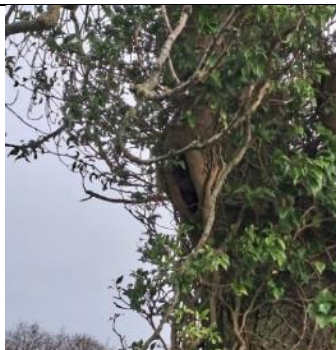
| Categorisation of Potential Bat Roost Habitat Suitability | | | | PRF-I |
|---|---|---|--|---|
| BT76 | Tree Description: | <p>Ash</p> <p>PRF 1: Butt-rot located on the stem orientated west. The rot faced west and was at a height of 2.5m. There was no evidence of bat use. There was potential for day/night/feeding/transitional occasional bat roost use.</p> <p>Potential Bat Roost Suitability: PRF-I</p> <p>H&amp;S Considerations: Proximity to road and water.</p> <p>Further Survey Requirements: PRF inspection survey – ropes.</p> <p>PRF 2: Ivy cover (no PRF but may obscure other features) located on the stem orientated all aspects. The ivy faced all aspects and was at a height of 1-5m. There was no evidence of bat use. There was potential for day/night/feeding/transitional occasional bat roost use.</p> <p>Potential Bat Roost Suitability: PRF-I</p> <p>H&amp;S Considerations: Proximity to road and water.</p> <p>Further Survey Requirements: PRF inspection survey – ropes.</p> | | |

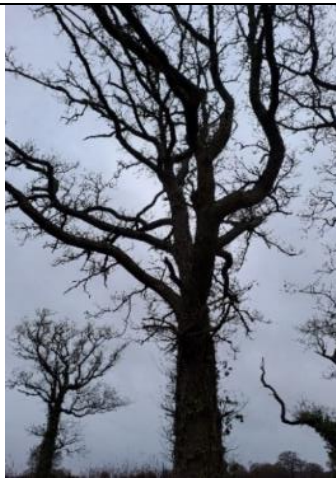
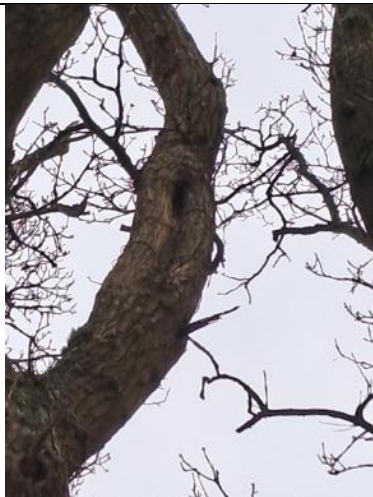
| Arb Reference | | | T26 |
|---|---|---|---|
| BT77 | Tree Description: | <p>Pedunculate oak</p> <p>PRF 1: Branch cavity located on a minor limb orientated south. The cavity faced south and was at a height of 7m. There was no evidence of bat use. There was potential for maternity/satellite/night/mating/swarming bat roost use.</p> <p>H&amp;S Considerations: Proximity to road and water.</p> <p>Further Survey Requirements: PRF inspection survey – ropes.</p> | |

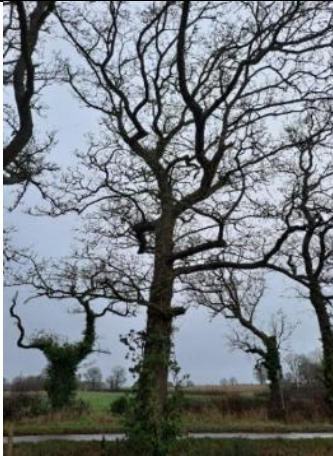
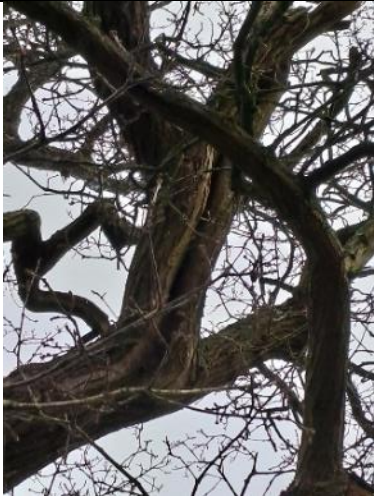
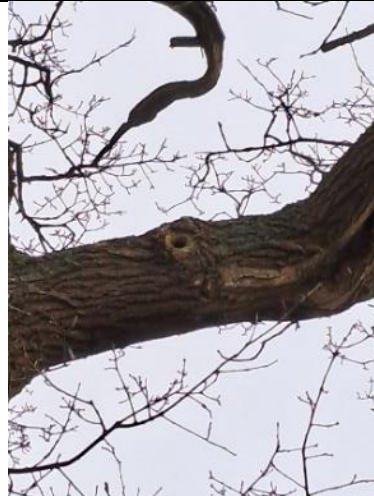
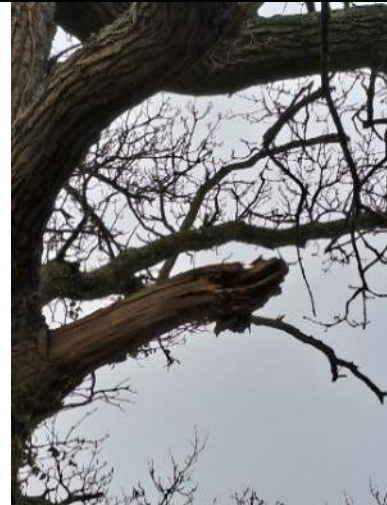
| Arb Reference | | | T26 |
|---|---|---|---|
| BT78 | Tree Description: | <p>Pedunculate oak</p> <p>PRF 1: Branch cavity located on a major limb orientated south. The cavity faced south and was at a height of 6m. There was no evidence of bat use. There was potential for maternity/satellite/night/mating/swarming bat roost use.</p> <p>Potential Bat Roost Suitability: PRF-M</p> <p>H&amp;S Considerations: Proximity to road.</p> | |

| | <p>Further Survey Requirements: PRF inspection survey – ropes.</p> <p>PRF 2: Knot-hole located on a major limb orientated south-west. The hole faced south-west and was at a height of 6m. There was no evidence of bat use. There was potential for maternity/satellite/night/mating/swarming bat roost use.</p> <p>Potential Bat Roost Suitability: PRF-M</p> <p>H&amp;S Considerations: Proximity to road and barbed wire.</p> <p>Further Survey Requirements: PRF inspection survey – ropes.</p> <p>PRF 3: Dead snapped branch located on a minor limb orientated north-east. The branch faced north-east and was at a height of 4m. There was no evidence of bat use. There was potential for maternity/satellite/night/mating/swarming bat roost use.</p> <p>Potential Bat Roost Suitability: PRF-M</p> <p>H&amp;S Considerations: Proximity to road and barbed wire.</p> <p>Further Survey Requirements: PRF inspection survey – ropes.</p> <p>Note: Due to the proximity to the road, a rope inspection may not be possible. If not, nocturnal surveys will be required.</p> |

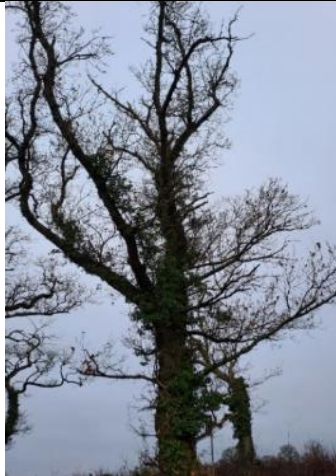
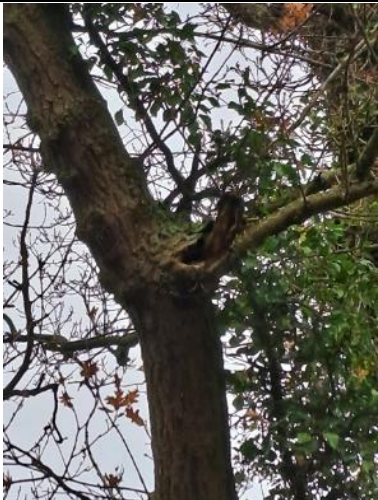
| | BT80 | Tree Description: | <p>Pedunculate oak</p> <p>PRF 1: Knot-hole located on a minor limb orientated south. The hole faced south and was at a height of 5m. There was no evidence of bat use. There was potential for day/night/feeding/transitional occasional bat roost use.</p> <p>H&amp;S Considerations: Proximity to road and barbed wire.</p> <p>Further Survey Requirements: PRF inspection survey – ropes.</p> <p>Note: Due to the proximity to the road, a rope inspection may not be possible. If not, nocturnal surveys will be required.</p> | |

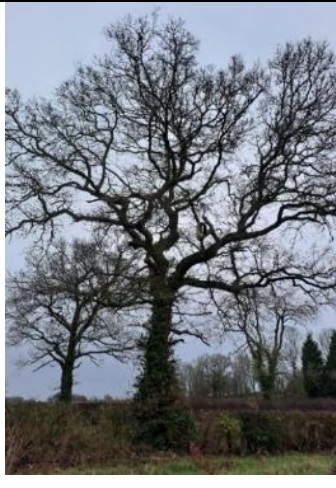
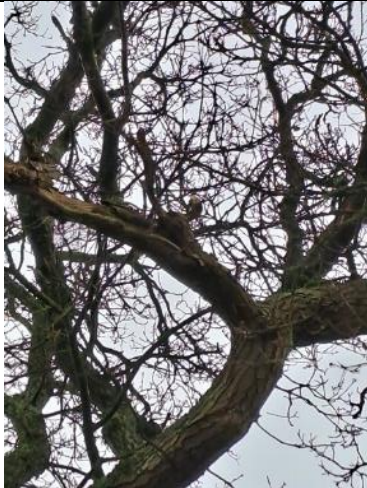
| | BT81 | Tree Description: | <p>Pedunculate oak</p> <p>PRF 1: Branch cavity located on a minor limb orientated south. The cavity faced south and was at a height of 6m. There was no evidence of bat use. There was potential for maternity/satellite/night/mating/swarming bat roost use.</p> <p>H&amp;S Considerations: Proximity to road and barbed wire.</p> <p>Further Survey Requirements: PRF inspection survey – ropes.</p> <p>Note: Due to the proximity to the road, a rope inspection may not be possible. If not, nocturnal surveys will be required.</p> | | |

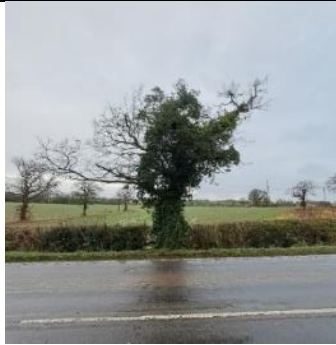
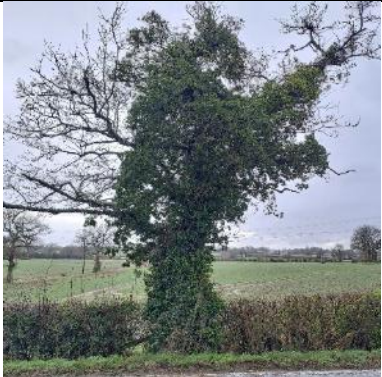
| | BT82 | Tree Description: | <p>Pedunculate oak</p> <p>PRF 1: Ivy cover mature (&gt;50mm diameter, lattice forming) located on the stem orientated all aspects. The ivy creates a PRF but may also obscure other PRFs. The ivy faced all aspects and was at a height of 1-5m. There was no evidence of bat use. There was potential for day/night/feeding/transitional occasional bat roost use.</p> <p>H&amp;S Considerations: Proximity to road and water.</p> <p>Further Survey Requirements: PRF inspection survey – ropes.</p> | | |

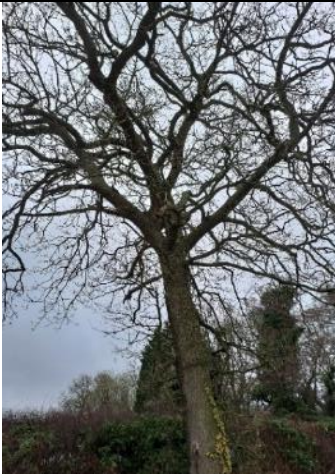
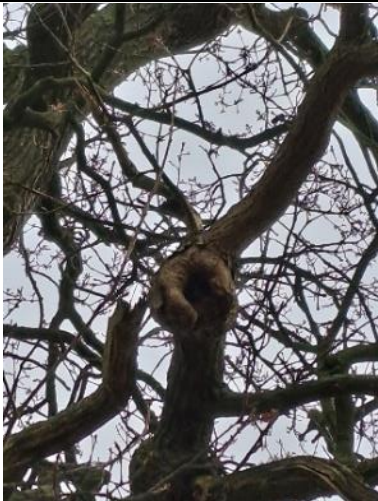
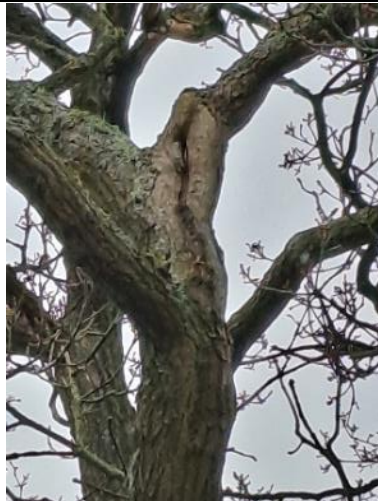
| | BT83 | Tree Description: | <p>Pedunculate oak</p> <p>PRF 1: Knot-hole located on a minor limb orientated south-east. The knot-hole faced south-east and was at a height of 4m. There was no evidence of bat use. There was potential for maternity/satellite/night/mating/swarming bat roost use.</p> <p>Potential Bat Roost Suitability: PRF-M</p> <p>H&amp;S Considerations: Proximity to road and water.</p> <p>Further Survey Requirements: PRF inspection survey – ropes.</p> <p>PRF 2: Knot-hole located on a minor limb orientated south-east. The knot-hole faced south-east and was at a height of 8m. There was no evidence of bat use. There was potential for maternity/satellite/night/mating/swarming bat roost use.</p> <p>Potential Bat Roost Suitability: PRF-M</p> <p>H&amp;S Considerations: Proximity to road and water.</p> <p>Further Survey Requirements: PRF inspection survey – ropes.</p> | | |

| | | Note: Due to the proximity to the road, a rope inspection may not be possible. If not, nocturnal surveys will be required. | | |

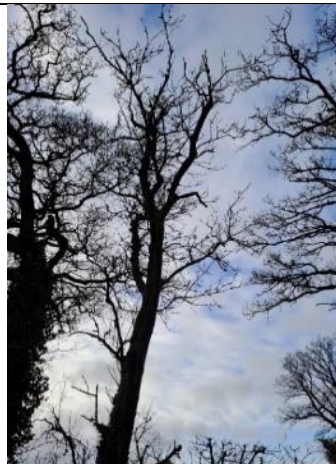
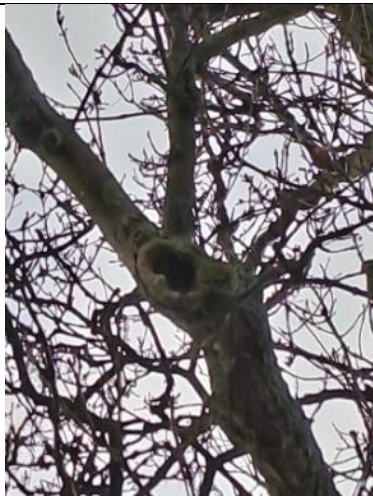
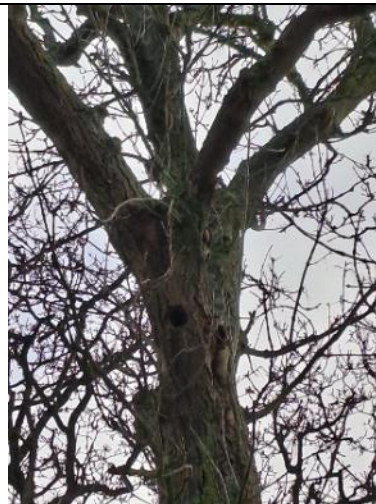
| BT84 | Tree Description: | <p>Pedunculate oak</p> <p>PRF 1: Knot-hole located on a minor limb orientated north-east. The knot-hole faced north-east and was at a height of 5m. There was no evidence of bat use. There was potential for maternity/satellite/night/mating/swarming bat roost use.</p> <p>Potential Bat Roost Suitability: PRF-M</p> <p>H&amp;S Considerations: None.</p> <p>Further Survey Requirements: PRF inspection survey – ropes.</p> | | |

| | | <p>PRF 2: Woodpecker-hole located on the stem orientated north. The hole faced north and was at a height of 6m. There was no evidence of bat use. There was potential for maternity/satellite/night/mating/swarming bat roost use. Potential Bat Roost Suitability: PRF-M<br/>H&amp;S Considerations: None.<br/>Further Survey Requirements: PRF inspection survey – ropes.</p> | | |

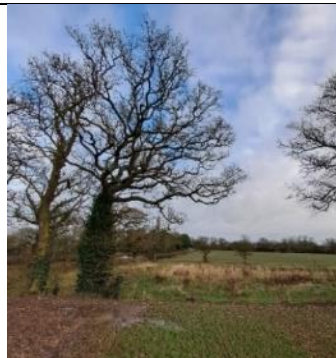
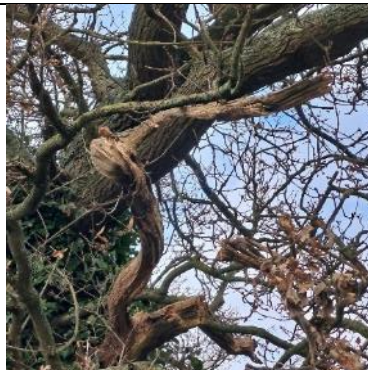
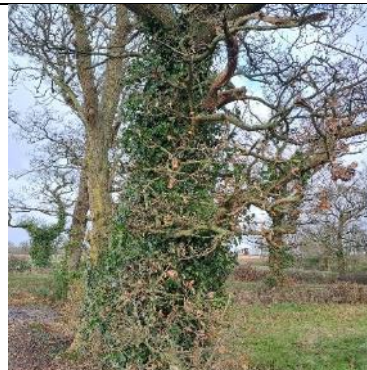
| BT85 | Tree Description: | <p>Oak <i>Quercus</i> sp.</p> <p>PRF 1: Desiccation-fissure located on a minor limb orientated south. The fissure faced south and was at a height of 3m. There was no evidence of bat use. There was potential for day/night/feeding/transitional occasional bat roost use.<br/>Potential Bat Roost Suitability: PRF-I<br/>H&amp;S Considerations: Excessively boggy ground and overhanging barbed wire fence.</p> | | |

| | | <p>Further Survey Requirements: PRF inspection survey – ropes.</p> <p>PRF 2: Ivy cover (no PRF but may obscure other features) located on the stem orientated all aspects. The hole faced all aspects and was at a height of 1-4m. There was no evidence of bat use. There was potential for day/night/feeding/transitional occasional bat roost use.</p> <p>Potential Bat Roost Suitability: PRF-I</p> <p>H&amp;S Considerations: Excessively boggy ground and overhanging barbed wire fence.</p> <p>Further Survey Requirements: PRF inspection survey – ropes.</p> | | | |
