## Oldbury to Meriden, Warwickshire

# Ground Level Tree Assessment Report

**Prepared For: Severn Trent Water**

Document Reference: 10408.04.001

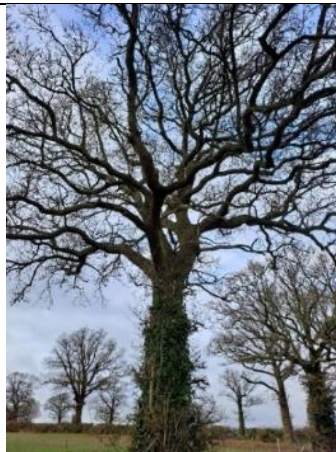
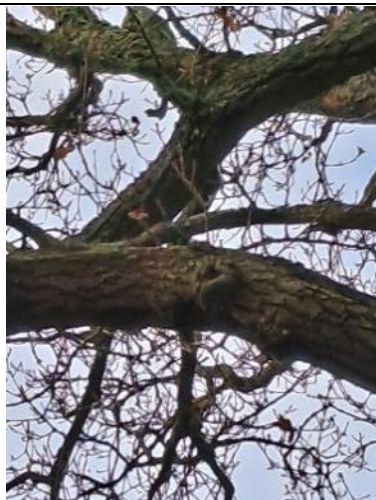
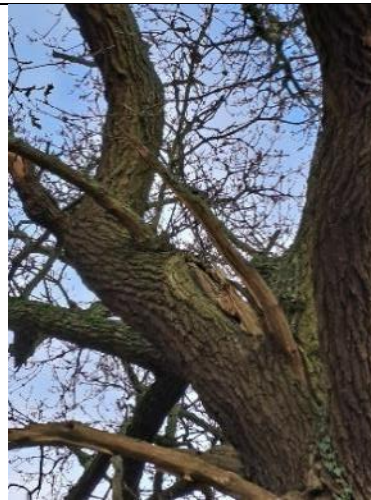
| | H&S Considerations: None. | | |
| | Further Survey Requirements: PRF inspection survey – ropes. | | |

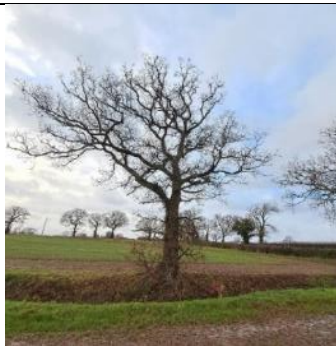
| | | <p>PRF 1: Desiccation-fissure located on a major limb orientated south. The fissure faced east and was at a height of 3.5m. There was no evidence of bat use. There was potential for maternity/satellite/night/mating/swarming bat roost use.</p> <p>H&amp;S Considerations: Proximity to water and steep ground.</p> <p>Further Survey Requirements: PRF inspection survey – ropes.</p> | | |

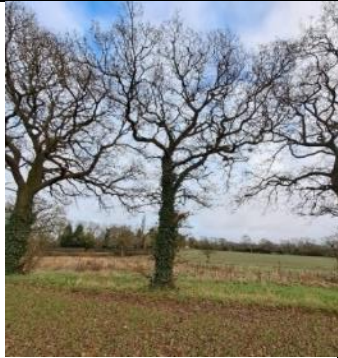
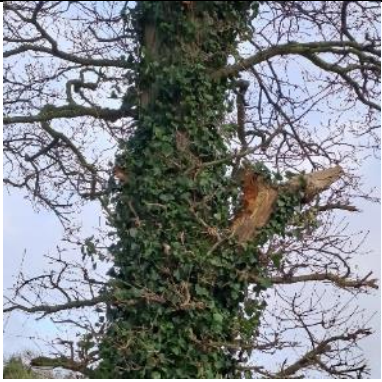
| BT88 | Tree Description: | <p>Pedunculate oak</p> <p>PRF 1: Ivy cover (no PRF but may obscure other features) located on the stem orientated all aspects. The ivy faced all aspects and was at a height of 1-7m. There was no evidence of bat use. There was potential for day/night/feeding/transitional occasional bat roost use.</p> <p>H&amp;S Considerations: Overhanging metal/spiked rails and excessively boggy ground.</p> <p>Further Survey Requirements: PRF inspection survey – ropes.</p> | | |

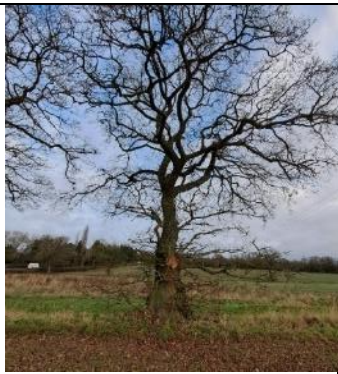
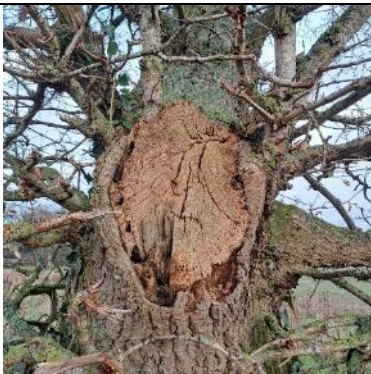
| BT89 | Tree Description: | <p>Sessile oak</p> <p>PRF 1: Branch cavity located on the stem orientated west. The cavity faced west and was at a height of 1m. There was no evidence of bat use. There was potential for day/night/feeding/transitional occasional bat roost use.</p> <p>H&amp;S Considerations: Overhanging metal/spiked rails and excessively boggy ground.</p> <p>Further Survey Requirements: Survey from ground level as feature is at head height.</p> | | | |

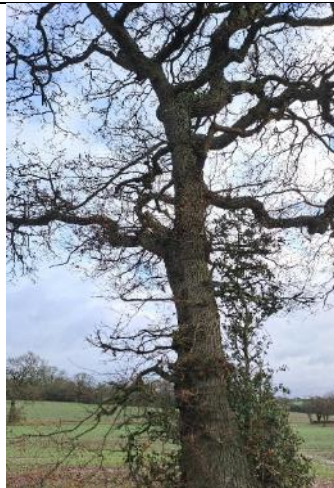
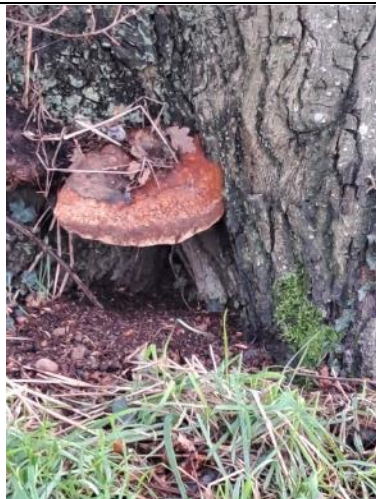
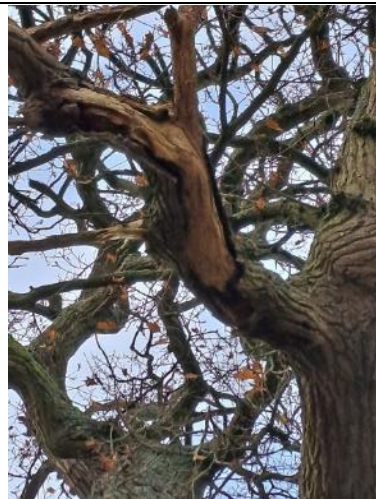
| Arb Reference | | T347 |
|---|---|---|
| BT90 | Tree Description: | <p>Pedunculate oak</p> <p>PRF 1: Trunk cavity located on the stem orientated north-west. The cavity faced north-west and was at a height of 0m. There was no evidence of bat use. There was potential for maternity/satellite/night/mating/swarming bat roost use.</p> <p>Potential Bat Roost Suitability: PRF-M</p> <p>H&amp;S Considerations: None.</p> <p>Further Survey Requirements: Presence/likely absence surveys – dusk emergence.</p> |
| | | <p>PRF 2: Branch cavity located on a minor limb orientated south-east. The cavity faced south-east and was at a height of 5m. There was no evidence of bat use. There was potential for maternity/satellite/night/mating/swarming bat roost use.</p> <p>Potential Bat Roost Suitability: PRF-M</p> <p>H&amp;S Considerations: None.</p> <p>Further Survey Requirements: PRF inspection survey – ropes.</p> |

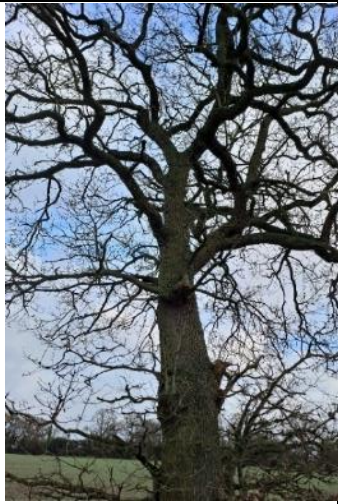
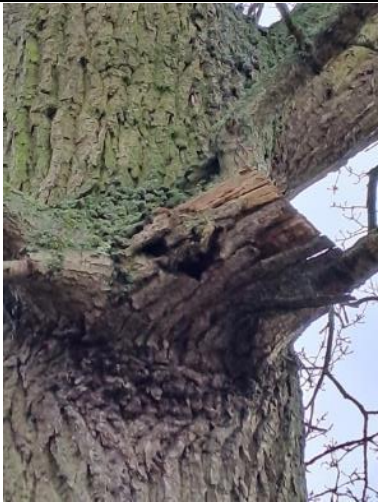
| BT91 | Tree Description: | Pedunculate oak<br><br>PRF 1: Branch cavity located on a major limb orientated south-west. The cavity faced south-west and was at a height of 2.5m. There was no evidence of bat use. There was potential for day/night/feeding/transitional occasional bat roost use.<br>H&S Considerations: None.<br>Further Survey Requirements: PRF inspection survey – ropes. | | | |

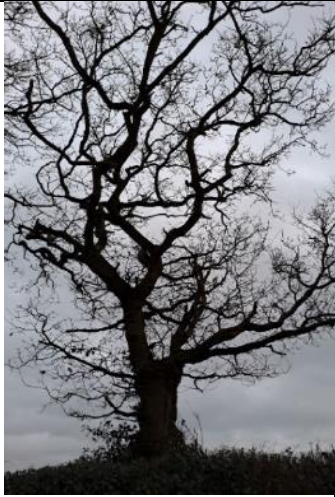
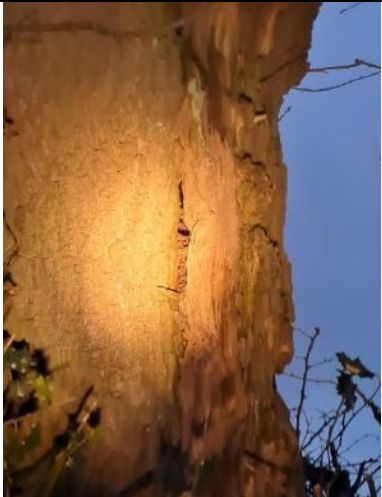
| BT92 | Tree Description: | <p>Pedunculate oak</p> <p>PRF 1: Trunk cavity located on the stem orientated east. The cavity faced east and was at a height of 2m. There was no evidence of bat use. There was potential for maternity/satellite/night/mating/swarming bat roost use.</p> <p>H&amp;S Considerations: None.</p> <p>Further Survey Requirements: PRF inspection survey – ropes.</p> | | | |

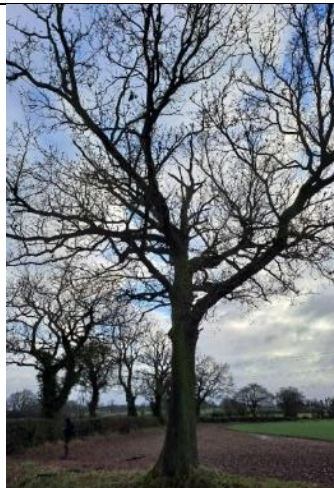
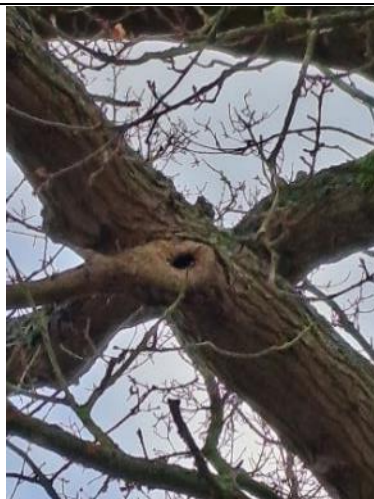
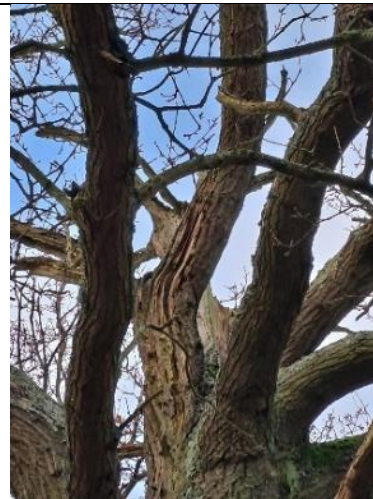
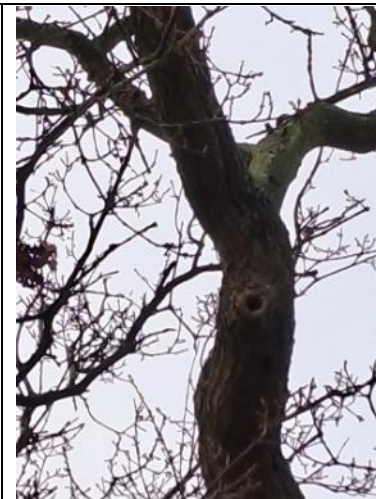
| | | H&S Considerations: Proximity to water. | | | |
| | | Further Survey Requirements: PRF inspection survey – ropes. | | | |

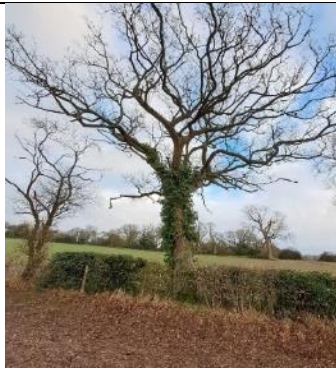
| | <p>PRF 1: Ivy cover (no PRF but may obscure other features) located on the stem oriented all aspects. The ivy faced all aspects and was at a height of 1-4m. There was no evidence of bat use. There was potential for maternity/satellite/night/mating/swarming bat roost use.</p> <p>Potential Bat Roost Suitability: PRF-M</p> <p>H&amp;S Considerations: Overhanging metal/spiked rails, steep ground and excessively boggy ground.</p> <p>Further Survey Requirements: PRF inspection survey – ropes.</p> <p>PRF 2: Desiccation-fissure located on a minor limb orientated west. The fissure faced west and was at a height of 3m. There was no evidence of bat use. There was potential for maternity/satellite/night/mating/swarming bat roost use.</p> <p>Potential Bat Roost Suitability: PRF-M</p> <p>H&amp;S Considerations: Overhanging metal/spiked rails and steep ground.</p> <p>Further Survey Requirements: PRF inspection survey – ladders.</p> | |

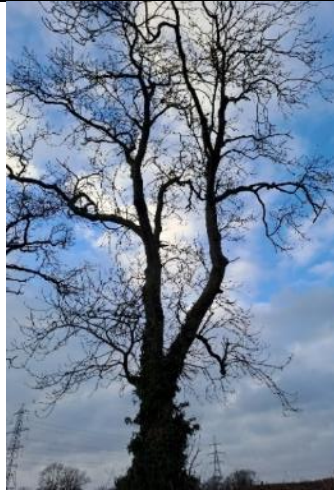
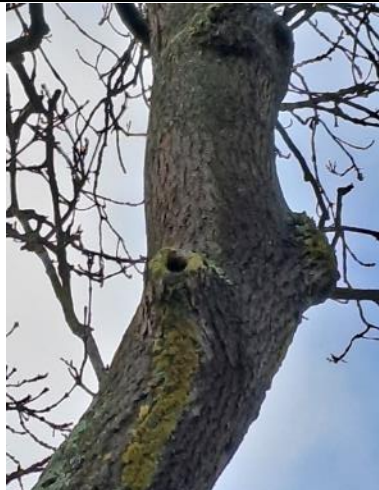
| | | PRF 1: Knot-hole located on a major limb oriented east. The hole faced east and was at a height of 4m. There was no evidence of bat use. There was potential for maternity/satellite/night/mating/swarming bat roost use.<br>H&S Considerations: Proximity to water.<br>Further Survey Requirements: PRF inspection survey – ropes. | | | |

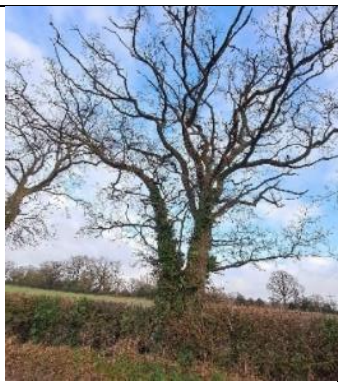
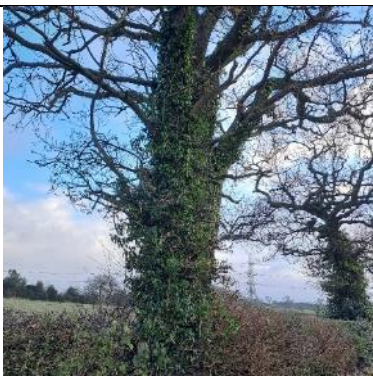
| BT96 | Tree Description: | Pedunculate oak<br><br>PRF 1: Ivy cover (no PRF but may obscure other features) located on the stem oriented all aspects. The ivy faced all aspects and was at a height of 1-5m. There was no evidence of bat use. There was potential for day/night/feeding/transitional occasional bat roost use.<br>H&S Considerations: Proximity to water and steep ground.<br>Further Survey Requirements: PRF inspection survey – ropes. | | | |

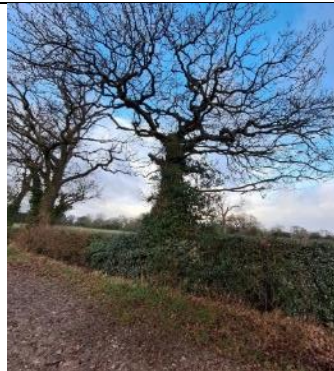
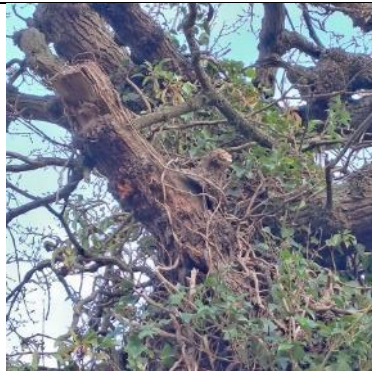
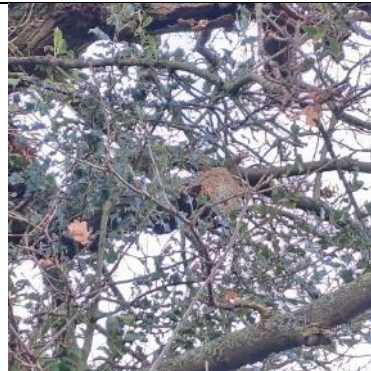
| | BT97 | Tree Description: | <p>Pedunculate oak</p> <p>PRF 1: Lifting-bark located on the stem oriented north-west. The bark faced north-west and was at a height of 3m. There was no evidence of bat use. There was potential for maternity/satellite/night/mating/swarming bat roost use. Potential Bat Roost Suitability: PRF-M</p> <p>H&amp;S Considerations: Steep ground and proximity to water.</p> <p>Further Survey Requirements: PRF inspection survey – ladders.</p> <p>PRF 2: Branch cavity located on a minor limb oriented south-east. The cavity faced south-east and was at a height of 3m. There was no evidence of bat use. There was potential for maternity/satellite/night/mating/swarming bat roost use.</p> <p>Potential Bat Roost Suitability: PRF-M</p> <p>H&amp;S Considerations: Steep ground and proximity to water.</p> <p>Further Survey Requirements: PRF inspection survey – ropes.</p> | | |

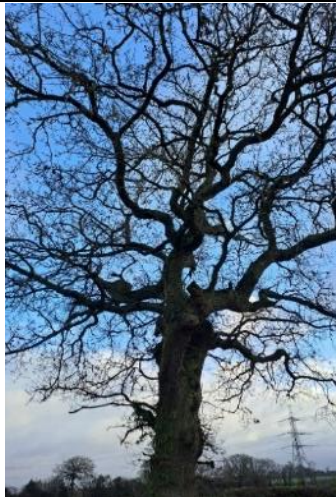
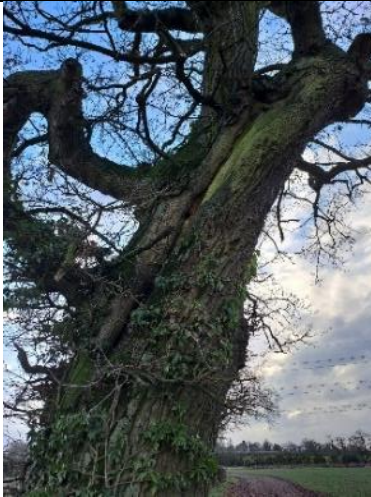
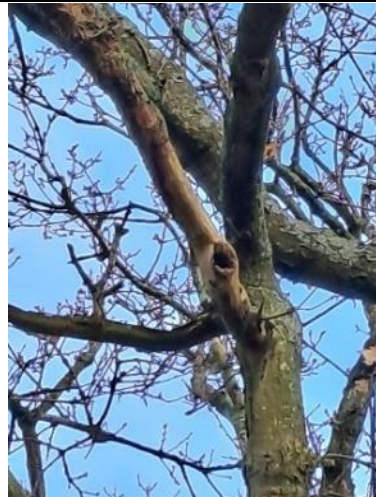
| BT98 | Tree Description: | <p>Pedunculate oak</p> <p>PRF 1: Trunk cavity located on the stem oriented north-east. The cavity faced north-east and was at a height of 0.5-2.5m. There was no evidence of bat use. There was potential for maternity/satellite/night/mating/swarming bat roost use.</p> <p>Potential Bat Roost Suitability: PRF-M</p> <p>H&amp;S Considerations: Proximity to water and barbed wire.</p> <p>Further Survey Requirements: PRF inspection survey – ladders.</p> <p>PRF 2: Knot-hole located on a minor limb oriented south-west. The hole faced south-west and was at a height of 8m. There was no evidence of bat use. There was potential for maternity/satellite/night/mating/swarming bat roost use.</p> <p>Potential Bat Roost Suitability: PRF-M</p> <p>H&amp;S Considerations: Steep ground and proximity to water.</p> <p>Further Survey Requirements: PRF inspection survey – ropes.</p> | | | |

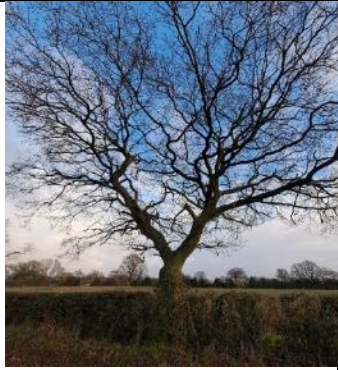
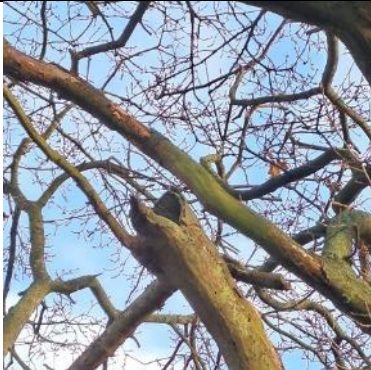
| BT99 | Tree Description: | <p>Pedunculate oak</p> <p>PRF 1: Branch cavity located on a minor limb oriented north-west. The cavity faced north-west and was at a height of 4m. There was no evidence of bat use. There was potential for maternity/satellite/night/mating/swarming bat roost use.</p> <p>H&amp;S Considerations: Steep ground, proximity to water and overhanging metal/spiked rails.</p> <p>Further Survey Requirements: PRF inspection survey – ropes.</p> | | | |

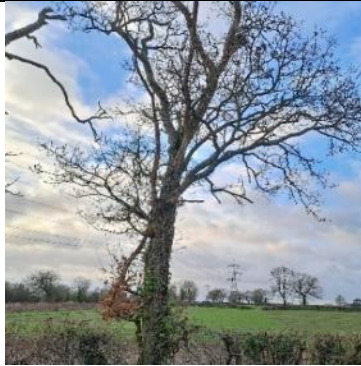
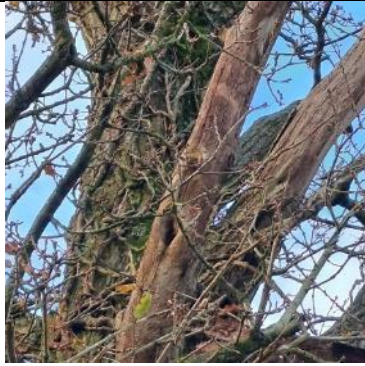
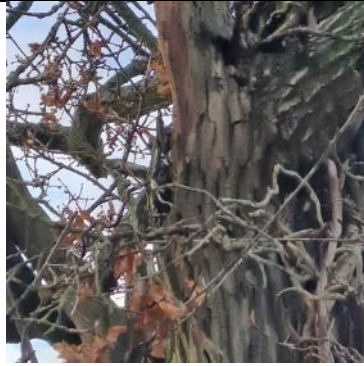
| BT100 | Tree Description: | <p>Pedunculate oak</p> <p>PRF 1: Branch cavity located on a major limb oriented south-east. The cavity faced south-east and was at a height of 3m. There was no evidence of bat use. There was potential for maternity/satellite/night/mating/swarming bat roost use.</p> <p>Potential Bat Roost Suitability: PRF-M</p> <p>H&amp;S Considerations: Steep ground and proximity to water.</p> <p>Further Survey Requirements: PRF inspection survey – ropes.</p> <p>PRF 2: Lifting-bark located on a major limb oriented south-east. The bark faced south-east and was at a height of 3m. There was no evidence of bat use. There was potential for maternity/satellite/night/mating/swarming bat roost use.</p> <p>Potential Bat Roost Suitability: PRF-M</p> <p>H&amp;S Considerations: Steep ground and proximity to water.</p> <p>Further Survey Requirements: PRF inspection survey – ropes.</p> | | | |

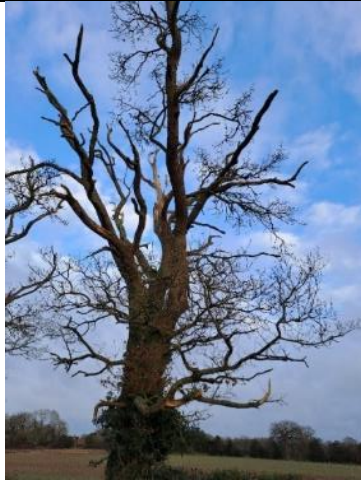
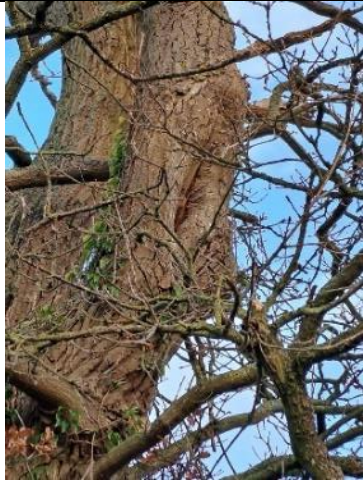
| BT101 | Tree Description: | <p>Pedunculate oak</p> <p>PRF 1: Knot-hole located on a major limb oriented south-west. The hole faced south-west and was at a height of 3m. There was no evidence of bat use. There was potential for maternity/satellite/night/mating/swarming bat roost use.</p> <p>H&amp;S Considerations: Proximity to water.</p> <p>Further Survey Requirements: PRF inspection survey – ropes.</p> | | | |

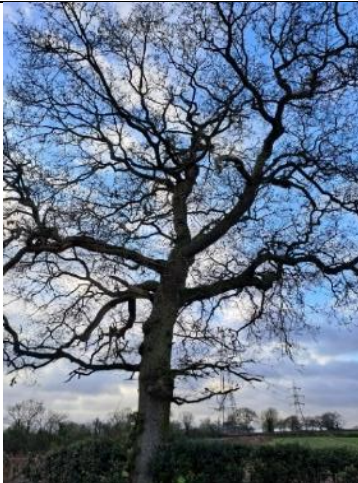
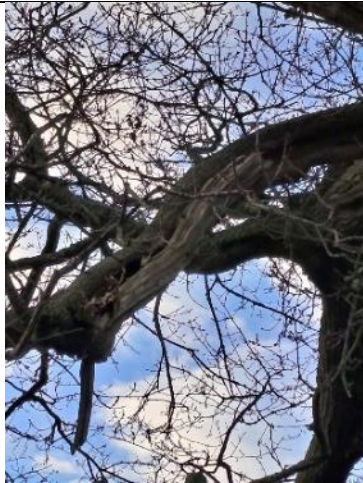
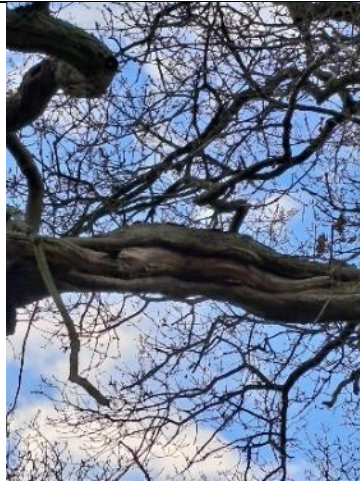
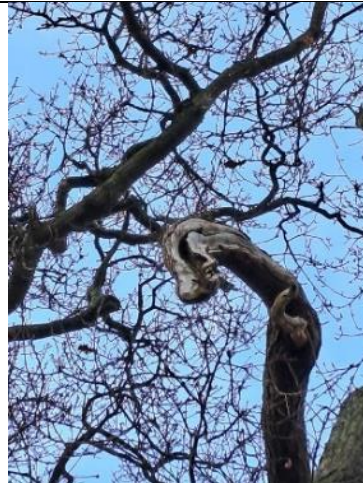
| BT102 | Tree Description: | <p>Pedunculate oak</p> <p>PRF 1: Branch cavity located on a minor limb oriented south-east. The cavity faced south-east and was at a height of 2.5m. There was no evidence of bat use. There was potential for maternity/satellite/night/mating/swarming bat roost use.</p> <p>Potential Bat Roost Suitability: PRF-M</p> <p>H&amp;S Considerations: Proximity to water.</p> <p>Further Survey Requirements: PRF inspection survey – ropes.</p> <p>PRF 2: Branch cavity located on a minor limb oriented south-east. The cavity faced south-east and was at a height of 3.5m. There was no evidence of bat use. There was potential for maternity/satellite/night/mating/swarming bat roost use.</p> | | | |

| | <p>Potential Bat Roost Suitability: PRF-M<br/>H&amp;S Considerations: Proximity to water.<br/>Further Survey Requirements: PRF inspection survey – ropes.</p> <p>PRF 3: Branch cavity located on a minor limb oriented east. The cavity faced east and was at a height of 4m. There was no evidence of bat use. There was potential for maternity/satellite/night/mating/swarming bat roost use.<br/>Potential Bat Roost Suitability: PRF-M<br/>H&amp;S Considerations: Proximity to water.<br/>Further Survey Requirements: PRF inspection survey – ropes.</p> | |

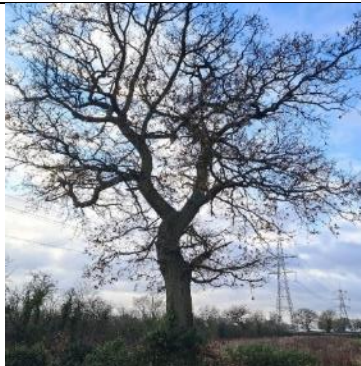
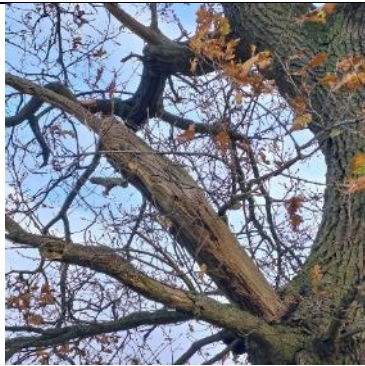
| BT103 | Tree Description: | Pedunculate oak |

| | | <p>PRF 1: Large broken limb with multiple entry holes into the branch located on a minor limb oriented north-west. The cavity faced north-west and was at a height of 3m. There was no evidence of bat use. There was potential for maternity/satellite/night/mating/swarming bat roost use.</p> <p>Potential Bat Roost Suitability: PRF-M</p> <p>H&amp;S Considerations: Proximity to water and steep ground.</p> <p>Further Survey Requirements: PRF inspection survey – ropes.</p> | | | |

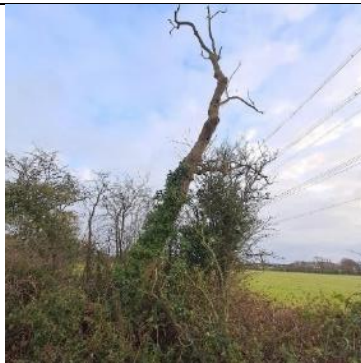
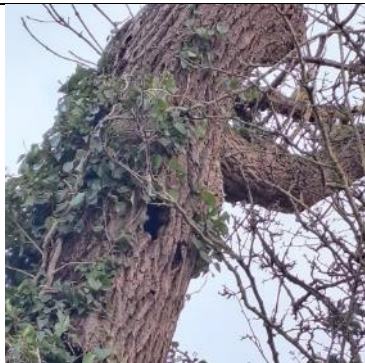
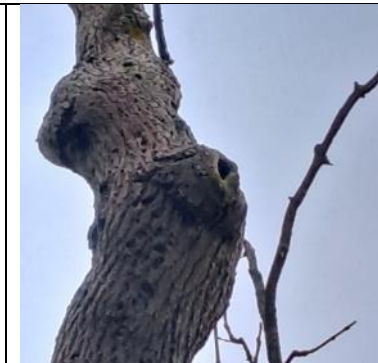
| BT104 | Tree Description: | <p>Sycamore</p> <p>PRF 1: Trunk cavity located on the stem oriented east. The cavity faced east and was at a height of 4m. There was no evidence of bat use. There was potential for maternity/satellite/night/mating/swarming bat roost use.</p> <p>Potential Bat Roost Suitability: PRF-M</p> <p>H&amp;S Considerations: Proximity to water and footpaths, PRF damage/disturbance likely and overhanging metal/spiked rails.</p> <p>Further Survey Requirements: Presence/likely absence surveys – dusk emergence.</p> | | | |

| | | <p>PRF 2: Knot-hole located on the stem oriented north-west. The hole faced south-west and was at a height of 8m. There was no evidence of bat use. There was potential for day/night/feeding/transitional occasional bat roost use. Potential Bat Roost Suitability: PRF-I</p> <p>H&amp;S Considerations: Proximity to water, PRF damage/disturbance likely and overhanging metal/spiked rails.</p> <p>Further Survey Requirements: Presence/likely absence surveys – dusk emergence.</p> | | |

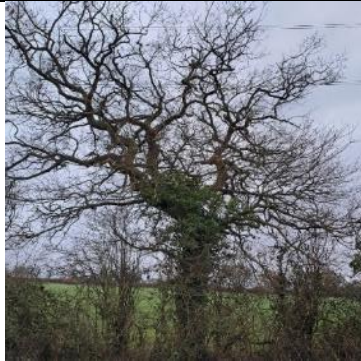
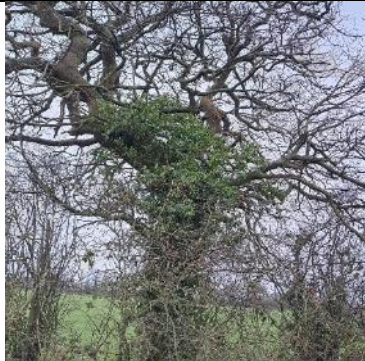
| BT105 | Tree Description: | <p>Pedunculate oak</p> <p>PRF 1: Ivy cover (no PRF but may obscure other features) located on the stem oriented north. The ivy faced north and was at a height of 1-3m. There was no evidence of bat use. There was potential for day/night/feeding/transitional occasional bat roost use.</p> <p>H&amp;S Considerations: Proximity to water and steep ground.</p> <p>Further Survey Requirements: PRF inspection survey – ropes.</p> | | |

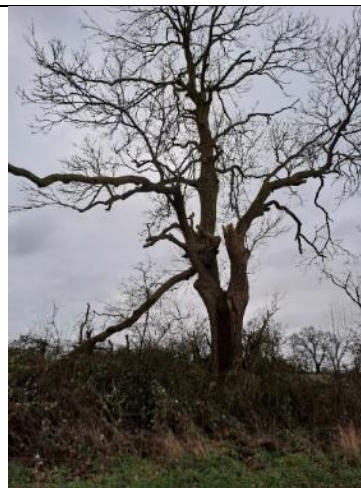
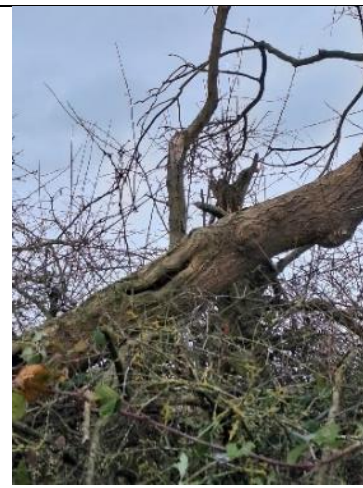
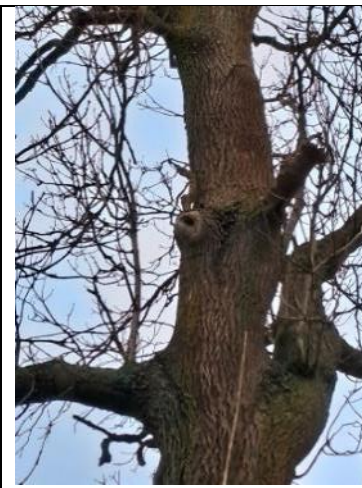
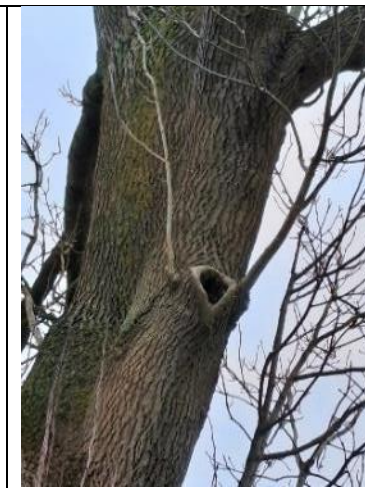
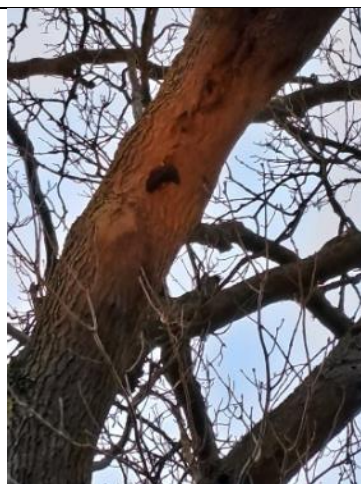
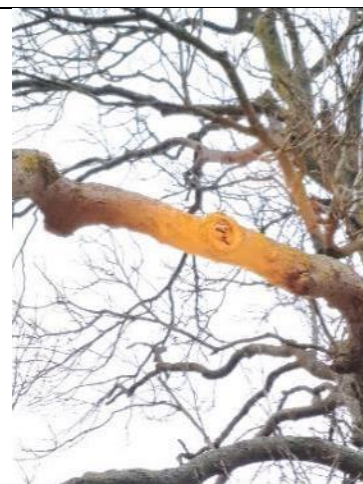
| | <p>PRF 3: Knot-hole located on a major limb oriented west. The hole faced west and was at a height of 4m. There was no evidence of bat use. There was potential for maternity/satellite/night/mating/swarming bat roost use.<br/>Potential Bat Roost Suitability: PRF-M<br/>H&amp;S Considerations: None.<br/>Further Survey Requirements: PRF inspection survey – ropes.</p> <p>PRF 4: Branch cavity located on a major limb oriented north-west. The cavity faced north-west and was at a height of 4m. There was no evidence of bat use. There was potential for maternity/satellite/night/mating/swarming bat roost use.<br/>Potential Bat Roost Suitability: PRF-M<br/>H&amp;S Considerations: None.<br/>Further Survey Requirements: PRF inspection survey – ropes.</p> <p>PRF 5: Knot-hole located on a minor limb oriented north. The hole faced north and was at a height of 3m. There was no evidence of bat use. There was potential for day/night/feeding/transitional occasional bat roost use.<br/>Potential Bat Roost Suitability: PRF-I<br/>H&amp;S Considerations: None.<br/>Further Survey Requirements: PRF inspection survey – ropes.</p> |

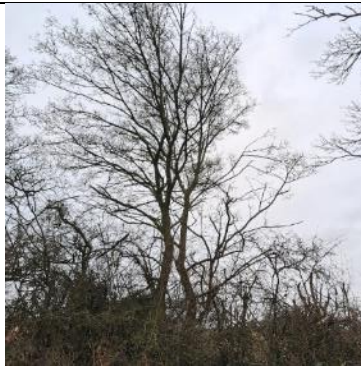
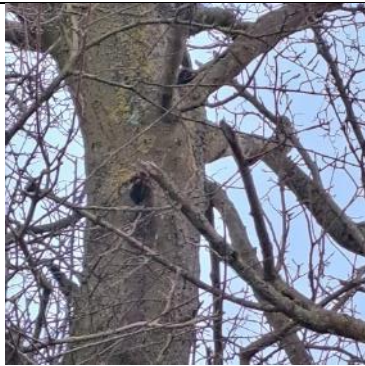
| Arb Reference | | | T140 |
|---|---|---|---|
| BT107 | Tree Description: | Field maple<br><br>PRF 1: Cavity located on the stem oriented north-west. The cavity faced north-west and was at a height of 2m. There was no evidence of bat use. There was potential for maternity/satellite/night/mating/swarming bat roost use.<br>Potential Bat Roost Suitability: PRF-M<br>H&S Considerations: Impenetrable vegetation, overhanging metal/ spiked rails, proximity to water and excessively boggy ground.<br>Further Survey Requirements: Presence/likely absence surveys - dusk emergence. | |

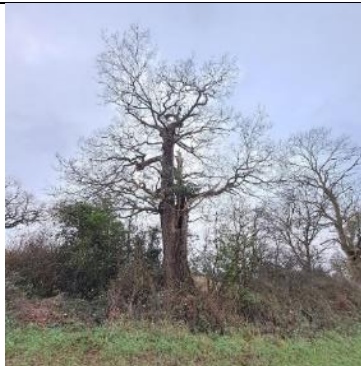
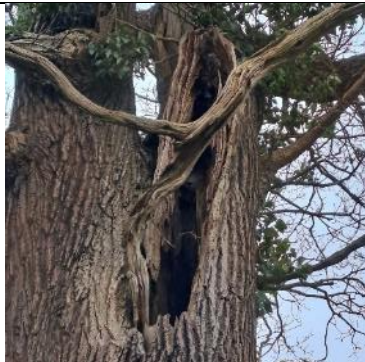
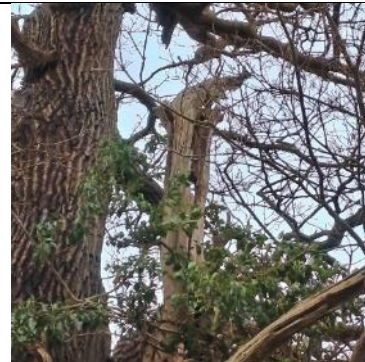
| Arb Reference | | | T140 |
|---|---|---|---|
| BT108 | Tree Description: | Pedunculate oak<br><br>PRF 1: Trunk cavity located on the stem oriented north-east. The cavity faced north-east and was at a height of 3m. There was no evidence of bat use. There was potential for maternity/satellite/night/mating/swarming bat roost use.<br>Potential Bat Roost Suitability: PRF-M<br>H&S Considerations: Proximity to water and excessively boggy ground.<br>Further Survey Requirements: PRF inspection survey – ropes. | |

| | | <p>PRF 2: Trunk cavity located on the stem oriented north-east. The cavity faced north-east and was at a height of 5m. There was no evidence of bat use. There was potential for maternity/satellite/night/mating/swarming bat roost use.</p> <p>Potential Bat Roost Suitability: PRF-M</p> <p>H&amp;S Considerations: Proximity to water, excessively boggy ground, overhanging metal/spiked rails and PRF damage/disturbance likely.</p> <p>Further Survey Requirements: PRF inspection survey – ropes.</p> | | |

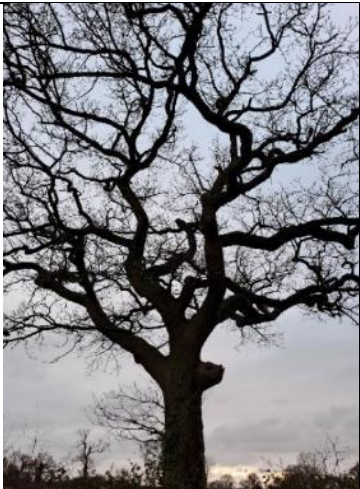
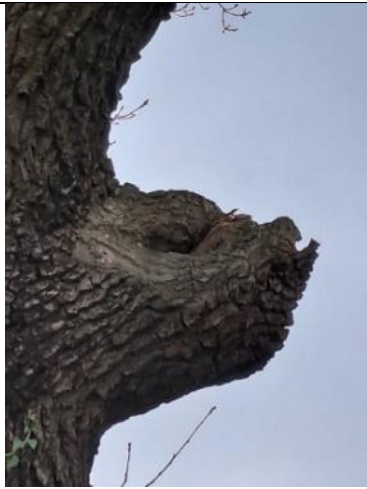
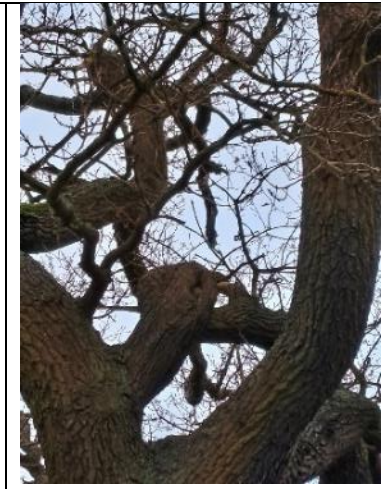
| BT109 | Tree Description: | <p>Pedunculate oak</p> <p>PRF 1: Knot-hole located on the stem oriented north. The cavity faced north and was at a height of 2.5m. There was no evidence of bat use. There was potential for maternity/satellite/night/mating/swarming bat roost use.</p> <p>Potential Bat Roost Suitability: PRF-M</p> <p>H&amp;S Considerations: Barbed wire.</p> <p>Further Survey Requirements: PRF inspection survey – ropes.</p> | | |

| | | <p>PRF 2: Knot-hole located on a minor limb oriented south-west. The hole faced south-west and was at a height of 4m. There was no evidence of bat use. There was potential for maternity/satellite/night/mating/swarming bat roost use.</p> <p>Potential Bat Roost Suitability: PRF-M</p> <p>H&amp;S Considerations: Barbed wire.</p> <p>Further Survey Requirements: PRF inspection survey – ropes.</p> | | |

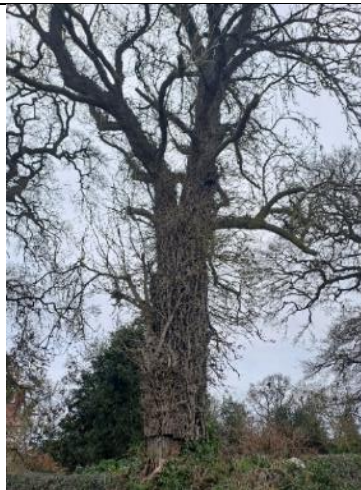
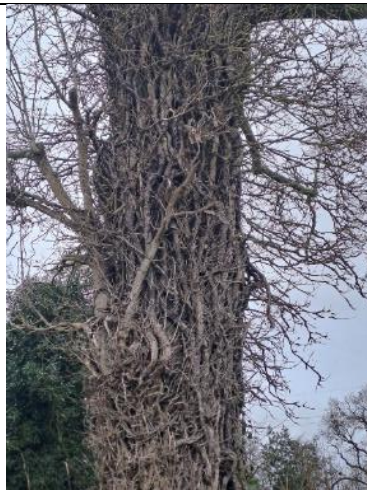
| BT110 | Tree Description: | <p>Ash</p> <p>PRF 1: Ivy cover mature (&gt;50mm diameter, lattice forming) located on the stem oriented all aspects. The ivy creates a PRF. The ivy faced all directions and was at a height of 1-6m. There was no evidence of bat use. There was potential for day/night/feeding/transitional occasional bat roost use.</p> <p>H&amp;S Considerations: None.</p> | | |

| | | Further Survey Requirements: Soft fell under supervision. | | | |

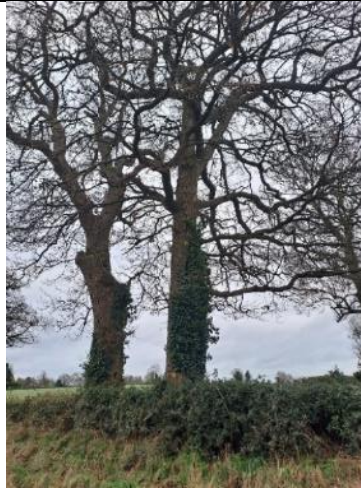
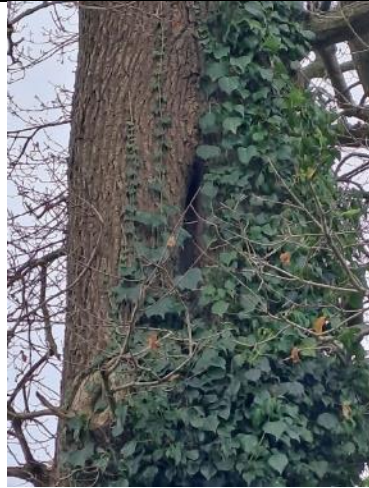
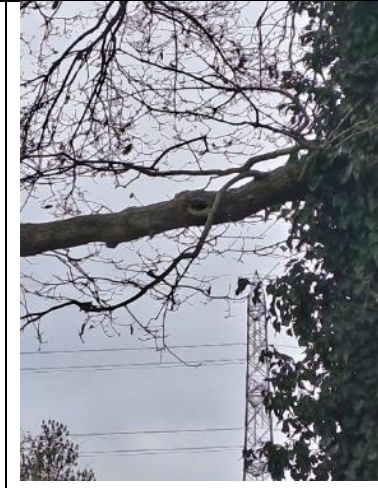
| BT111 | Tree Description: | <p>Pedunculate oak</p> <p>PRF 1: Knot-hole located on the stem oriented north-west. The hole faced north-west and was at a height of 3m. There was no evidence of bat use. There was potential for maternity/satellite/night/mating/swarming bat roost use.</p> <p>H&amp;S Considerations: Proximity to road and water.</p> <p>Further Survey Requirements: Presence/likely absence surveys - dusk emergence</p> | | | |

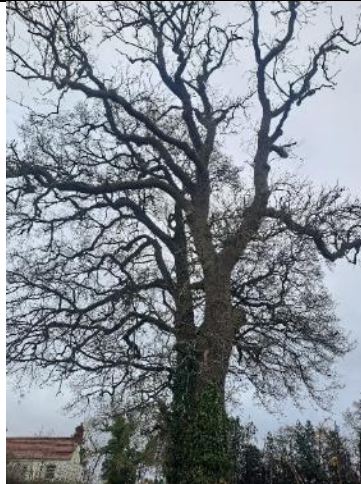
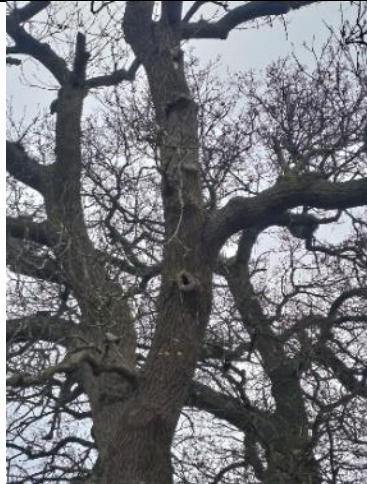
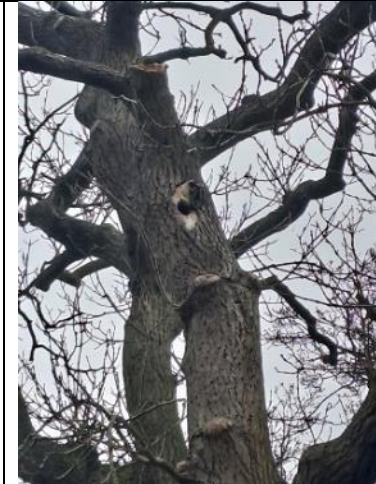
| | BT112 | Tree Description: | <p>Pedunculate oak</p> <p>PRF 1: Knot-hole located on the stem oriented north. The hole faced north-east and was at a height of 6m. There was no evidence of bat use. There was potential for maternity/satellite/night/mating/swarming bat roost use.<br/>Potential Bat Roost Suitability: PRF-M<br/>H&amp;S Considerations: Proximity to road.<br/>Further Survey Requirements: Presence/likely absence surveys - dusk emergence</p> <p>PRF 2: Woodpecker-hole located on the stem oriented north. The hole faced north and was at a height of 8m. There was no evidence of bat use. There was potential for maternity/satellite/night/mating/swarming bat roost use.<br/>Potential Bat Roost Suitability: PRF-M<br/>H&amp;S Considerations: Proximity to road.<br/>Further Survey Requirements: PRF inspection survey – ropes.</p> | | |

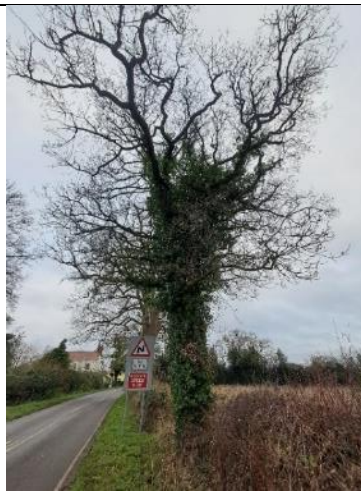
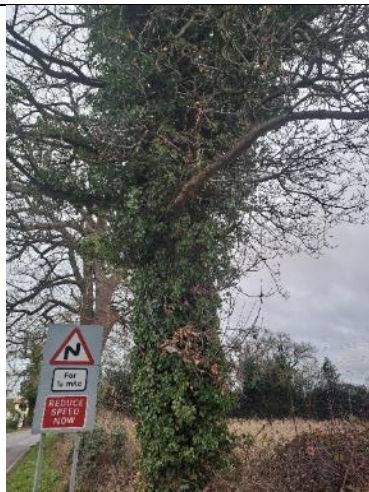
| BT113 | Tree Description: | <p>Pedunculate oak</p> <p>PRF 1: Ivy cover mature (&gt;50mm diameter, lattice forming) located on the stem oriented all aspects. The ivy creates a PRF. The ivy faced all directions and was at a height of 0-8m. There was no evidence of bat use. There was potential for day/night/feeding/transitional occasional bat roost use.</p> <p>H&amp;S Considerations: Proximity to road.</p> <p>Further Survey Requirements: Soft fell under bat-licenced supervision</p> | | | |

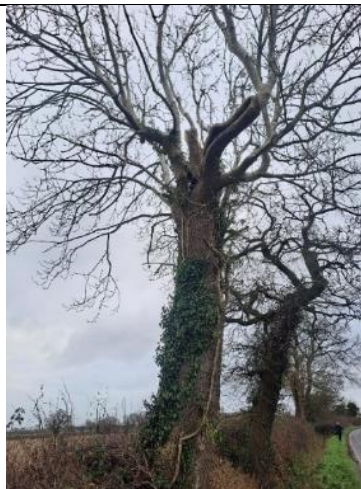
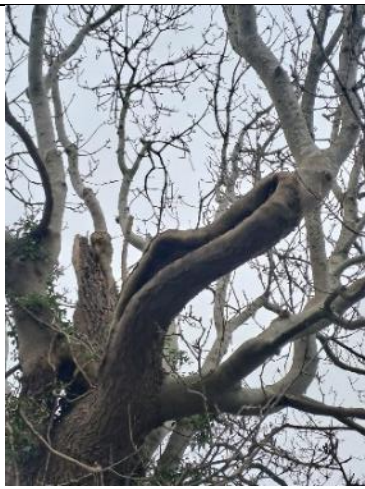
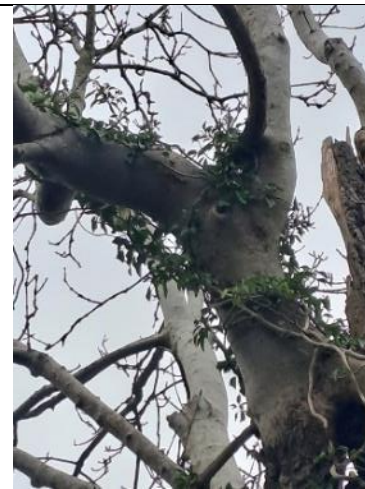
| BT114 | Tree Description: | <p>Ash</p> <p>PRF 1: Branch cavity located on a major limb oriented south. The cavity faced north-west and was at a height of 6m. There was no evidence of bat use. There was potential for maternity/satellite/night/mating/swarming bat roost use.<br/>Potential Bat Roost Suitability: PRF-M<br/>H&amp;S Considerations: Proximity to road and ditch.<br/>Further Survey Requirements: Presence/likely absence surveys - dusk emergence.</p> <p>PRF 2: Knot-hole located on a major limb oriented north-west. The hole faced west and was at a height of 6m. There was no evidence of bat use. There was potential for day/night/feeding/transitional occasional bat roost use.<br/>Potential Bat Roost Suitability: PRF-I<br/>H&amp;S Considerations: Proximity to road and ditch.<br/>Further Survey Requirements: Presence/likely absence surveys - dusk emergence.</p> | | | |

| | | <p>PRF 3: Trunk cavity located on the stem oriented all aspects. The cavity faced all aspects and was at a height of 5m. There was no evidence of bat use. There was potential for maternity/satellite/night/mating/swarming bat roost use.</p> <p>Potential Bat Roost Suitability: PRF-M</p> <p>H&amp;S Considerations: Proximity to road and ditch.</p> <p>Further Survey Requirements: Presence/likely absence surveys - dusk emergence.</p> | | |

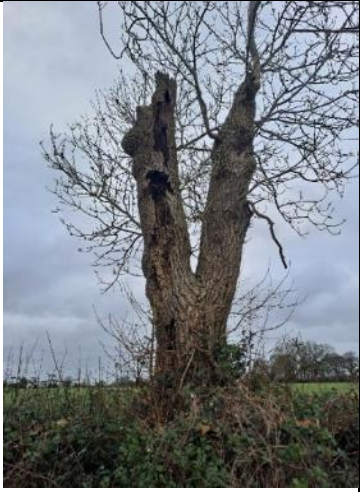
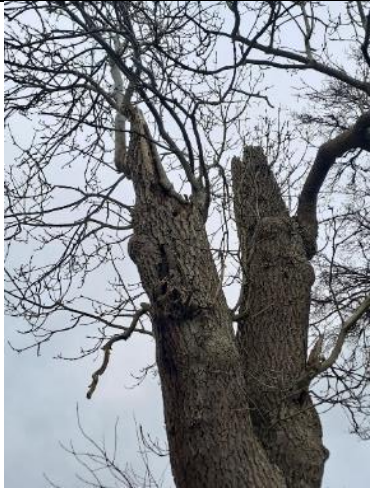
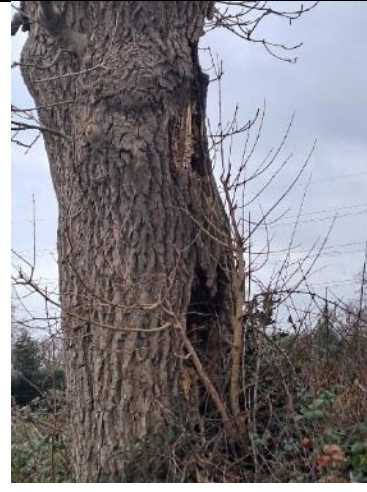
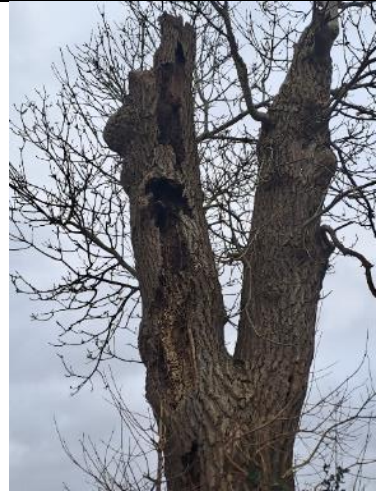
| BT116 | Tree Description: | <p>Pedunculate oak</p> <p>PRF 1: Trunk cavity on the stem oriented all aspects. The cavity faced north-west and was at a height of 3-4m. There was no evidence of bat use. There was potential for maternity/satellite/night/mating/swarming bat roost use.</p> <p>H&amp;S Considerations: Proximity to road and water.</p> <p>Further Survey Requirements: Presence/likely absence surveys - dusk emergence.</p> | | |

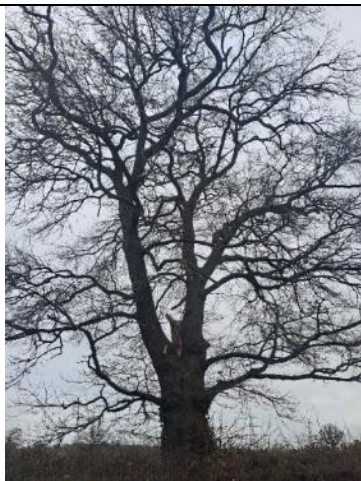
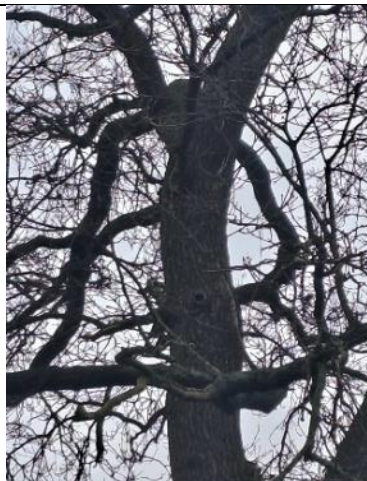
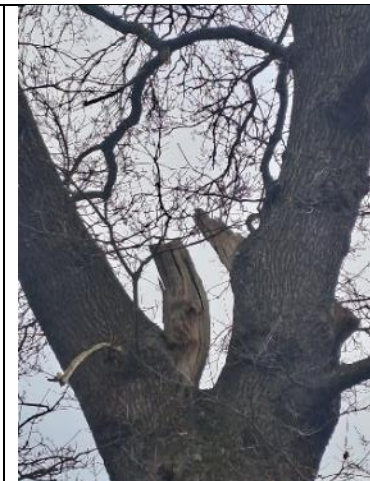
| BT117 | Tree Description: | <p>Pedunculate oak</p> <p>PRF 1: Knot-hole on the stem oriented south. The hole faced south and was at a height of 7m. There was no evidence of bat use. There was potential for day/night/feeding/transitional occasional bat roost use.<br/>Potential Bat Roost Suitability: PRF-I<br/>H&amp;S Considerations: Proximity to road.<br/>Further Survey Requirements: PRF inspection survey – ropes.</p> <p>PRF 2: Split on a minor limb oriented south. The limb faced south and was at a height of 4m. There was no evidence of bat use. There was potential for day/night/feeding/transitional occasional bat roost use.<br/>Potential Bat Roost Suitability: PRF-I<br/>H&amp;S Considerations: Proximity to road.<br/>Further Survey Requirements: PRF inspection survey – ladders.</p> | | | |

| | | <p>PRF 3: Knot-hole on the stem oriented west. The hole faced west and was at a height of 6m. There was no evidence of bat use. There was potential for day/night/feeding/transitional occasional bat roost use.</p> <p>Potential Bat Roost Suitability: PRF-I</p> <p>H&amp;S Considerations: Proximity to road.</p> <p>Further Survey Requirements: PRF inspection survey – ropes.</p> | | |

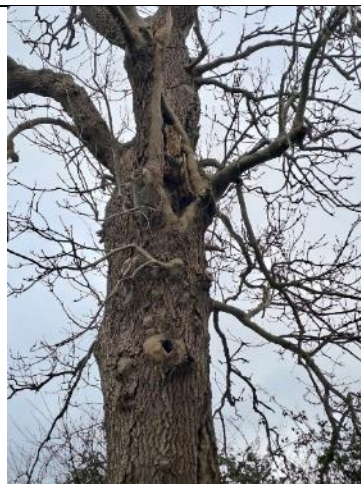
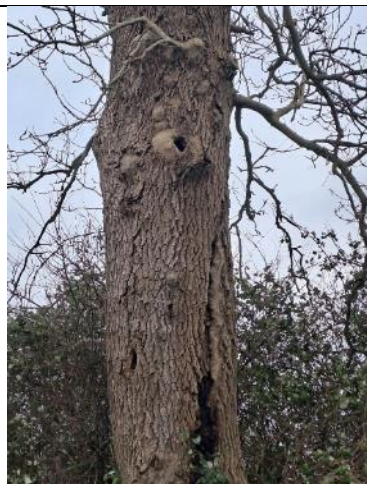
| BT118 | Tree Description: | <p>Ash</p> <p>PRF 1: Wound on the stem oriented south. The wound faced south and was at a height of 3-4m. There was no evidence of bat use. There was potential for maternity/satellite/night/mating/swarming bat roost use.</p> <p>Potential Bat Roost Suitability: PRF-M</p> <p>H&amp;S Considerations: Proximity to road and PRF damage/disturbance likely.</p> | | |

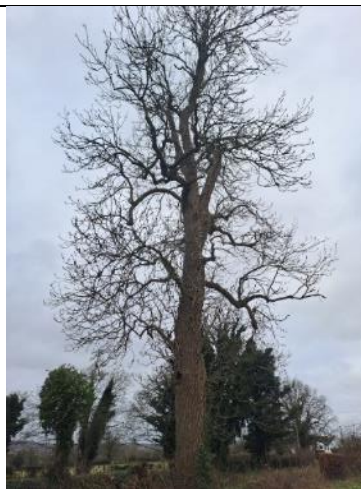
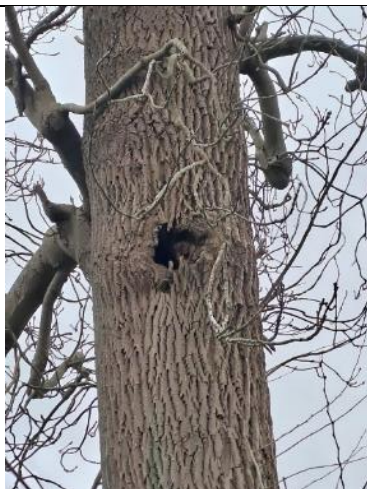
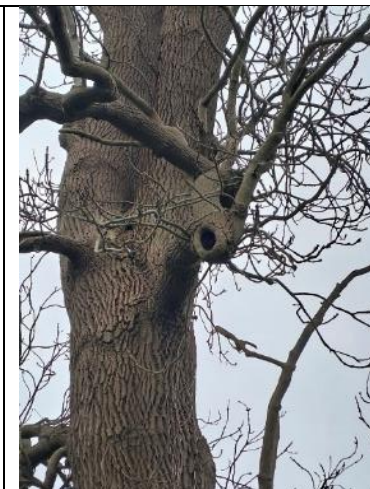
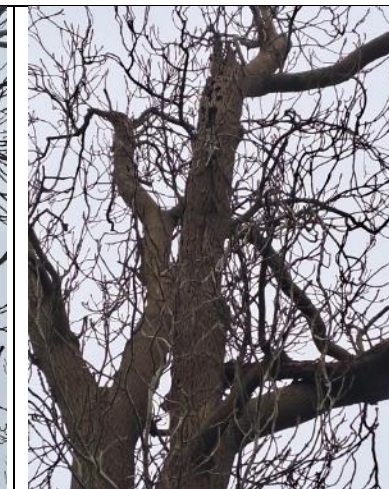
| Arb Reference | | N/A |
|---|---|---|
| BT119 | <p>Tree Description:</p> <p>Ash</p> <p>PRF 1: Wound on the stem oriented south-east. The wound faced south-east and was at a height of 3m. There was no evidence of bat use. There was potential for maternity/satellite/night/mating/swarming bat roost use.<br/>Potential Bat Roost Suitability: PRF-M<br/>H&amp;S Considerations: Proximity to road.<br/>Further Survey Requirements: PRF inspection survey – ropes.</p> <p>PRF 2: Knot-hole on a minor limb oriented north-west. The hole faced north-west and was at a height of 3m. There was no evidence of bat use. There was potential for maternity/satellite/night/mating/swarming bat roost use.<br/>Potential Bat Roost Suitability: PRF-M<br/>H&amp;S Considerations: Proximity to road.<br/>Further Survey Requirements: PRF inspection survey – ropes.</p> <p>PRF 3: Woodpecker-holes on the stem oriented north. The holes faced north-west and were at a height of 7-8m. There was no evidence of bat use. There was potential for maternity/satellite/night/mating/swarming bat roost use.<br/>Potential Bat Roost Suitability: PRF-M<br/>H&amp;S Considerations: Proximity to road.<br/>Further Survey Requirements: PRF inspection survey – ropes.</p> <p>Note: Other features may be present on the tree but due to high numbers, not all were recorded.</p> | |

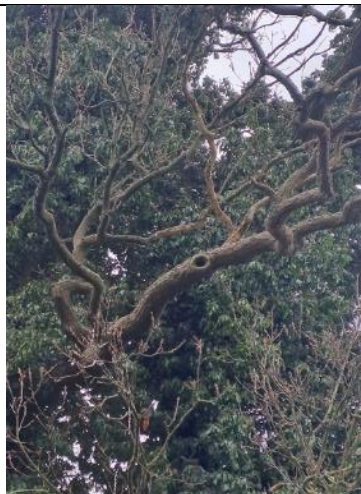
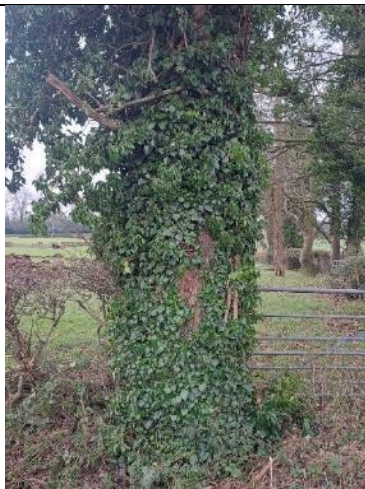
| | H&S Considerations: Proximity to road and uneven ground surrounding.<br>Further Survey Requirements: Presence/likely absence surveys - dusk emergence. | | | |

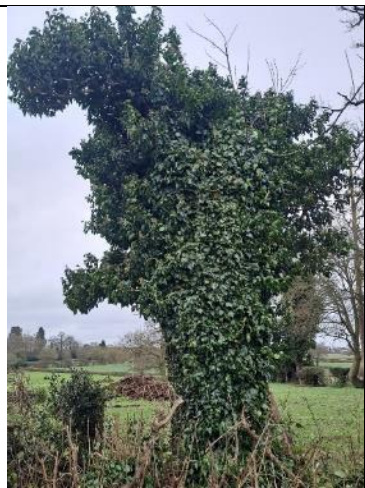
| BT121 | Tree Description: | <p>Sycamore</p> <p>PRF 1: Ivy cover (no PRF but may obscure other features) on the stem oriented all aspects. The ivy faced all aspects and was at a height of 0-4m. There was no evidence of bat use. There was potential for day/night/feeding/transitional occasional bat roost use.</p> <p>H&amp;S Considerations: Proximity to road, uneven ground surrounding and barbed wire.</p> <p>Further Survey Requirements: Soft fell under bat-licenced supervision</p> | | |
