## Oldbury to Meriden, Warwickshire

# Ground Level Tree Assessment Report

**Prepared For: Severn Trent Water**

Document Reference: 10408.04.001

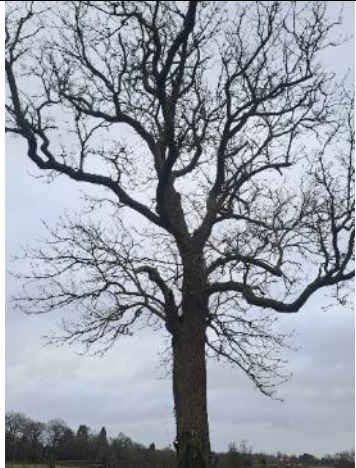
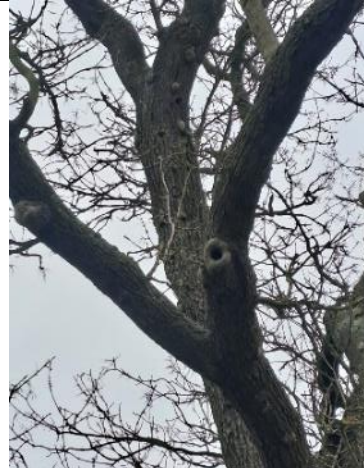
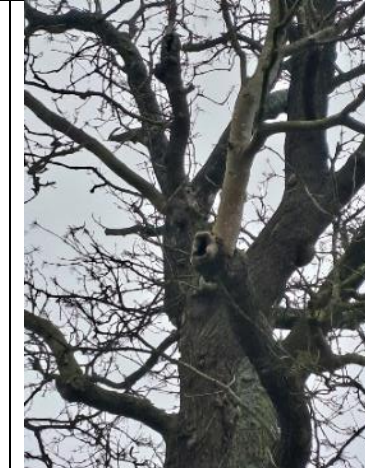
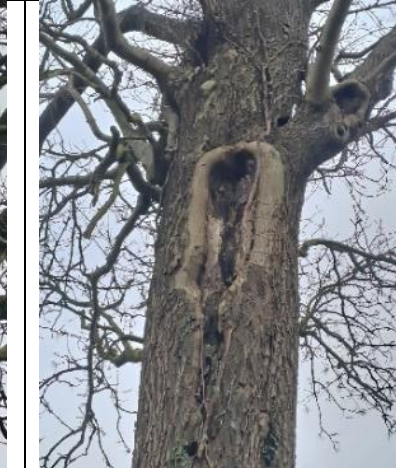
| BT122 | Tree<br>Description: | <p>Ash</p> <p>PRF 1: Branch cavity on a major limb oriented north-east. The cavity faced east and was at a height of 4m. There was no evidence of bat use. There was potential for maternity/satellite/night/mating/swarming bat roost use.<br/>Potential Bat Roost Suitability: PRF-M<br/>H&amp;S Considerations: Proximity to road.<br/>Further Survey Requirements: PRF inspection survey – ropes.</p> <p>PRF 2: Knot-hole located on a major limb oriented north-east. The hole faced north-west and was at a height of 5m. There was no evidence of bat use. There was potential for day/night/feeding/transitional occasional bat roost use.<br/>Potential Bat Roost Suitability: PRF-I<br/>H&amp;S Considerations: Proximity to road.<br/>Further Survey Requirements: PRF inspection survey – ropes.</p> | | | |

| | | <p>PRF 3: Knot-hole on a minor limb oriented south-west. The hole faced south-west and was at a height of 5m. There was no evidence of bat use. There was potential for day/night/feeding/transitional occasional bat roost use.<br/>Potential Bat Roost Suitability: PRF-I<br/>H&amp;S Considerations: Proximity to road.<br/>Further Survey Requirements: PRF inspection survey – ropes.</p> <p>PRF 4: Tear-out located on the stem oriented south-east. The tear-out faced south-east and was at a height of 3m. There was no evidence of bat use. There was potential for day/night/feeding/transitional occasional bat roost use.<br/>Potential Bat Roost Suitability: PRF-M<br/>H&amp;S Considerations: Proximity to road.<br/>Further Survey Requirements: PRF inspection survey – ropes.</p> <p>Note: Due to the proximity of the road, ropes may not be possible. If not, presence/likely absence surveys - dusk emergence.</p> |

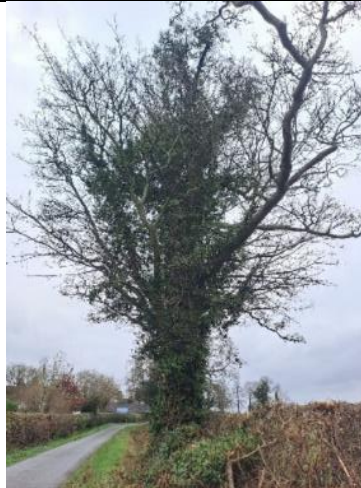
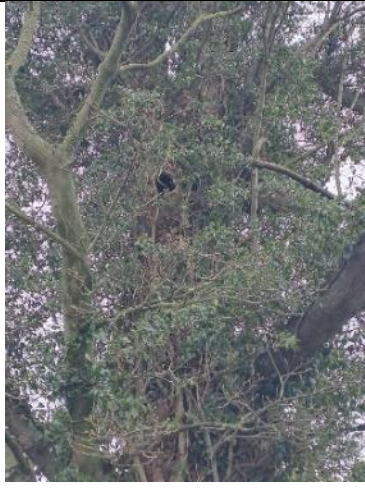
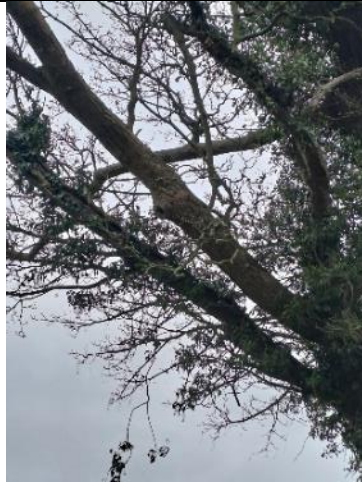
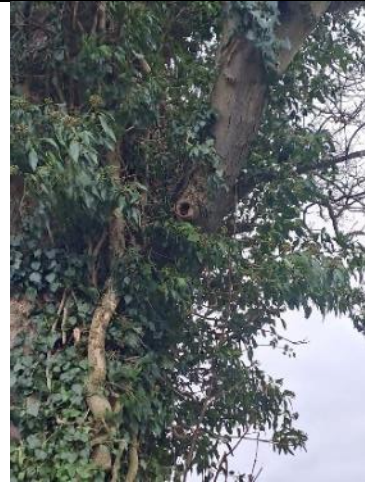
| BT123 | Tree<br>Description: | <p>Sycamore</p> <p>PRF 1: Knot-hole on a minor limb oriented west. The hole faced west and was at a height of 4m. There was no evidence of bat use. There was potential for maternity/satellite/night/mating/swarming bat roost use.<br/>Potential Bat Roost Suitability: PRF-M<br/>H&amp;S Considerations: Proximity to road and livestock risk.<br/>Further Survey Requirements: PRF inspection survey – ropes.</p> <p>PRF 2: Various PRFs assessed as one including knot-holes and split branches located on a minor limb oriented all aspects. The PRFs faced all aspects and were at a height of 2-5m. There was no evidence of bat use. There was potential for maternity/satellite/night/mating/swarming bat roost use.<br/>Potential Bat Roost Suitability: PRF-I<br/>H&amp;S Considerations: Livestock risk.<br/>Further Survey Requirements: PRF inspection survey – ropes.</p> | | |

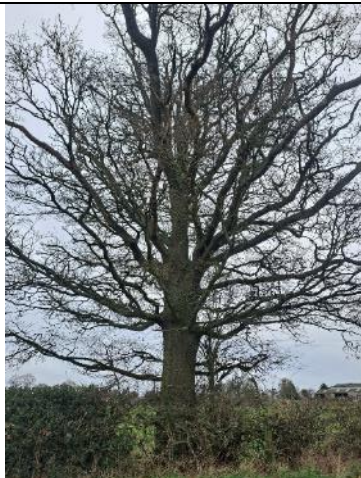
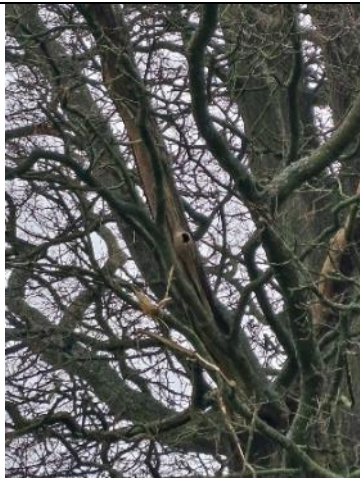
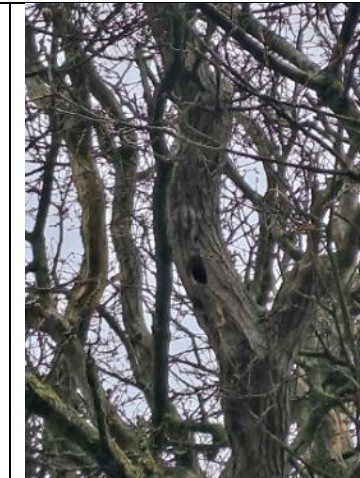
| | BT125 | Tree Description: | <p>Pedunculate oak</p> <p>PRF 1: Knot-hole on a minor limb oriented south-west. The hole faced south and was at a height of 5m. There was no evidence of bat use. There was potential for day/night/feeding/transitional occasional bat roost use.<br/>Potential Bat Roost Suitability: PRF-I<br/>H&amp;S Considerations: Barbed wire fence.<br/>Further Survey Requirements: PRF inspection survey – ropes.</p> <p>PRF 2: Wound on a minor limb oriented east. The wound faced south-east and was at a height of 8m. There was no evidence of bat use. There was potential for maternity/satellite/night/mating/swarming bat roost use.<br/>Potential Bat Roost Suitability: PRF-M<br/>H&amp;S Considerations: Barbed wire fence.<br/>Further Survey Requirements: PRF inspection survey – ropes.</p> | | |

| | | <p>PRF 3: Lifting-bark on a minor limb oriented south. The bark faced west and was at a height of 5m. There was no evidence of bat use. There was potential for day/night/feeding/transitional occasional bat roost use.</p> <p>Potential Bat Roost Suitability: PRF-I</p> <p>H&amp;S Considerations: Barbed wire fence.</p> <p>Further Survey Requirements: PRF inspection survey – ropes.</p> | | |

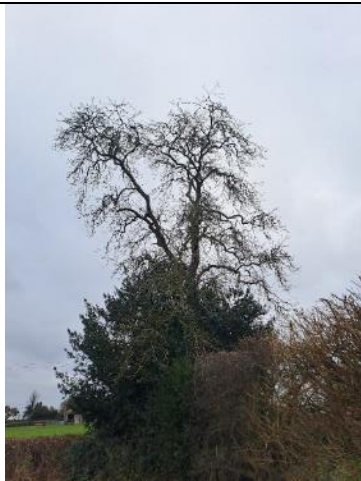
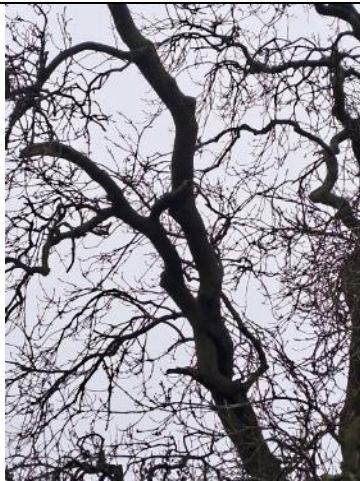
| | | Further Survey Requirements: PRF inspection survey – ropes. | | | |
| | | Note: The tree was on the outside/on the edge of working area so unlikely to be impacted. It was only surveyed from south-western side due to time constraints and the presence of cows on other side of tree. Numerous knot-holes were recorded, all appearing to be small and so were not assessed individually. The tree was assessed as PRF-M on a precautionary basis. | | | |

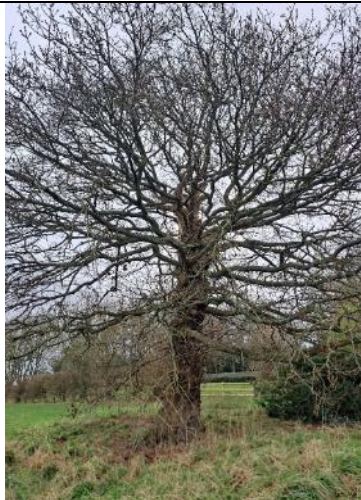
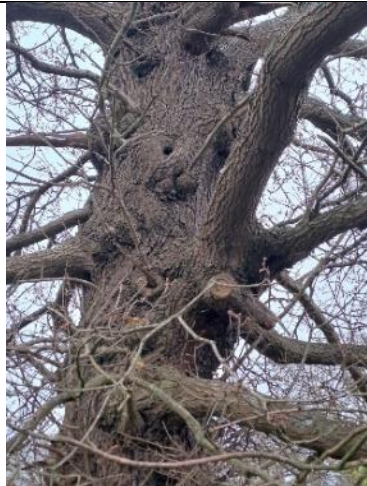
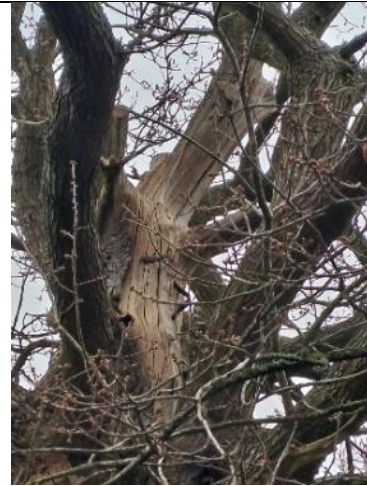
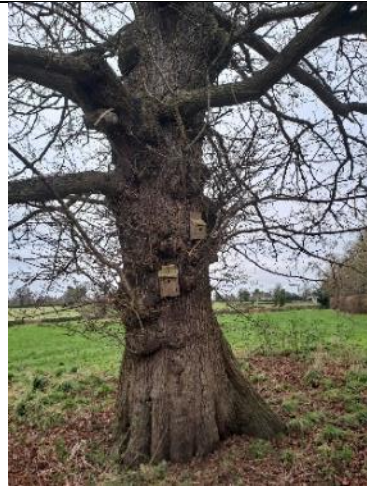
| BT127 | Tree Description: | <p>Pedunculate oak</p> <p>PRF 1: Knot-hole on the stem oriented north-west. The hole faced north-west and was at a height of 4m. There was no evidence of bat use. There was potential for maternity/satellite/night/mating/swarming bat roost use.</p> <p>Potential Bat Roost Suitability: PRF-M</p> <p>H&amp;S Considerations: None.</p> <p>Further Survey Requirements: PRF inspection survey – ropes.</p> | | | |

| | | <p>PRF 2: Dead top of stem making a possible trunk cavity on the stem oriented all aspects. The cavity faced all aspects and was at a height of 6-7m. There was no evidence of bat use. There was potential for maternity/satellite/night/mating/swarming bat roost use.</p> <p>Potential Bat Roost Suitability: PRF-M</p> <p>H&amp;S Considerations: none.</p> <p>Further Survey Requirements: PRF inspection survey – ropes.</p> <p>Note: PRF-I features also recorded, including bird boxes, but not assessed separately.</p> | | |

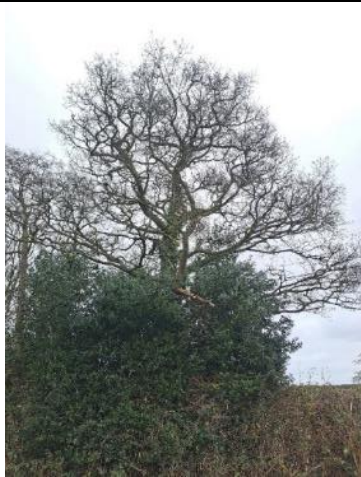
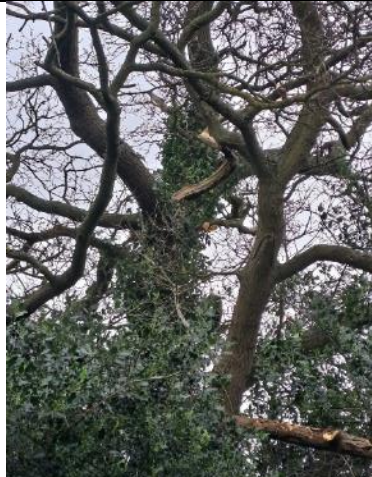
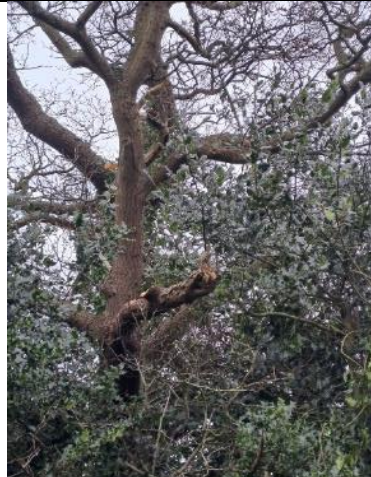
| | <p>PRF 1: Ivy cover (no PRF but may obscure other features) on the stem oriented all aspects. The ivy faced all aspects and was at a height of 0-8m. There was no evidence of bat use. There was potential for day/night/feeding/transitional occasional bat roost use.<br/>Potential Bat Roost Suitability: PRF-I<br/>H&amp;S Considerations: Impenetrable vegetation and proximity to road and water.<br/>Further Survey Requirements: Soft fell under bat-licensed supervision</p> <p>PRF 2: Branch cavity on a minor limb oriented south. The cavity faced south-west and was at a height of 3m. There was no evidence of bat use. There was potential for day/night/feeding/transitional occasional bat roost use.<br/>Potential Bat Roost Suitability: PRF-I<br/>H&amp;S Considerations: Impenetrable vegetation and proximity to road and water.<br/>Further Survey Requirements: Soft fell under bat-licensed supervision</p> | | | |

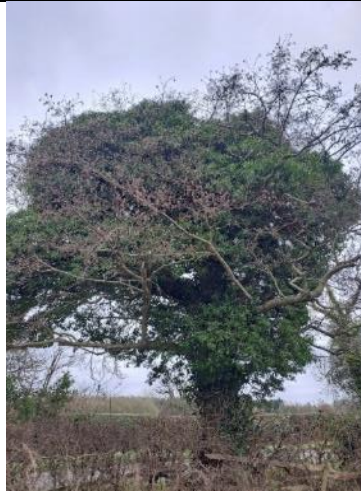
| BT129 | Tree<br>Description: | <p>Alder species</p> <p>PRF 1: Ivy cover (no PRF but may obscure other features) on the stem oriented all aspects. The ivy faced all aspects and was at a height of 0-8m. There was no evidence of bat use. There was potential for day/night/feeding/transitional occasional bat roost use.</p> <p>H&amp;S Considerations: Proximity to road and barbed wire fence.</p> <p>Further Survey Requirements: Soft fell under bat-licensed supervision</p> | | | |

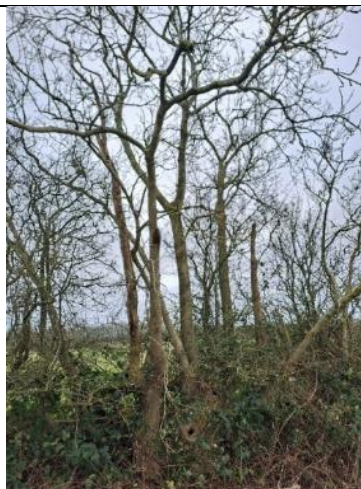
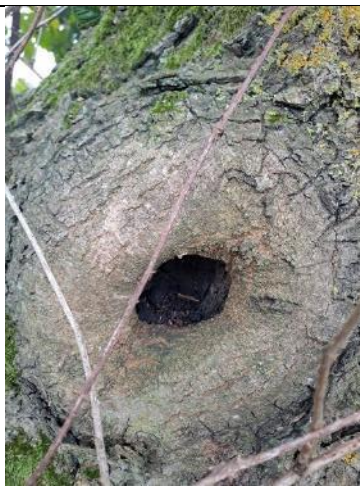
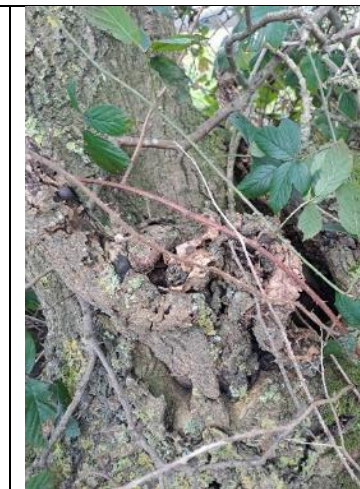
| BT130 | Tree<br>Description: | <p>Ash</p> <p>PRF 1: Knot-hole on the stem oriented north-west. The hole faced north-west and was at a height of 0.5m. There was no evidence of bat use. There was potential for maternity/satellite/night/mating/swarming bat roost use.</p> <p>Potential Bat Roost Suitability: PRF-M</p> <p>H&amp;S Considerations: None.</p> | | | |

| | | <p>Further Survey Requirements: Endoscope from ground level.</p> <p>PRF 2: Trunk cavity on the stem oriented north-west. The cavity faced north-west and was at a height of 1m. There was no evidence of bat use. There was potential for maternity/satellite/night/mating/swarming bat roost use.</p> <p>Potential Bat Roost Suitability: PRF-M</p> <p>H&amp;S Considerations: None.</p> <p>Further Survey Requirements: Endoscope from ground level.</p> | | | |

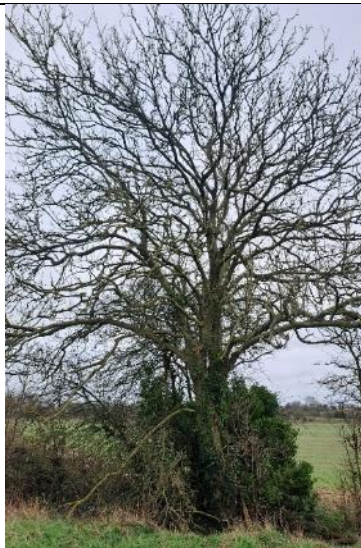
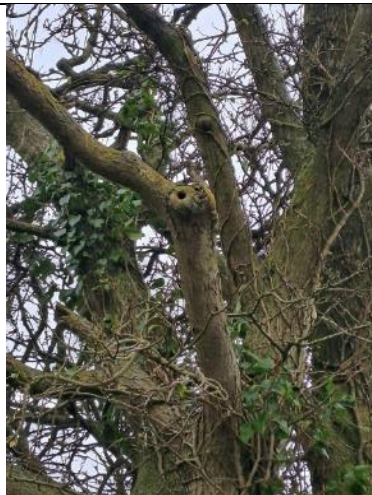
| BT131 | Tree Description: | <p>Pedunculate oak</p> <p>PRF 1: Knot-hole on the stem oriented north. The hole faced north-west and was at a height of 4m. There was no evidence of bat use. There was potential for day/night/feeding/transitional occasional bat roost use.</p> <p>H&amp;S Considerations: Uneven ground surrounding.</p> | | | |

| | Further Survey Requirements: PRF inspection survey – ropes. | | | |

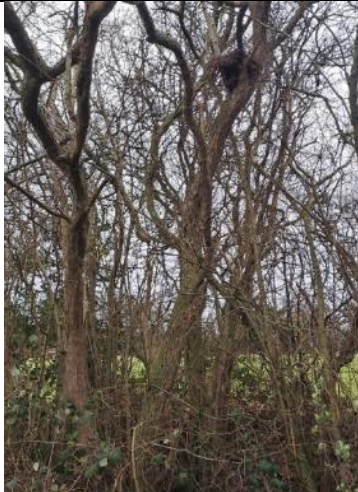
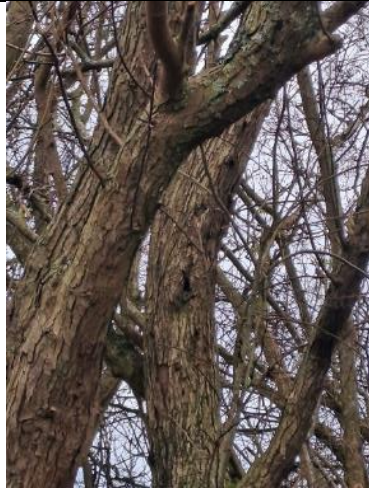
| BT132 | Tree Description: | <p>Unknown tree species.</p> <p>PRF 1: Knot-hole on the stem oriented east. The hole faced east and was at a height of 3m. There was no evidence of bat use. There was potential for day/night/feeding/transitional occasional bat roost use.</p> <p>H&amp;S Considerations: Uneven ground surrounding, proximity to water and barbed wire.</p> <p>Further Survey Requirements: PRF inspection survey – ropes.</p> | | |

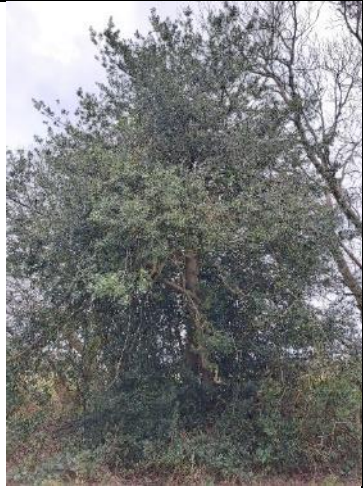
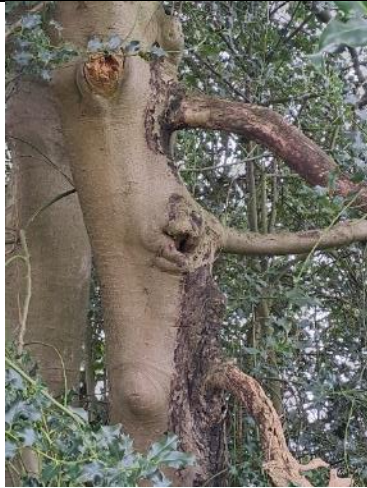
| | BT133 | Tree Description: | <p>Holly</p> <p>PRF 1: Knot-hole on the stem oriented west. The hole faced west and was at a height of 3m. There was no evidence of bat use. There was potential for day/night/feeding/transitional occasional bat roost use.</p> <p>H&amp;S Considerations: Barbed wire.</p> <p>Further Survey Requirements: PRF inspection survey – ladders.</p> | | |

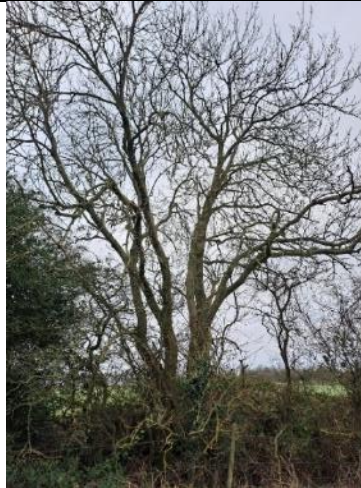
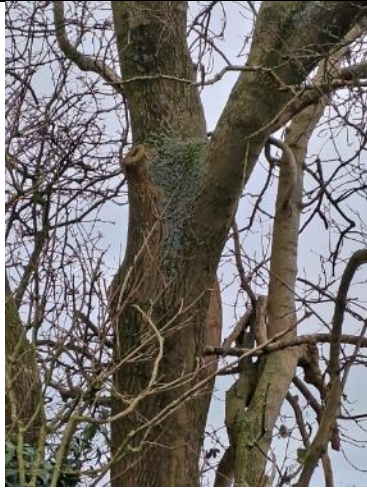
| BT134 | Tree Description: | <p>Ash</p> <p>PRF 1: Several small knot-holes on the stem oriented all aspects. The holes faced all aspects and were at a height of 3-6m. There was no evidence of bat use. There was potential for day/night/feeding/transitional occasional bat roost use.</p> <p>H&amp;S Considerations: Barbed wire.</p> <p>Further Survey Requirements: Soft fell under bat-licenced supervision.</p> | | | |

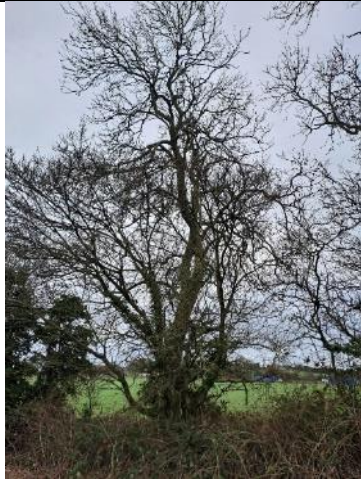
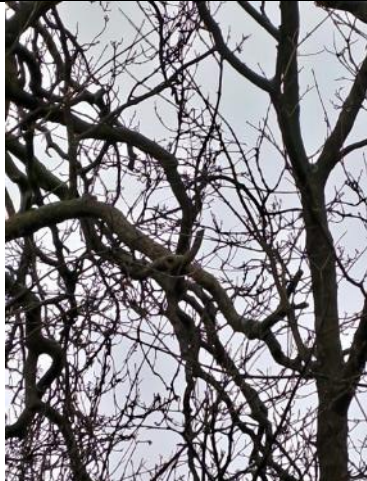
| BT135 | Tree Description: | <p>Ash</p> <p>PRF 1: Knot-hole on a minor limb oriented north. The hole faced north and was at a height of 4m. There was no evidence of bat use. There was potential for day/night/feeding/transitional occasional bat roost use.</p> <p>H&amp;S Considerations: Barbed wire.</p> <p>Further Survey Requirements: May be possible to climb with ropes. Suggested soft fell under supervision.</p> | | | |

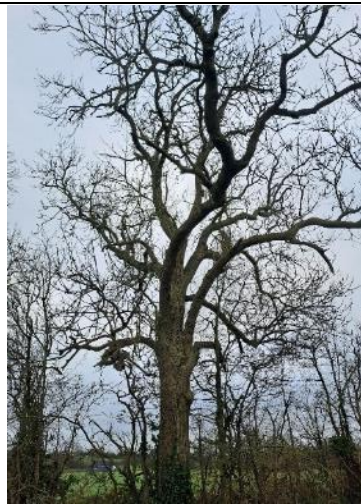
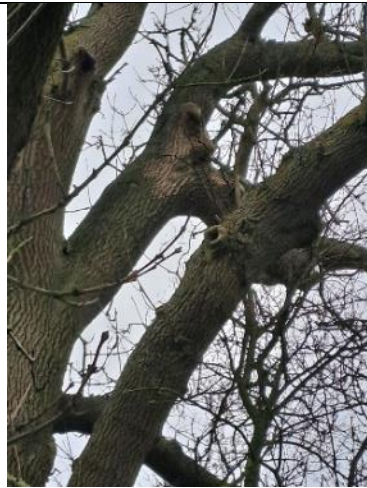
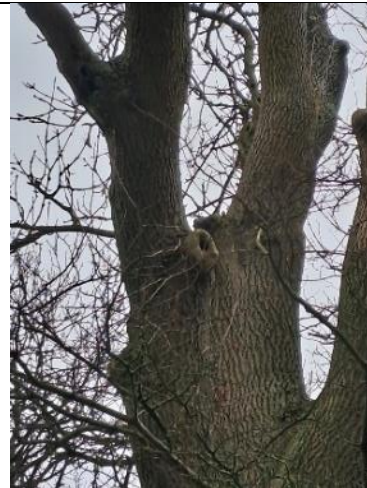
| | BT136 | Tree Description: | <p>Ash</p> <p>PRF 1: Knot-hole on a major limb oriented south-west. The hole faced north-west and was at a height of 6m. There was no evidence of bat use. There was potential for day/night/feeding/transitional occasional bat roost use.<br/>Potential Bat Roost Suitability: PRF-I<br/>H&amp;S Considerations: Uneven ground surrounding.<br/>Further Survey Requirements: PRF inspection survey – ropes.</p> <p>PRF 2: Knot-hole on a major limb oriented south-west. The hole faced south and was at a height of 6m. There was no evidence of bat use. There was potential for day/night/feeding/transitional occasional bat roost use.<br/>Potential Bat Roost Suitability: PRF-I<br/>H&amp;S Considerations: Uneven ground surrounding.<br/>Further Survey Requirements: PRF inspection survey – ropes.</p> | | |

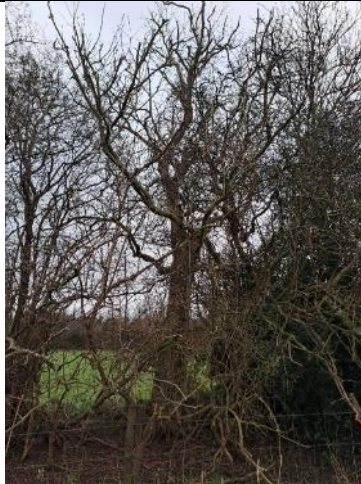
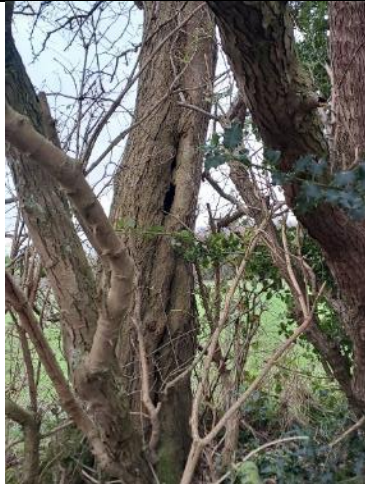
| BT137 | Tree Description: | <p>Ash</p> <p>PRF 1: Several knot-holes on the stem oriented all aspects. The holes faced all aspects and were at a height of 1.5-6m. There was no evidence of bat use. There was potential for maternity/satellite/night/mating/swarming bat roost use.</p> <p>H&amp;S Considerations: Barbed wire fence.</p> <p>Further Survey Requirements: PRF inspection survey – ropes.</p> | | | |

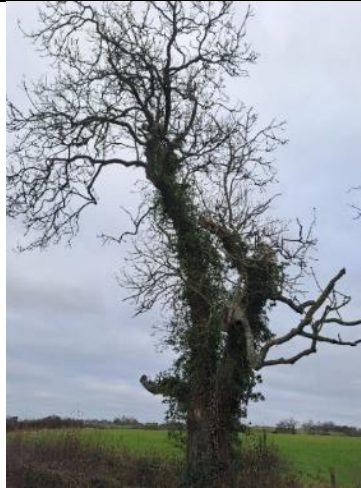
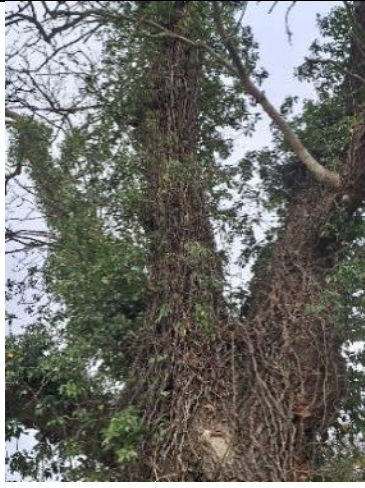
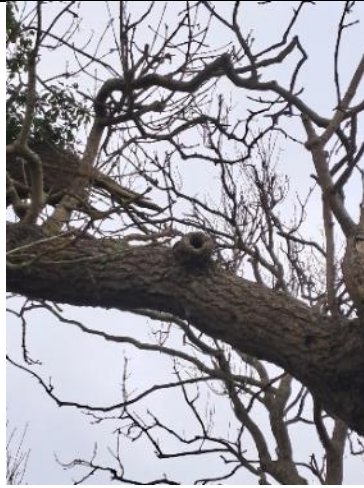
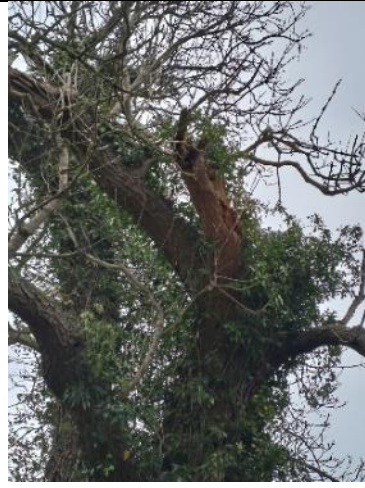
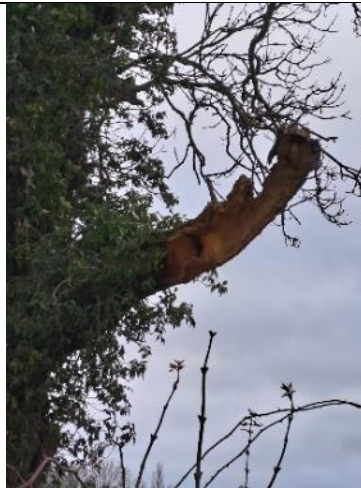
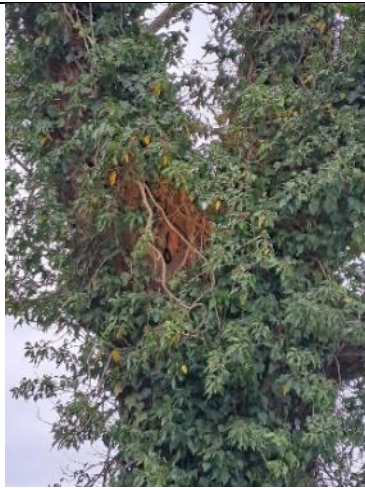
| BT139 | Tree Description: | <p>Ash</p> <p>PRF 1: Ivy cover (no PRF but may obscure other features) on the stem oriented all aspects. The ivy faced all aspects and was at a height of 0-9m. There was no evidence of bat use. There was potential for day/night/feeding/transitional occasional bat roost use.</p> <p>Potential Bat Roost Suitability: PRF-I</p> <p>H&amp;S Considerations: Proximity to water and uneven ground.</p> <p>Further Survey Requirements: PRF inspection survey – ropes.</p> <p>PRF 2: Knot-hole on a major limb oriented north-west. The hole faced north-west and was at a height of 3m. There was no evidence of bat use. There was potential for day/night/feeding/transitional occasional bat roost use.</p> | | | |

| | <p>Potential Bat Roost Suitability: PRF-I<br/>H&amp;S Considerations: Proximity to water and uneven ground.<br/>Further Survey Requirements: PRF inspection survey – ropes.</p> <p>PRF 3: Trunk cavity on the stem oriented west. The cavity faced south and was at a height of 5m. There was no evidence of bat use. There was potential for maternity/satellite/night/mating/swarming bat roost use.<br/>Potential Bat Roost Suitability: PRF-M<br/>H&amp;S Considerations: Proximity to water and uneven ground.<br/>Further Survey Requirements: PRF inspection survey – ropes.</p> <p>PRF 4: Trunk cavity on a major limb oriented north-east. The cavity faced north-east and was at a height of 3m. There was no evidence of bat use. There was potential for maternity/satellite/night/mating/swarming bat roost use.<br/>Potential Bat Roost Suitability: PRF-M<br/>H&amp;S Considerations: Proximity to water and uneven ground surrounding.<br/>Further Survey Requirements: PRF inspection survey – ropes.</p> <p>PRF 5: Knot-hole on the stem oriented east. The hole faced east and was at a height of 3m. There was no evidence of bat use. There was potential for maternity/satellite/night/mating/swarming bat roost use.<br/>Potential Bat Roost Suitability: PRF-M<br/>H&amp;S Considerations: Proximity to water and uneven ground surrounding.<br/>Further Survey Requirements: PRF inspection survey – ropes.</p> <p>Note: Due to proximity to water, ropes may not be possible. If not, presence/likely absence surveys - dusk emergence.</p> |

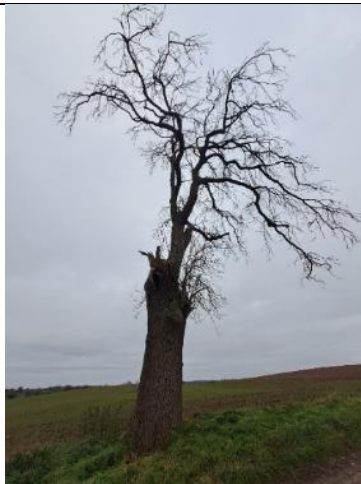
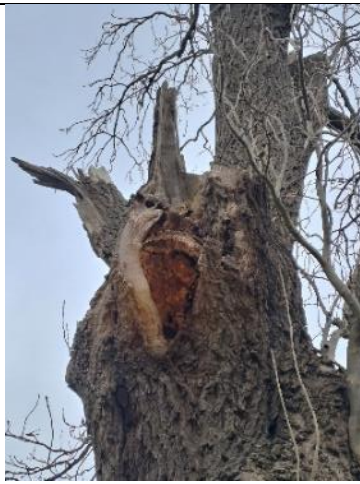
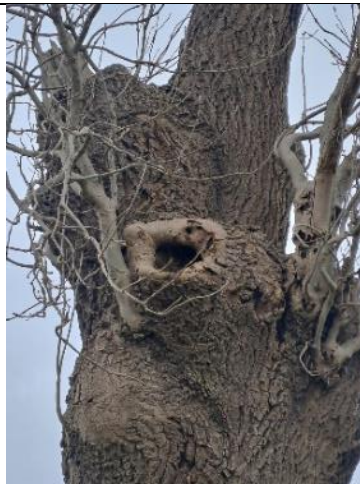
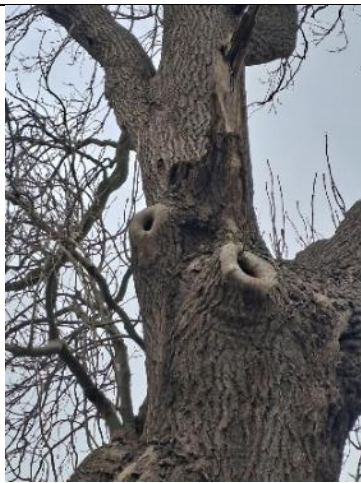
| BT141 | Tree<br>Description: | <p>Ash</p> <p>PRF 1: Trunk cavity on the stem oriented south-west. The cavity faced south-west and was at a height of 3m. There was no evidence of bat use. There was potential for maternity/satellite/night/mating/swarming bat roost use.<br/>Potential Bat Roost Suitability: PRF-M<br/>H&amp;S Considerations: Proximity to farm track.<br/>Further Survey Requirements: PRF inspection survey – ladders.</p> <p>PRF 2: Knot-hole on the stem oriented south-east. The hole faced south-east and was at a height of 3m. There was no evidence of bat use. There was potential for maternity/satellite/night/mating/swarming bat roost use.<br/>Potential Bat Roost Suitability: PRF-M<br/>H&amp;S Considerations: Proximity to farm track.<br/>Further Survey Requirements: PRF inspection survey – ladders.</p> <p>PRF 3: Knot-hole on the stem oriented north-east. The hole faced north-east and was at a height of 3m. There was no evidence of bat use. There was potential for maternity/satellite/night/mating/swarming bat roost use.<br/>Potential Bat Roost Suitability: PRF-M<br/>H&amp;S Considerations: Proximity to farm track.<br/>Further Survey Requirements: PRF inspection survey – ladders.</p> <p>PRF 4: 2 knot-holes on the stem oriented north-west. The holes faced north-west and were at a height of 3m. There was no evidence of bat use. There was potential for maternity/satellite/night/mating/swarming bat roost use.<br/>Potential Bat Roost Suitability: PRF-M<br/>H&amp;S Considerations: Proximity to farm track.</p> | | |

| Further Survey Requirements: PRF inspection survey – ropes. | | | | |

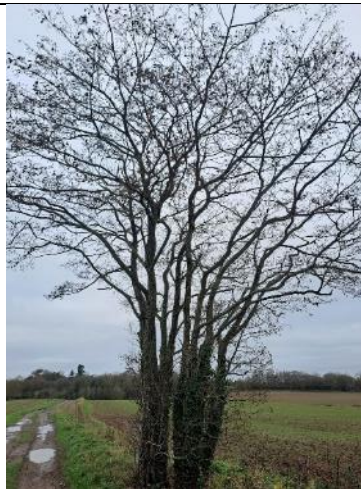
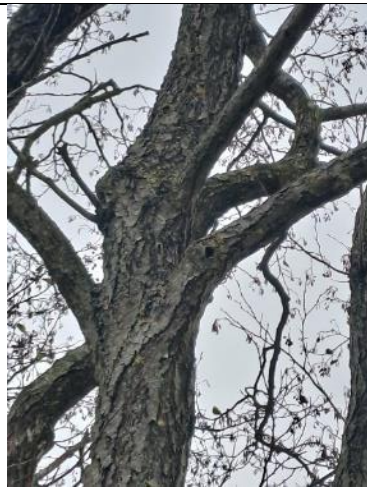
| BT142 | Tree Description: | <p>Alder</p> <p>PRF 1: Knot-hole on a minor limb oriented south-east. The hole faced south-east and was at a height of 3m. There was no evidence of bat use. There was potential for day/night/feeding/transitional occasional bat roost use.</p> <p>H&amp;S Considerations: Uneven ground surrounding and proximity to farm track.</p> <p>Further Survey Requirements: PRF inspection survey – ladders.</p> | |

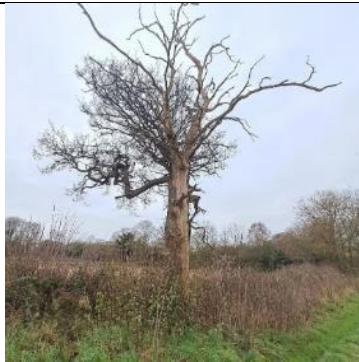
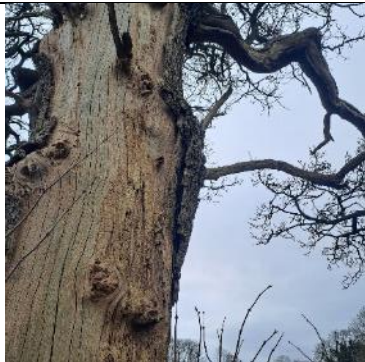
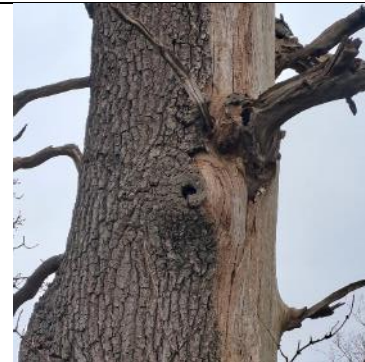
| BT143 | Tree Description: | <p>Pedunculate oak</p> <p>PRF 1: Lifting-bark on the stem oriented all aspects. The bark faced all aspects and was at a height of 1-4m. There was no evidence of bat use. There was potential for maternity/satellite/night/mating/swarming bat roost use.</p> <p>Potential Bat Roost Suitability: PRF-M</p> | |

| | <p>H&amp;S Considerations: Proximity to farm track and uneven ground surrounding.<br/>Further Survey Requirements: PRF inspection survey – ropes.</p> <p>PRF 2: Knot-hole on the stem oriented all aspects. The hole faced all aspects and was at a height of 1-4m. There was no evidence of bat use. There was potential for day/night/feeding/transitional occasional bat roost use.<br/>Potential Bat Roost Suitability: PRF-I<br/>H&amp;S Considerations: Proximity to farm track and uneven ground surrounding.<br/>Further Survey Requirements: PRF inspection survey – ropes.</p> <p>PRF 3: Desiccation-fissure on the stem oriented south-west. The hole faced north-west and was at a height of 3m. There was no evidence of bat use. There was potential for day/night/feeding/transitional occasional bat roost use.<br/>Potential Bat Roost Suitability: PRF-I<br/>H&amp;S Considerations: Proximity to farm track, unstable dead/diseased wood throughout and uneven ground surrounding.<br/>Further Survey Requirements: PRF inspection survey – ropes.</p> | | | |

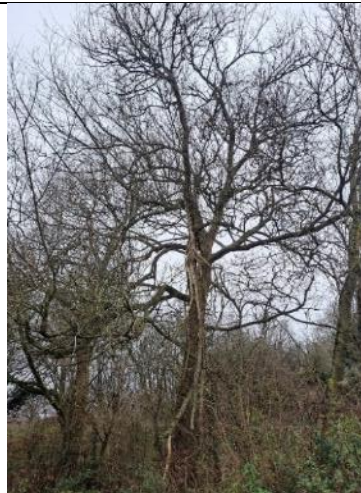
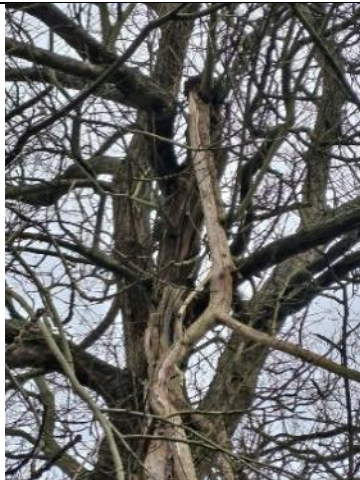
| BT144 | Tree<br>Description: | <p>Ash</p> <p>PRF 1: Split major limb oriented south-east. The limb faced south-east and was at a height of 6m. There was no evidence of bat use. There was potential for maternity/satellite/night/mating/swarming bat roost use.<br/>Potential Bat Roost Suitability: PRF-M<br/>H&amp;S Considerations: Proximity to water and uneven ground surrounding.<br/>Further Survey Requirements: Presence/likely absence surveys - dusk emergence.</p> <p>PRF 2: Split minor limb oriented south. The hole faced south-east and was at a height of 4m. There was no evidence of bat use. There was potential for maternity/satellite/night/mating/swarming bat roost use.<br/>Potential Bat Roost Suitability: PRF-M<br/>H&amp;S Considerations: Proximity to water and uneven ground surrounding.<br/>Further Survey Requirements: Presence/likely absence surveys - dusk emergence.</p> | | |

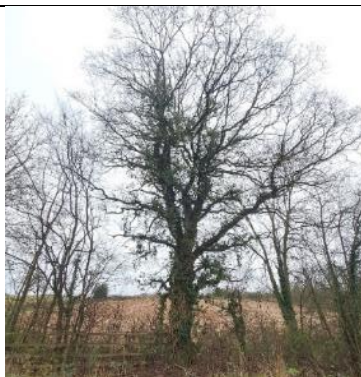
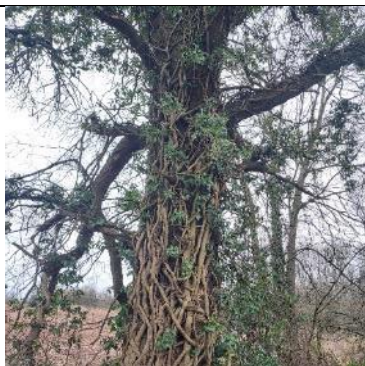
| Arb Reference | | | | G84 |
|---|---|---|---|---|
| BT145 | Tree Description: | <p>Oak sp.</p> <p>PRF 1: Ivy cover mature (&gt;50mm diameter, lattice forming) on the stem oriented all aspects. The ivy creates a PRF. The ivy faced all aspects and was at a height of 1-8m. There was no evidence of bat use. There was potential for day/night/feeding/transitional occasional bat roost use.</p> <p>Potential Bat Roost Suitability: PRF-I</p> <p>H&amp;S Considerations: Proximity to water and farm track, steep ground, overhanging metal/spiked rails, and uneven ground surrounding.</p> <p>Further Survey Requirements: PRF inspection survey – ropes.</p> <p>PRF 2: Compression-fork on a major limb oriented east. The fork faced south-east and was at a height of 2-3m. There was no evidence of bat use. There was potential for maternity/satellite/night/mating/swarming bat roost use.</p> <p>Potential Bat Roost Suitability: PRF-M</p> <p>H&amp;S Considerations: Proximity to water, steep ground and overhanging metal/spiked rails.</p> <p>Further Survey Requirements: PRF inspection survey – ladders.</p> | | |

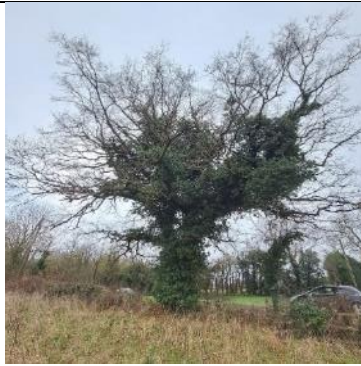
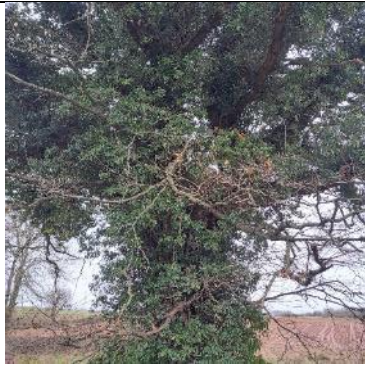
| Arb Reference | | | G84 |
|---|---|---|---|
| BT146 | Tree Description: | <p>Pedunculate oak</p> <p>PRF 1: Ivy cover mature (&gt;50mm diameter, lattice forming) on the stem oriented all aspects. The ivy creates a PRF. The ivy faced all aspects and was at a height of 1-9m. There was no evidence of bat use. There was potential for maternity/satellite/night/mating/swarming bat roost use.</p> <p>H&amp;S Considerations: Proximity to road and uneven ground surrounding.</p> <p>Further Survey Requirements: PRF inspection survey – ropes.</p> | |

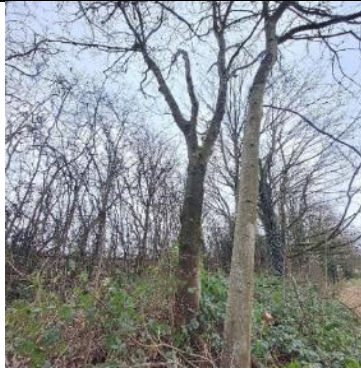
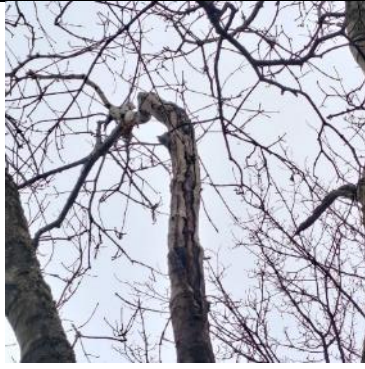
| Arb Reference | | | G84 |
|---|---|---|---|
| BT147 | Tree Description: | <p>Sycamore</p> <p>PRF 1: Desiccation-fissure on the stem oriented south. The fissure faced south and was at a height of 4m. There was no evidence of bat use. There was potential for day/night/feeding/transitional occasional bat roost use.</p> <p>H&amp;S Considerations: Proximity to road and steep ground.</p> <p>Further Survey Requirements: PRF inspection survey – ropes.</p> | |

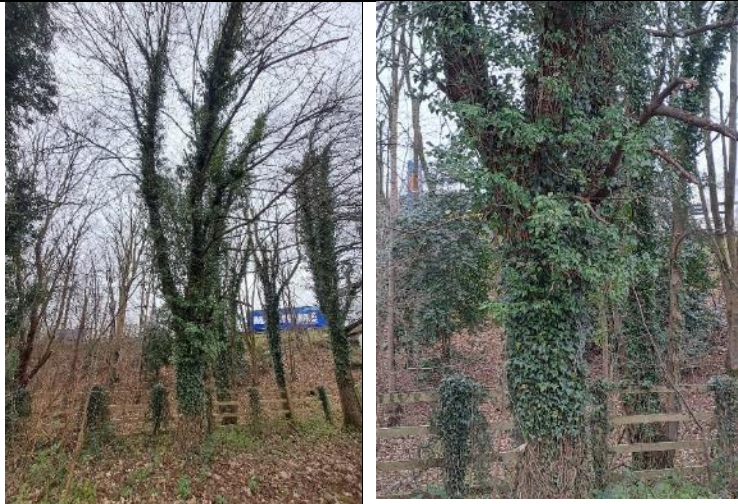
| BT148 | Tree Description: | <p>Cherry species</p> <p>PRF 1: Ivy cover (no PRF but may obscure other features) on the stem oriented all aspects. The ivy faced all aspects and was at a height of 0-9m. There was no evidence of bat use. There was potential for day/night/feeding/transitional occasional bat roost use.</p> <p>H&amp;S Considerations: Proximity to road and barbed wire fence.</p> <p>Further Survey Requirements: PRF inspection survey – ropes.</p> | | | |

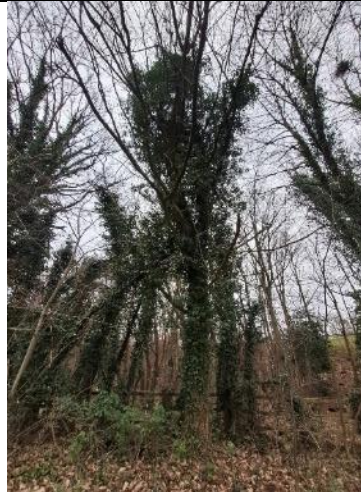
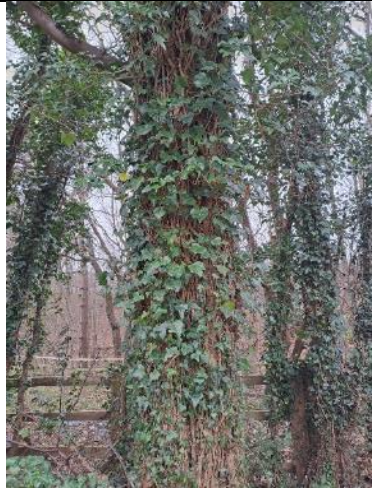
| | BT149 | <p>Tree Description:</p> <p>Sycamore</p> <p>PRF 1: Ivy cover (no PRF but may obscure other features) on the stem oriented all aspects. The ivy faced all aspects and was at a height of 0-8m. There was no evidence of bat use. There was potential for day/night/feeding/transitional occasional bat roost use.</p> <p>H&amp;S Considerations: Proximity to road and barbed wire fence.</p> <p>Further Survey Requirements: PRF inspection survey – ropes.</p> | | |

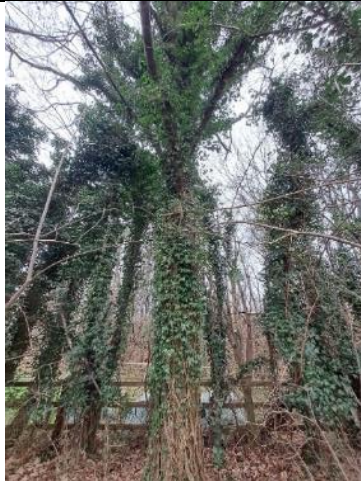
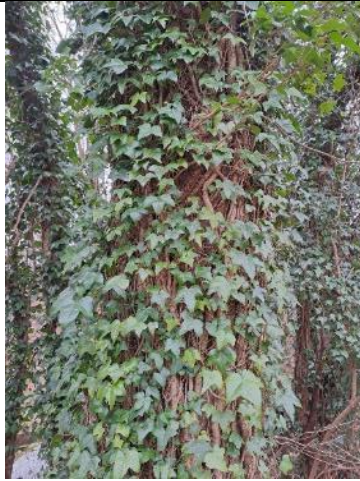
| | BT150 | Tree Description: | <p>Cherry species</p> <p>PRF 1: Ivy cover (no PRF but may obscure other features) on the stem oriented all aspects. The ivy faced all aspects and was at a height of 0-9m. There was no evidence of bat use. There was potential for day/night/feeding/transitional occasional bat roost use.</p> <p>H&amp;S Considerations: Proximity to road and barbed wire fence.</p> <p>Further Survey Requirements: PRF inspection survey – ropes.</p> | | |

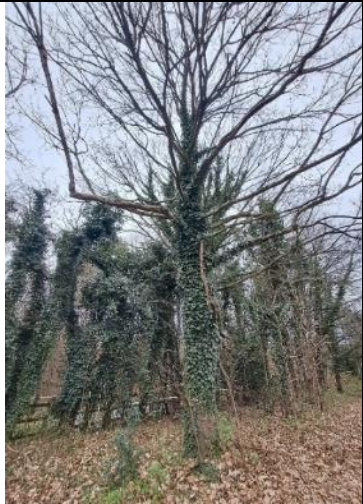
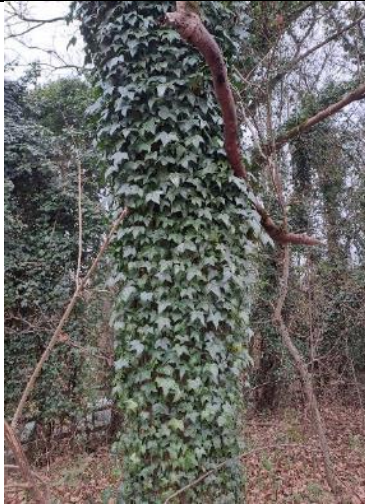
| | BT151 | Tree Description: | <p>Cherry species</p> <p>PRF 1: Ivy cover (no PRF but may obscure other features) on the stem oriented all aspects. The ivy faced all aspects and was at a height of 0-9m. There was no evidence of bat use. There was potential for day/night/feeding/transitional occasional bat roost use.</p> <p>H&amp;S Considerations: Proximity to road.</p> <p>Further Survey Requirements: PRF inspection survey – ropes.</p> | | |

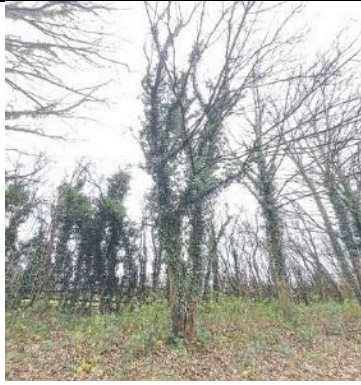
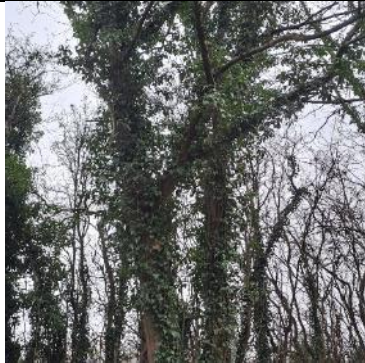
| | BT152 | Tree Description: | <p>Beech species</p> <p>PRF 1: Ivy cover (no PRF but may obscure other features) on the stem oriented all aspects. The ivy faced all aspects and was at a height of 1-7m. There was no evidence of bat use. There was potential for day/night/feeding/transitional occasional bat roost use.</p> <p>H&amp;S Considerations: Proximity to road and uneven ground surrounding.</p> <p>Further Survey Requirements: PRF inspection survey – ropes.</p> | | |

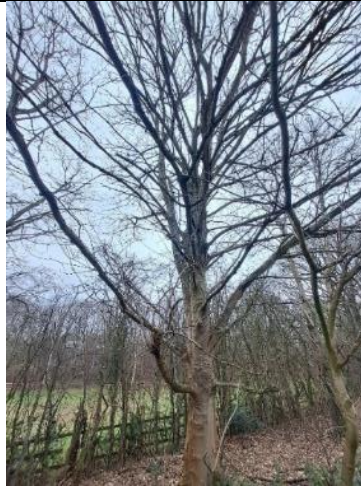
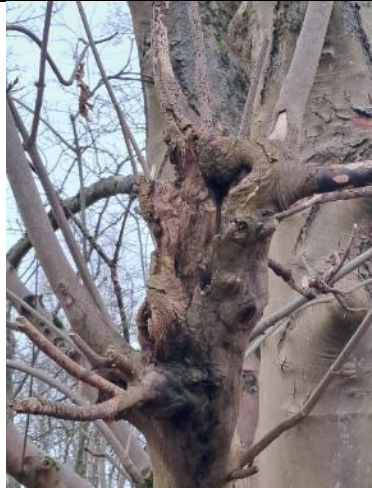
| | BT153 | Tree Description: | <p>Sycamore</p> <p>PRF 1: Branch cavity on a minor limb oriented south-east. The cavity faced south-east and was at a height of 2m. There was no evidence of bat use. There was potential for day/night/feeding/transitional occasional bat roost use.</p> <p>H&amp;S Considerations: Proximity to road.</p> <p>Further Survey Requirements: PRF inspection survey – ladders.</p> | | |

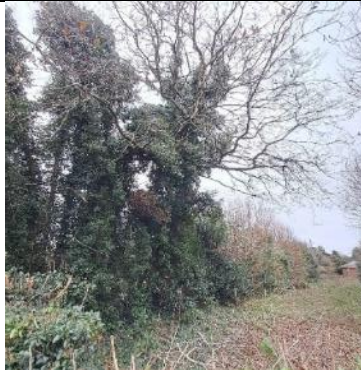
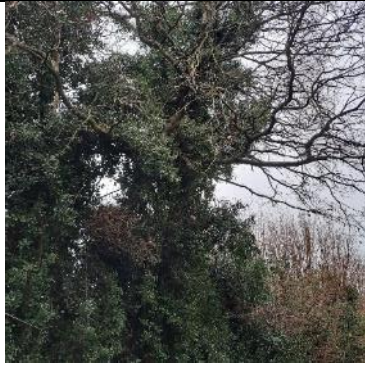
| BT155 | Tree Description: | <p>Pedunculate oak</p> <p>PRF 1: Ivy cover (no PRF but may obscure other features) on the stem oriented all aspects. The ivy faced all aspects and was at a height of 1-6m. There was no evidence of bat use. There was potential for day/night/feeding/transitional occasional bat roost use.</p> <p>H&amp;S Considerations: None.</p> <p>Further Survey Requirements: PRF inspection survey – ropes.</p> | | | |

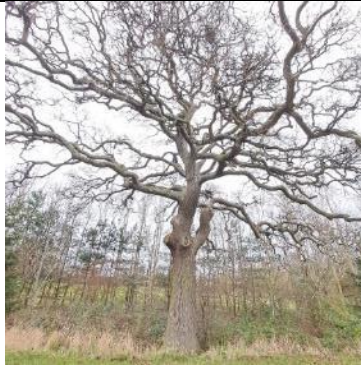
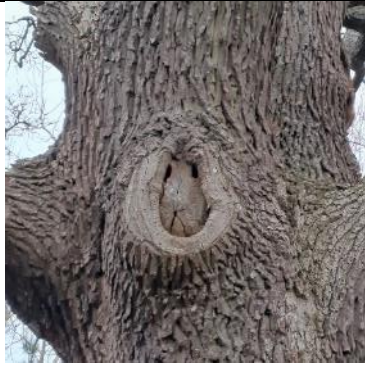
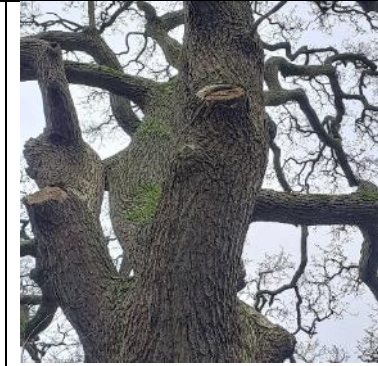
| | BT156 | Tree Description: | <p>Pedunculate oak</p> <p>PRF 1: Knot-hole on the stem oriented south-east. The hole faced south-east and was at a height of 3m. There was no evidence of bat use. There was potential for maternity/satellite/night/mating/swarming bat roost use.<br/>Potential Bat Roost Suitability: PRF-M<br/>H&amp;S Considerations: Proximity to water.<br/>Further Survey Requirements: PRF inspection survey – ladders.</p> <p>PRF 2: Multiple knot-holes around the stem oriented north. The holes faced north and were at a height of 3-4m. There was no evidence of bat use. There was potential for maternity/satellite/night/mating/swarming bat roost use.<br/>Potential Bat Roost Suitability: PRF-M<br/>H&amp;S Considerations: Impenetrable vegetation and uneven ground surrounding.<br/>Further Survey Requirements: PRF inspection survey – ropes.</p> | | |

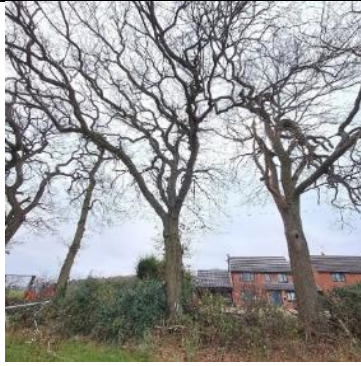
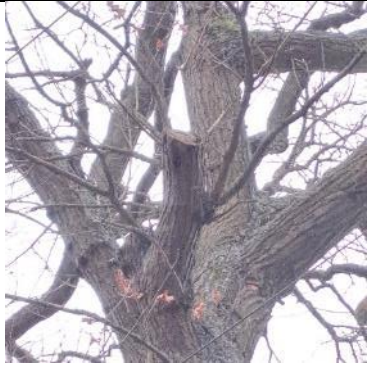
| BT157 | Tree Description: | <p>Pedunculate oak</p> <p>PRF 1: Branch cavity on a major limb oriented south-west. The cavity faced south-west and was at a height of 6m. There was no evidence of bat use. There was potential for maternity/satellite/night/mating/swarming bat roost use.</p> <p>H&amp;S Considerations: Proximity to road, uneven ground surrounding, proximity to overhead cables and barbed wire fence.</p> <p>Further Survey Requirements: PRF inspection survey – ropes.</p> | | | |

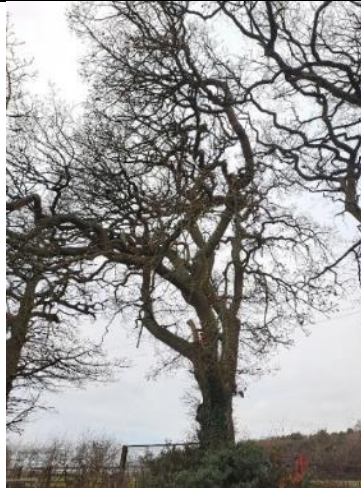
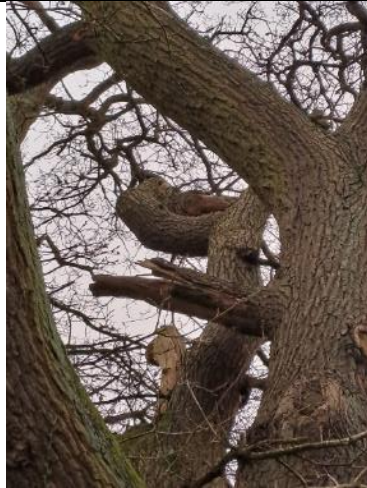
| | BT158 | Tree Description: | <p>Pedunculate oak</p> <p>PRF 1: Split in a major limb oriented south-east. The split faced south-east and was at a height of 4m. There was no evidence of bat use. There was potential for maternity/satellite/night/mating/swarming bat roost use.</p> <p>H&amp;S Considerations: Proximity to road, proximity to overhead cables and barbed wire fence.</p> <p>Further Survey Requirements: PRF inspection survey – ropes.</p> | | |

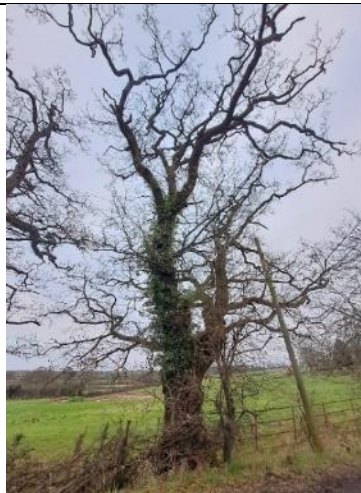
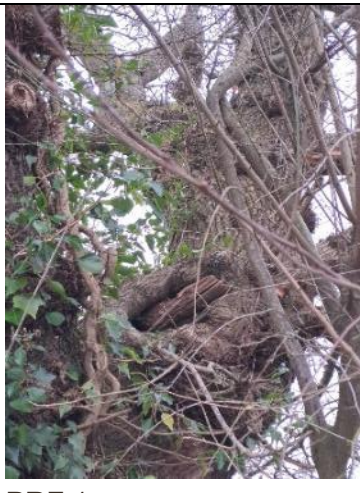
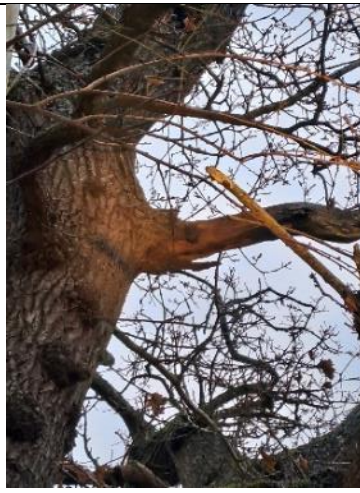
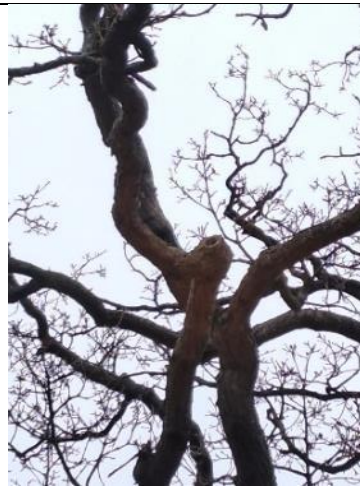
| BT159 | Tree Description: | <p>Pedunculate oak</p> <p>PRF 1: Knot-hole on the stem oriented south-east. The hole faced west and was at a height of 3m. There was no evidence of bat use. There was potential for maternity/satellite/night/mating/swarming bat roost use.</p> <p>Potential Bat Roost Suitability: PRF-M</p> <p>H&amp;S Considerations: Proximity to road, uneven ground surrounding, proximity to overhead cables and barbed wire fence.</p> <p>Further Survey Requirements: PRF inspection survey – ladders.</p> <p>PRF 2: Lifting-bark on a minor limb oriented south-east. The bark faced south-east and was at a height of 4m. There was no evidence of bat use. There was potential for day/night/feeding/transitional occasional bat roost use.</p> <p>Potential Bat Roost Suitability: PRF-I</p> | | | |

| | | <p>H&amp;S Considerations: Proximity to road, uneven ground surrounding, proximity to overhead cables and barbed wire fence.</p> <p>Further Survey Requirements: PRF inspection survey – ropes.</p> <p>PRF 3: Knot-hole on a minor limb oriented south-west. The hole faced south-west and was at a height of 7m. There was no evidence of bat use. There was potential for day/night/feeding/transitional occasional bat roost use.</p> <p>Potential Bat Roost Suitability: PRF-I</p> <p>H&amp;S Considerations: Proximity to road, uneven ground surrounding, proximity to overhead cables and barbed wire fence.</p> <p>Further Survey Requirements: PRF inspection survey – ropes.</p> |
