## Oldbury to Meriden, Warwickshire

# Ground Level Tree Assessment Report

**Prepared For: Severn Trent Water**

Document Reference: 10408.04.001

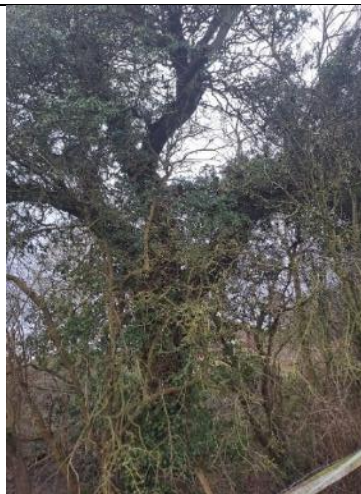
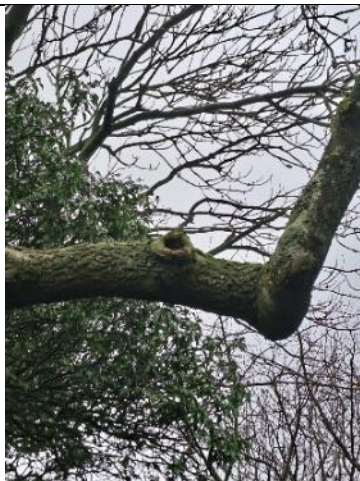
| BT160 | Tree Description: | Unknown tree species |

| | <p>PRF 1: Ivy cover (no PRF but may obscure other features) on the stem oriented all aspects. The ivy faced all aspects and was at a height of 0-8m. There was no evidence of bat use. There was potential for day/night/feeding/transitional occasional bat roost use.<br/>Potential Bat Roost Suitability: PRF-I<br/>H&amp;S Considerations: Proximity to water.<br/>Further Survey Requirements: PRF inspection survey – ropes.</p> <p>PRF 2: Knot-hole on a minor limb oriented east. The hole faced east and was at a height of 3m. There was no evidence of bat use. There was potential for day/night/feeding/transitional occasional bat roost use.<br/>Potential Bat Roost Suitability: PRF-I<br/>H&amp;S Considerations: Proximity to water.<br/>Further Survey Requirements: PRF inspection survey – ropes.</p> | | | |

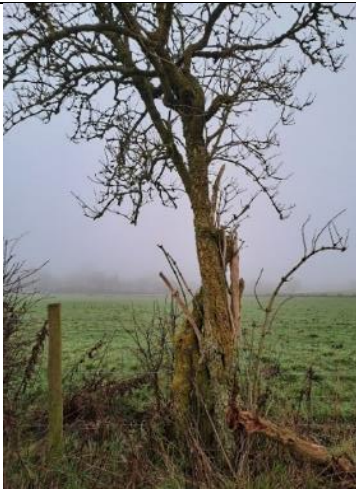
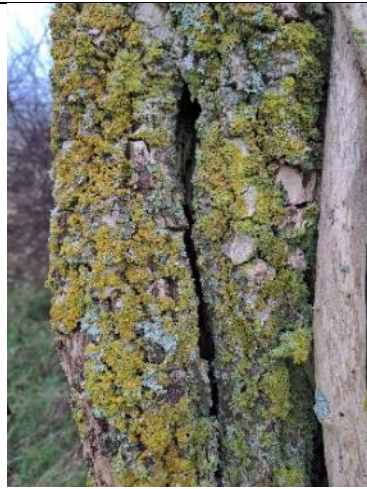
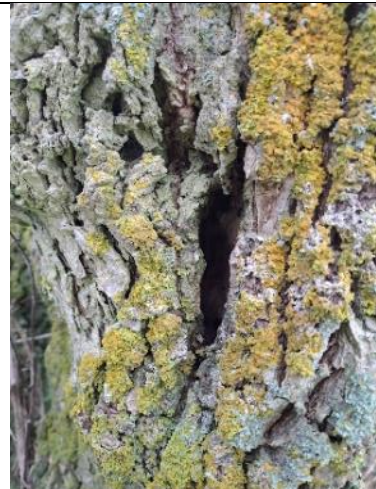
| BT161 | Tree Description: | Elder<br><br>PRF 1: Trunk cavity on the stem oriented all aspects. The cavity faced all aspects and was the length of the tree. There was no evidence of bat use. There was potential for maternity/satellite/night/mating/swarming bat roost use.<br>H&S Considerations: Barbed wire fence.<br>Further Survey Requirements: PRF inspection survey – ladders. | | | |

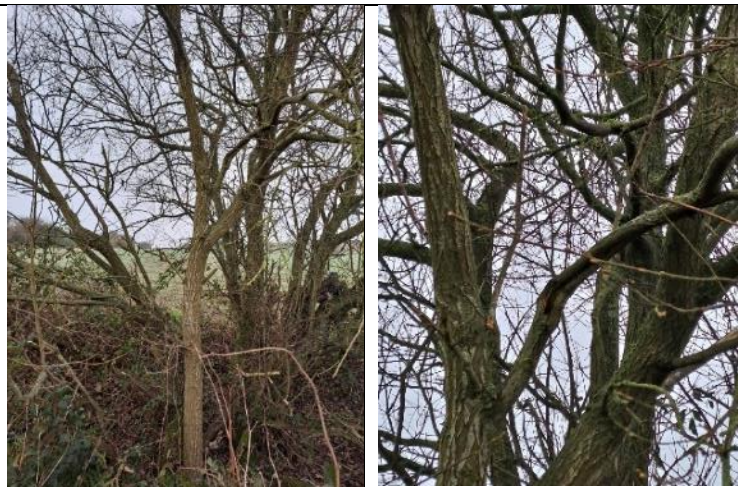
| BT162 | Tree Description: | Unknown tree species<br><br>PRF 1: Branch cavity on a minor limb oriented south-west. The cavity faced south-west and was at a height of 4m. There was no evidence of bat use. There was potential for day/night/feeding/transitional occasional bat roost use.<br>H&S Considerations: Uneven ground and proximity to water.<br>Further Survey Requirements: PRF inspection survey – ropes.<br>Note: Unsure whether it's safe to climb. May be able to section off PRF when soft felling and place elsewhere. | | | |

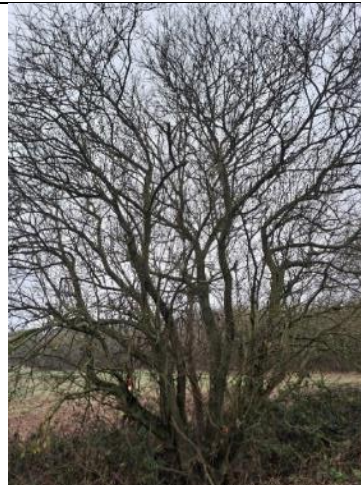
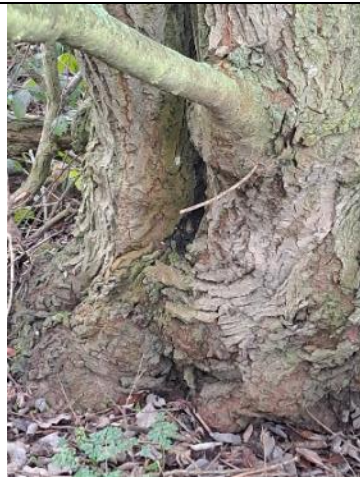
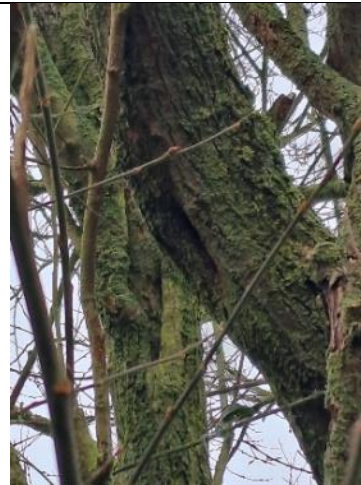
| | BT163 | <p>Tree Description:</p> <p>Unknown tree species</p> <p>PRF 1: Trunk cavity on the stem oriented south. The cavity faced south and was at a height of 0m. There was no evidence of bat use. There was potential for day/night/feeding/transitional occasional bat roost use.<br/>Potential Bat Roost Suitability: PRF-I<br/>H&amp;S Considerations: Proximity to water.<br/>Further Survey Requirements: PRF inspection survey – ground level.</p> <p>PRF 2: Branch cavity on a major limb oriented south. The cavity faced south and was at a height of 2.5m. There was no evidence of bat use. There was potential for maternity/satellite/night/mating/swarming bat roost use.<br/>Potential Bat Roost Suitability: PRF-M<br/>H&amp;S Considerations: Proximity to water.<br/>Further Survey Requirements: PRF inspection survey – ropes.</p> | | |

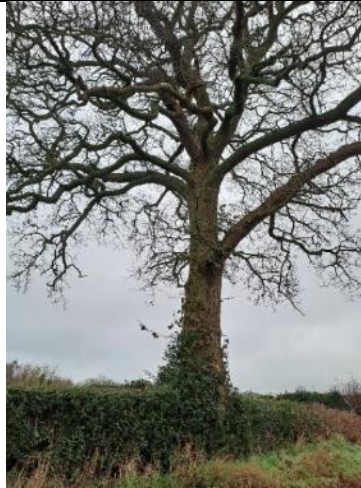
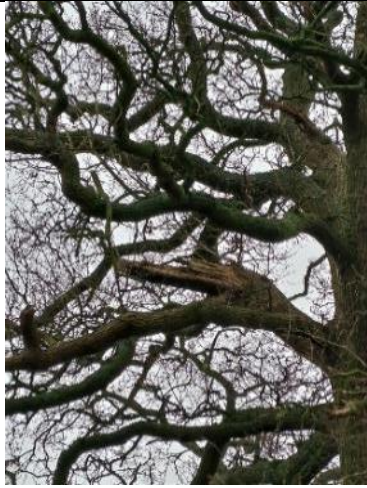
| BT164 | Tree Description: | Pedunculate oak<br><br>PRF 1: Branch cavity on a major limb oriented south. The cavity faced east and was at a height of 7m. There was no evidence of bat use. There was potential for maternity/satellite/night/mating/swarming bat roost use.<br>H&S Considerations: Barbed wire.<br>Further Survey Requirements: PRF inspection survey – ropes. | | | |

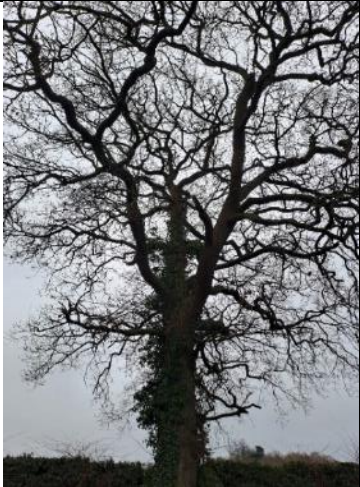
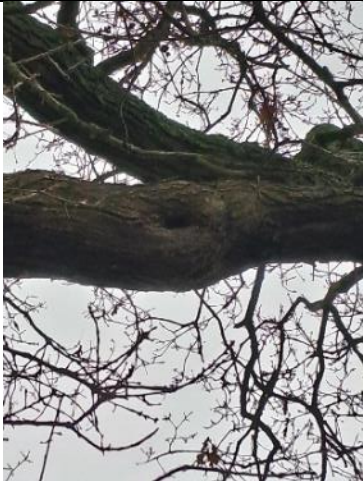
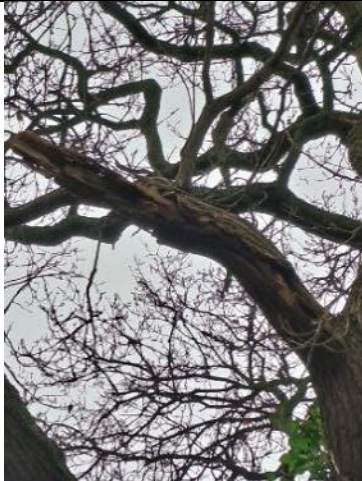
| BT165 | Tree Description: | <p>Pedunculate oak</p> <p>PRF 1: Knot-hole on a minor limb oriented east. The hole faced east and was at a height of 7m. There was no evidence of bat use. There was potential for maternity/satellite/night/mating/swarming bat roost use.<br/>Potential Bat Roost Suitability: PRF-M<br/>H&amp;S Considerations: Proximity to road.<br/>Further Survey Requirements: PRF inspection survey – ropes.</p> <p>PRF 2: Branch cavity on a minor limb oriented east. The cavity faced east and was at a height of 4m. There was no evidence of bat use. There was potential for maternity/satellite/night/mating/swarming bat roost use.<br/>Potential Bat Roost Suitability: PRF-M<br/>H&amp;S Considerations: Proximity to road.<br/>Further Survey Requirements: PRF inspection survey – ropes.</p> | | | |

| | | Note: Due to the proximity of the road, rope inspections may not be possible. If not, nocturnal surveys required. | | |

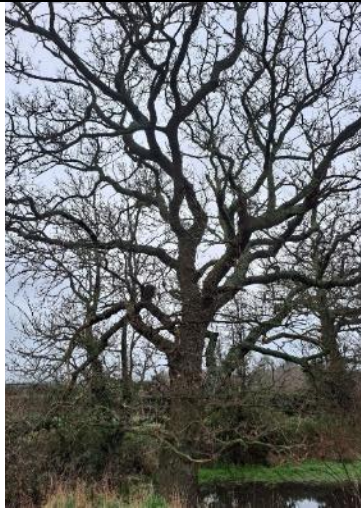
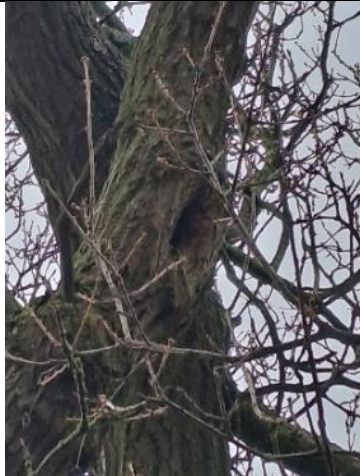
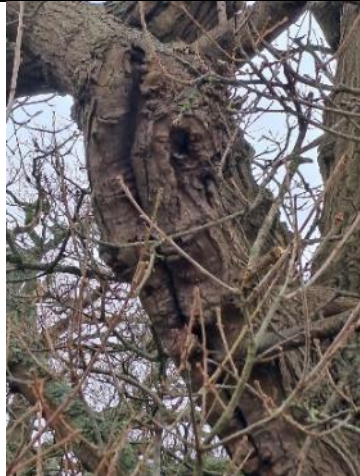
| BT167 | Tree Description: | <p>Pedunculate oak</p> <p>PRF 1: Knot-hole on a minor limb oriented south. The hole faced south and was at a height of 5m. There was no evidence of bat use. There was potential for maternity/satellite/night/mating/swarming bat roost use.<br/>Potential Bat Roost Suitability: PRF-M<br/>H&amp;S Considerations: Proximity to water.<br/>Further Survey Requirements: PRF inspection survey – ropes.</p> <p>PRF 2: Branch cavity on a minor limb oriented south. The cavity faced south and was at a height of 2.5m. There was no evidence of bat use. There was potential for maternity/satellite/night/mating/swarming bat roost use.<br/>Potential Bat Roost Suitability: PRF-M<br/>H&amp;S Considerations: Proximity to water.<br/>Further Survey Requirements: PRF inspection survey – ropes.</p> | | | |

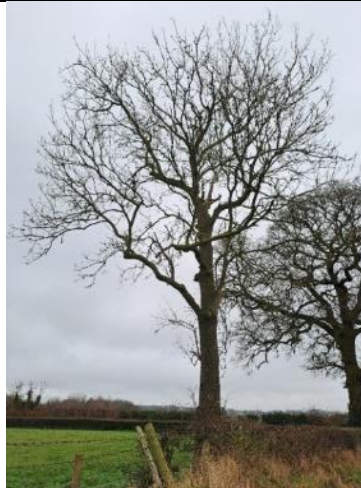
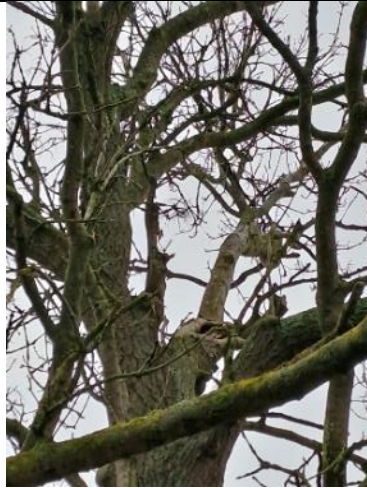
| BT169 | Tree Description: | <p>Ash</p> <p>PRF 1: Branch cavity on a minor limb oriented north-east. The cavity faced south-east and was at a height of 6m. There was no evidence of bat use. There was potential for maternity/satellite/night/mating/swarming bat roost use.</p> <p>H&amp;S Considerations: Barbed wire.</p> <p>Further Survey Requirements: PRF inspection survey – ropes.</p> | | | |

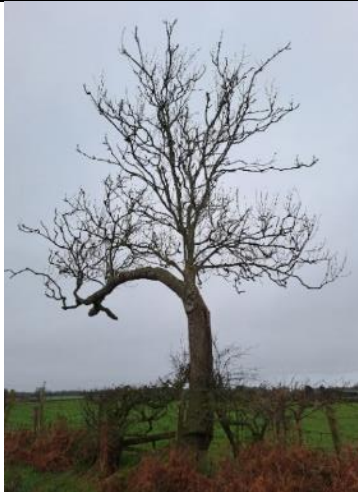
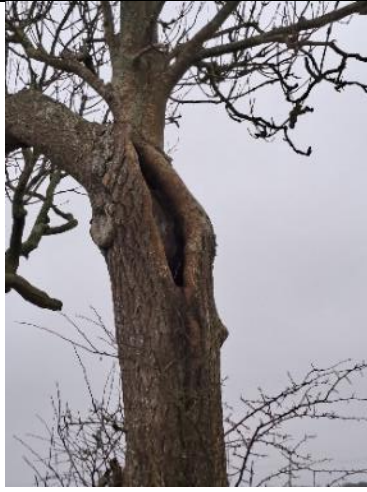
| BT170 | Tree Description: | <p>Ash</p> <p>PRF 1: Trunk cavity on the stem oriented east. The cavity faced east and was at a height of 2-3m. There was no evidence of bat use. There was potential for maternity/satellite/night/mating/swarming bat roost use.</p> <p>H&amp;S Considerations: None.</p> <p>Further Survey Requirements: PRF inspection survey – ropes.</p> | | | |

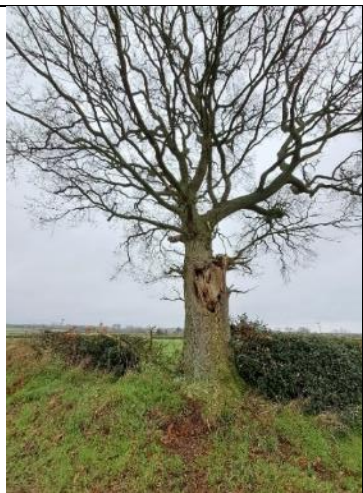
| BT171 | Tree Description: | <p>Pedunculate oak</p> <p>PRF 1: Wound on the stem oriented east. The wound faced east and was at a height of 2m. There was no evidence of bat use. There was potential for maternity/satellite/night/mating/swarming bat roost use.<br/>Potential Bat Roost Suitability: PRF-M<br/>H&amp;S Considerations: Barbed wire.<br/>Further Survey Requirements: PRF inspection survey – ladders.</p> <p>PRF 2: Lifting-bark on a minor limb oriented south-west. The bark faced south-west and was at a height of 3m. There was no evidence of bat use. There was potential for day/night/feeding/transitional occasional bat roost use.<br/>Potential Bat Roost Suitability: PRF-I<br/>H&amp;S Considerations: Barbed wire.<br/>Further Survey Requirements: Soft fell under supervision as unsafe to climb.</p> | | | |

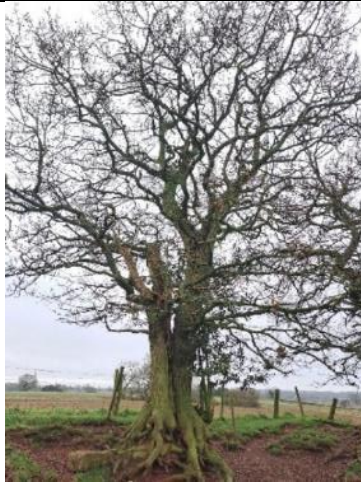
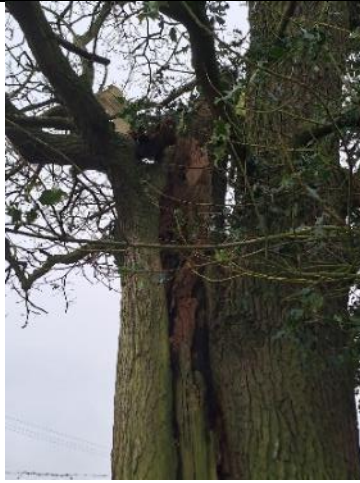
| BT172 | Tree Description: | <p>Pedunculate oak</p> <p>PRF 1: Trunk cavity on the stem oriented north-west. The cavity faced north-west and was at a height of 2-4m. There was no evidence of bat use. There was potential for maternity/satellite/night/mating/swarming bat roost use.</p> <p>H&amp;S Considerations: Barbed wire.</p> <p>Further Survey Requirements: PRF inspection survey – ropes.</p> | | | |

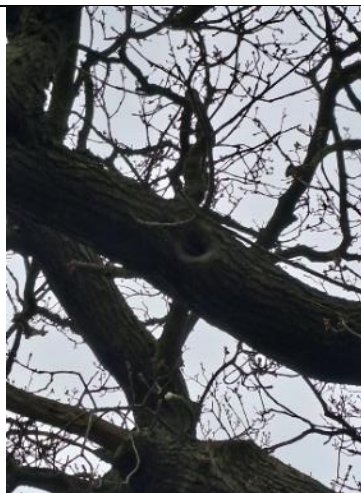
| | BT173 | Tree Description: | <p>Pedunculate oak</p> <p>PRF 1: Butt-rot on the stem oriented south-east. The rot faced south-east and was at a height of 0m. There was no evidence of bat use. There was potential for maternity/satellite/night/mating/swarming bat roost use.<br/>Potential Bat Roost Suitability: PRF-M<br/>H&amp;S Considerations: Barbed wire.<br/>Further Survey Requirements: PRF inspection survey – ground level.</p> <p>PRF 2: Knot-hole on a major limb oriented south-east. The hole faced south-east and was at a height of 2.5m. There was no evidence of bat use. There was potential for maternity/satellite/night/mating/swarming bat roost use.<br/>Potential Bat Roost Suitability: PRF-M<br/>H&amp;S Considerations: Barbed wire.<br/>Further Survey Requirements: PRF inspection survey – ropes.</p> | | |

| | | <p>PRF 3: Branch cavity on the stem oriented east. The cavity faced east and was at a height of 4m. There was no evidence of bat use. There was potential for maternity/satellite/night/mating/swarming bat roost use.<br/>Potential Bat Roost Suitability: PRF-M<br/>H&amp;S Considerations: Barbed wire.<br/>Further Survey Requirements: PRF inspection survey – ropes.</p> <p>PRF 4: Knot-hole on a major limb oriented west. The hole faced west and was at a height of 4m. There was no evidence of bat use. There was potential for maternity/satellite/night/mating/swarming bat roost use.<br/>Potential Bat Roost Suitability: PRF-M<br/>H&amp;S Considerations: Barbed wire.<br/>Further Survey Requirements: PRF inspection survey – ropes.</p> <p>Note: There were a further knot-holes and cavities on the tree not recorded in detail.</p> |

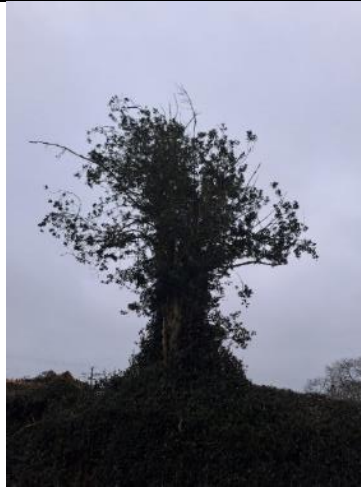
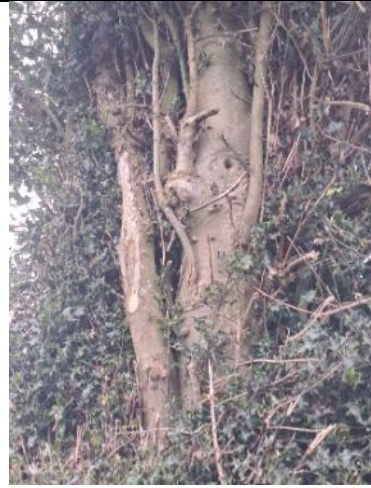
| BT174 | Tree Description: | <p>Holly</p> <p>PRF 1: A few holes on the stem oriented west. The holes faced west and were at a height of 2m. There was no evidence of bat use. There was potential for day/night/feeding/transitional occasional bat roost use.</p> <p>H&amp;S Considerations: Barbed wire.</p> <p>Further Survey Requirements: PRF inspection survey – ladders.</p> | | | |

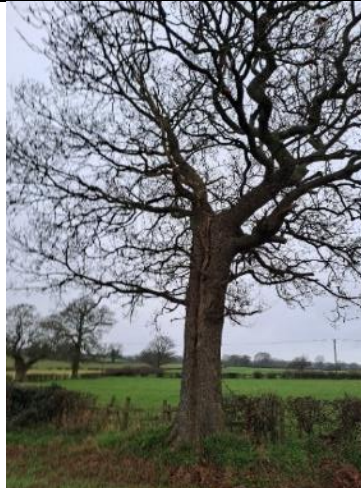
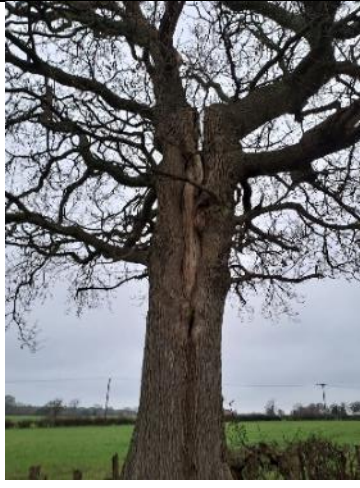
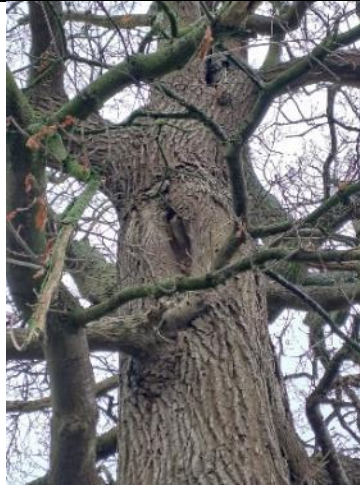
| BT175 | Tree<br>Description: | <p>Pedunculate oak</p> <p>PRF 1: Trunk cavity on the stem oriented all aspects. The cavity faced east and was at a height of 3m. There was no evidence of bat use. There was potential for maternity/satellite/night/mating/swarming bat roost use.<br/>Potential Bat Roost Suitability: PRF-M<br/>H&amp;S Considerations: Barbed wire.<br/>Further Survey Requirements: PRF inspection survey – ropes.</p> <p>PRF 2: Wound on the stem oriented all aspects. The wound faced south-west and was at a height of 4m. There was no evidence of bat use. There was potential for maternity/satellite/night/mating/swarming bat roost use.<br/>Potential Bat Roost Suitability: PRF-M<br/>H&amp;S Considerations: Barbed wire.<br/>Further Survey Requirements: PRF inspection survey – ropes.</p> | | | |

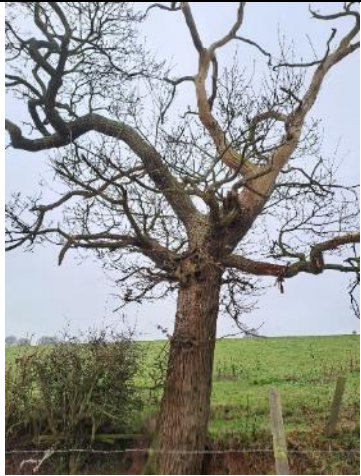
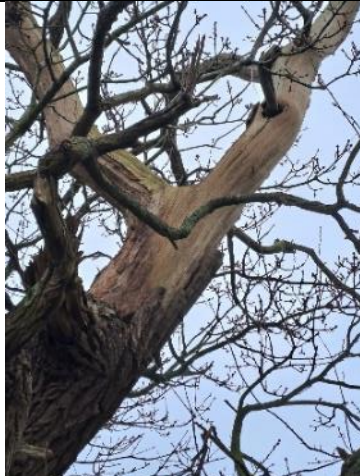
| BT176 | Tree Description: | <p>Pedunculate oak</p> <p>PRF 1: Lifting-bark on the stem oriented all aspects. The bark faced north and was at a height of 3m. There was no evidence of bat use. There was potential for day/night/feeding/transitional occasional bat roost use.</p> <p>H&amp;S Considerations: Proximity to water.</p> <p>Further Survey Requirements: PRF inspection survey – ropes.</p> <p>Note: There are other PRFs but doesn't look as if they lead to anywhere. Could potentially climb but the tree is near a dry ditch. If being removed, consider soft felling under supervision.</p> | | | |

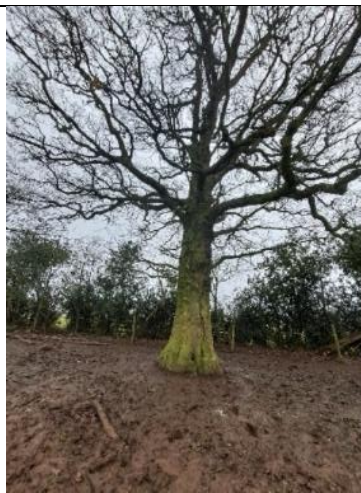
| | BT178 | Tree Description: | <p>Pedunculate oak</p> <p>PRF 1: Hole at the bottom of the stem oriented all aspects. The hole faced west and was at a height of 0.5m. There was no evidence of bat use. There was potential for maternity/satellite/night/mating/swarming bat roost use.</p> <p>H&amp;S Considerations: None.</p> <p>Further Survey Requirements: Endoscope form ground level.</p> | | |

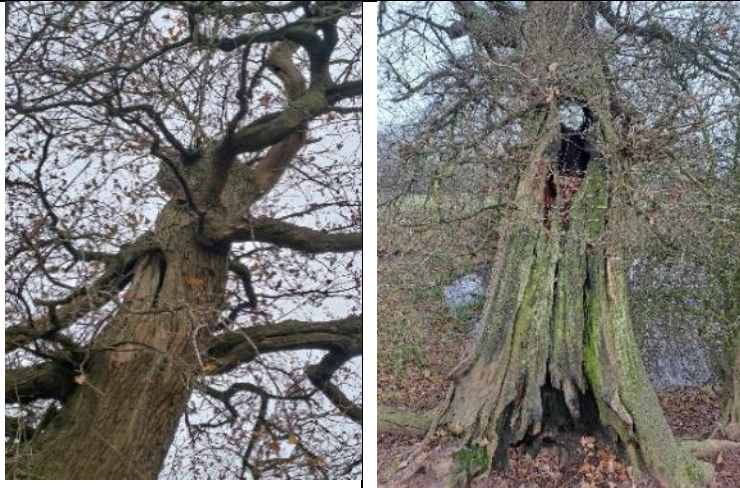
| BT179 | Tree Description: | <p>Pedunculate oak</p> <p>PRF 1: Trunk cavity on the stem oriented all aspects. The cavity faced all aspects and was at a height of 1-4m. There was no evidence of bat use. There was potential for maternity/satellite/night/mating/swarming bat roost use.</p> <p>H&amp;S Considerations: Proximity to water and steep ground.</p> <p>Further Survey Requirements: PRF inspection survey – ropes.</p> | | | |

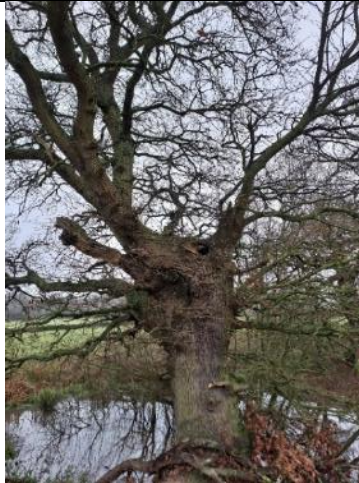
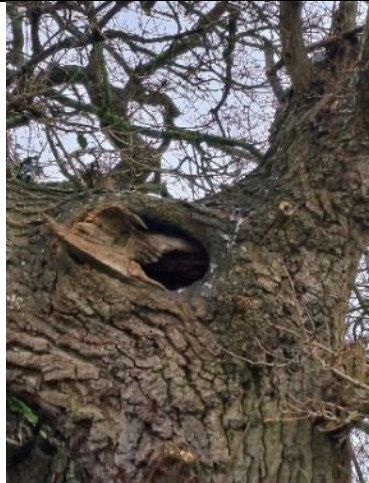
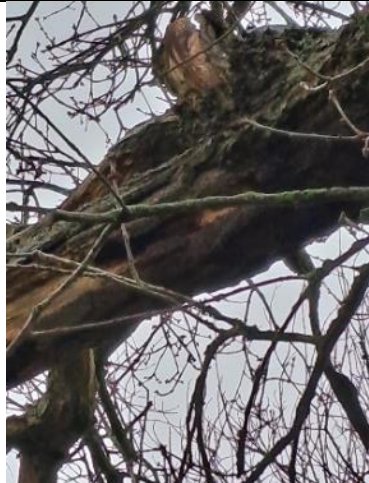
| BT180 | Tree Description: | <p>Pedunculate oak</p> <p>PRF 1: Trunk cavity on the stem oriented east. The cavity faced east and was at a height of 2.5m. There was no evidence of bat use. There was potential for maternity/satellite/night/mating/swarming bat roost use.<br/>Potential Bat Roost Suitability: PRF-M<br/>H&amp;S Considerations: Proximity to water.<br/>Further Survey Requirements: PRF inspection survey – ropes.</p> <p>PRF 2: Branch cavity on a minor limb oriented south-east. The cavity faced south-east and was at a height of 3.5m. There was no evidence of bat use. There was potential for maternity/satellite/night/mating/swarming bat roost use.<br/>Potential Bat Roost Suitability: PRF-M<br/>H&amp;S Considerations: Proximity to water.<br/>Further Survey Requirements: PRF inspection survey – ropes.</p> | | |

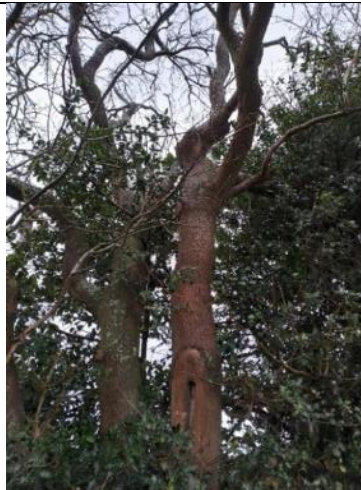
| | | <p>PRF 1: Wound on the stem oriented all aspects. The wound faced south-west and was at a height of 1m. There was no evidence of bat use. There was potential for maternity/satellite/night/mating/swarming bat roost use.</p> <p>H&amp;S Considerations: Proximity to footpaths.</p> <p>Further Survey Requirements: PRF inspection survey – endoscope from the ground.</p> | | |

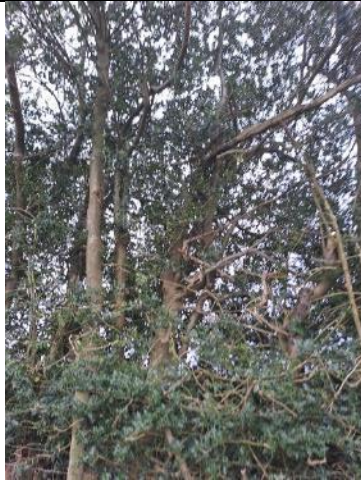
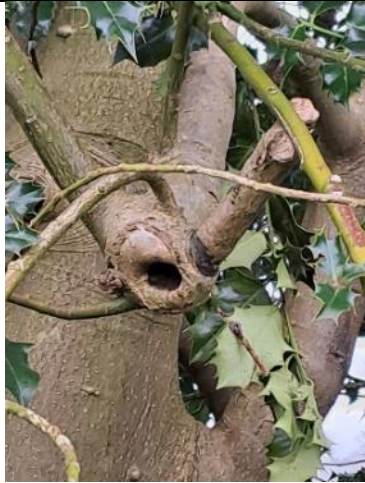
| BT184 | Tree Description: | <p>Holly</p> <p>PRF 1: Knot-hole on a minor limb oriented north. The hole faced north and was at a height of 1m. There was no evidence of bat use. There was potential for day/night/feeding/transitional occasional bat roost use.</p> <p>H&amp;S Considerations: None.</p> <p>Further Survey Requirements: PRF inspection survey – ladders.</p> | | | |

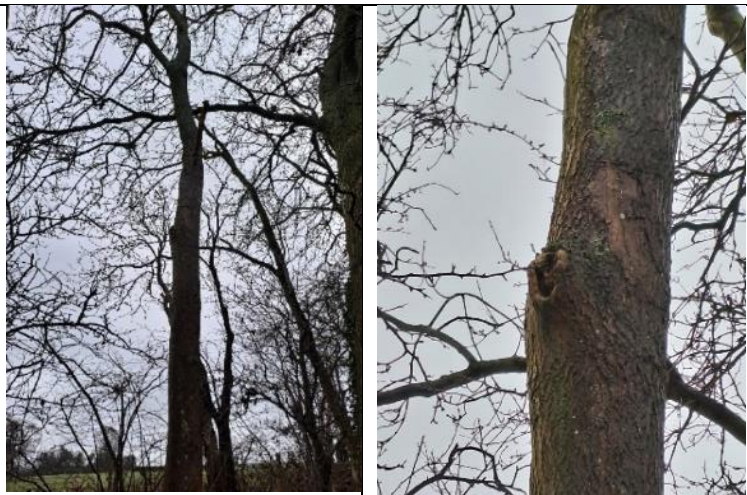
| | BT185 | Tree Description: | <p>Unknown tree species</p> <p>PRF 1: Knot-hole on the stem oriented south-west. The hole faced south-west and was at a height of 3m. There was no evidence of bat use. There was potential for day/night/feeding/transitional occasional bat roost use.</p> <p>H&amp;S Considerations: None.</p> <p>Further Survey Requirements: PRF inspection survey – ropes.</p> | | |

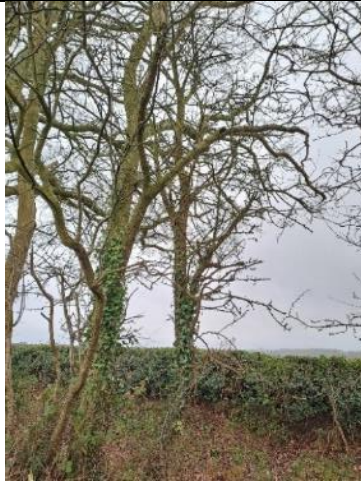
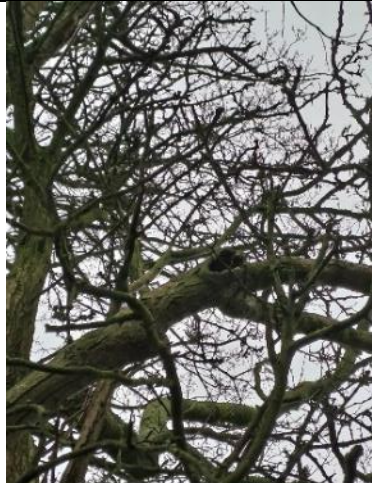
| | BT186 | Tree Description: | <p>Hawthorn</p> <p>PRF 1: Knot-hole on a minor limb oriented south-west. The hole faced south-west and was at a height of 3m. There was no evidence of bat use. There was potential for day/night/feeding/transitional occasional bat roost use.</p> <p>H&amp;S Considerations: Proximity to footpaths.</p> <p>Further Survey Requirements: PRF inspection survey – ropes.</p> | |

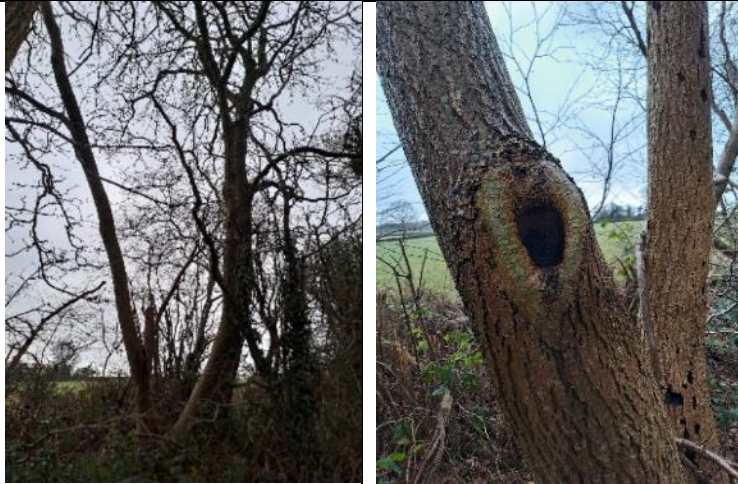
| | BT187 | Tree Description: | <p>Ash</p> <p>PRF 1: Knot-hole on the stem oriented south. The hole faced south and was at a height of 1m. There was no evidence of bat use. There was potential for day/night/feeding/transitional occasional bat roost use.</p> <p>H&amp;S Considerations: None.</p> <p>Further Survey Requirements: PRF inspection survey – ground-level.</p> | | |

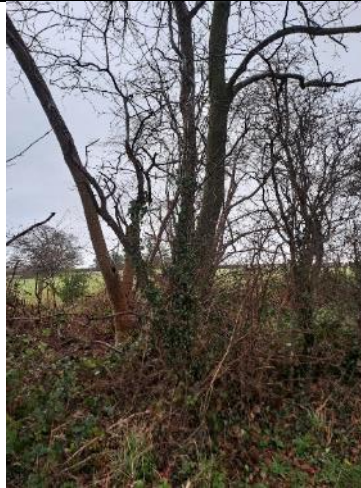
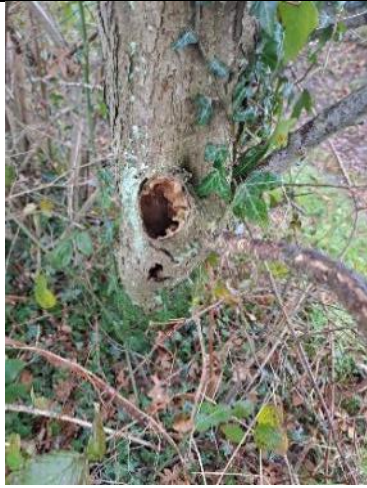
| | BT188 | Tree Description: | <p>Unknown tree species</p> <p>PRF 1: Knot-hole on the stem oriented west. The hole faced west and was at a height of 0.5m. There was no evidence of bat use. There was potential for day/night/feeding/transitional occasional bat roost use.</p> <p>H&amp;S Considerations: None.</p> <p>Further Survey Requirements: PRF inspection survey – ground-level.</p> | |

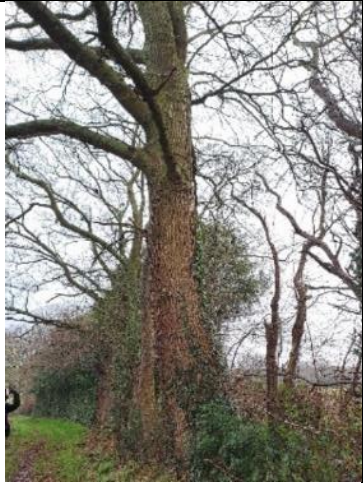
| | BT189 | Tree Description: | <p>Pedunculate oak</p> <p>PRF 1: No obvious features but of size and age to support features if they develop overtime.</p> <p>H&amp;S Considerations: Proximity to footpaths.</p> <p>Further Survey Requirements: PRF inspection survey – ropes.</p> | | |

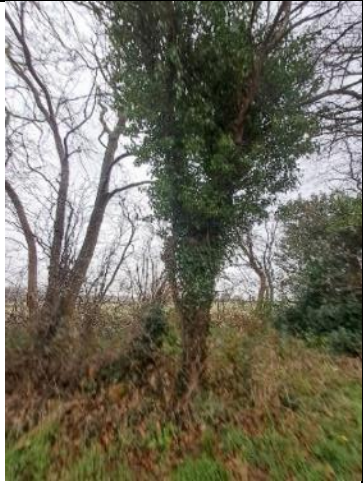
| BT190 | Tree Description: | <p>Hawthorn</p> <p>PRF 1: Ivy cover mature (&gt;50mm diameter, lattice forming) on the stem oriented all aspects. The ivy creates a PRF. The ivy faced all aspects and was at a height of 1-6m. There was no evidence of bat use. There was potential for day/night/feeding/transitional occasional bat roost use.</p> <p>H&amp;S Considerations: Proximity to footpaths.</p> <p>Further Survey Requirements: PRF inspection survey – ladders.</p> | | | |

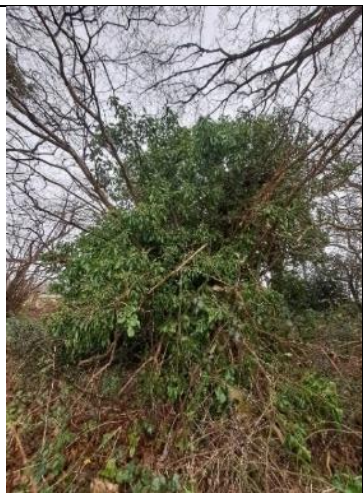
| BT191 | Tree<br>Description: | <p>Holly</p> <p>PRF 1: Ivy cover (no PRF but may obscure other features) on the stem oriented all aspects. The ivy faced all aspects and was at a height of 1-3m. There was no evidence of bat use. There was potential for day/night/feeding/transitional occasional bat roost use.</p> <p>H&amp;S Considerations: Proximity to footpaths.</p> <p>Further Survey Requirements: Soft fell under supervision.</p> | | | |

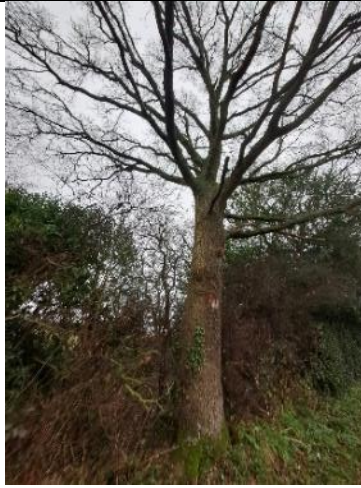
| BT192 | Tree Description: | <p>Pedunculate oak</p> <p>PRF 1: There were no obvious features but the tree was of the size and age to support features if they develop over time.</p> <p>H&amp;S Considerations: Proximity to footpaths.</p> <p>Further Survey Requirements: PRF inspection survey – ropes.</p> | | | |

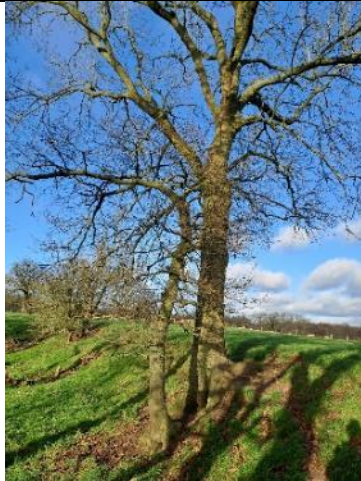
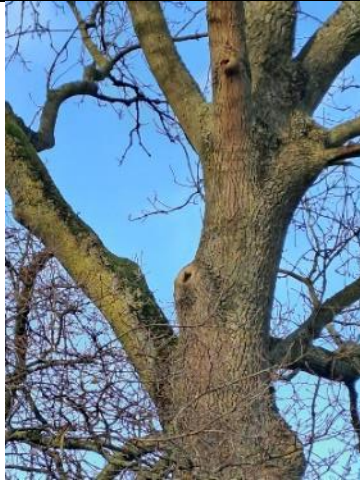
| BT193 | Tree<br>Description: | <p>Ash</p> <p>PRF 1: Knot-hole on the stem oriented east. The hole faced east and was at a height of 5m. There was no evidence of bat use. There was potential for maternity/satellite/night/mating/swarming bat roost use.<br/>Potential Bat Roost Suitability: PRF-M<br/>H&amp;S Considerations: Uneven ground surrounding and unstable dead/diseased wood throughout.<br/>Further Survey Requirements: Presence/likely absence surveys - dusk emergence.</p> <p>PRF 2: Knot-hole on the stem oriented south. The hole faced south and was at a height of 4m. There was no evidence of bat use. There was potential for maternity/satellite/night/mating/swarming bat roost use.<br/>Potential Bat Roost Suitability: PRF-M<br/>H&amp;S Considerations: Uneven ground surrounding and unstable dead/diseased wood throughout.<br/>Further Survey Requirements: Presence/likely absence surveys - dusk emergence.</p> | | | |

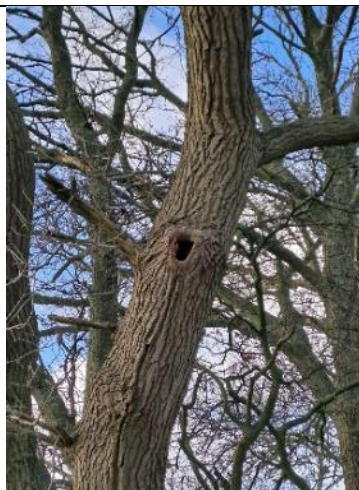
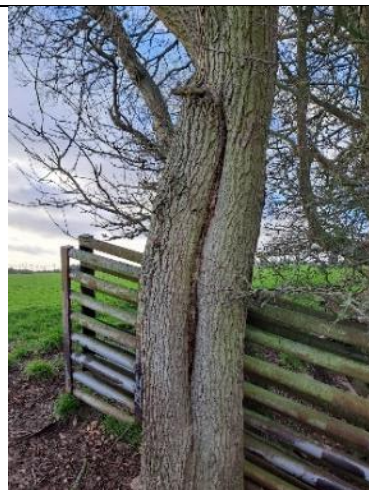
| BT194 | Tree Description: | <p>Pedunculate oak</p> <p>PRF 1: Knot-hole on the stem oriented east. The hole faced east and was at a height of 4m. There was no evidence of bat use. There was potential for day/night/feeding/transitional occasional bat roost use.<br/>Potential Bat Roost Suitability: PRF-I<br/>H&amp;S Considerations: Uneven ground surrounding.<br/>Further Survey Requirements: PRF inspection survey – ropes.</p> <p>PRF 2: Trunk cavity on the stem oriented east. The cavity faced east and was at a height of 1.5m. There was no evidence of bat use. There was potential for day/night/feeding/transitional occasional bat roost use.<br/>Potential Bat Roost Suitability: PRF-I<br/>H&amp;S Considerations: Steep ground.</p> | | | |

| | | Further Survey Requirements: PRF inspection survey – ground-level. | | | |

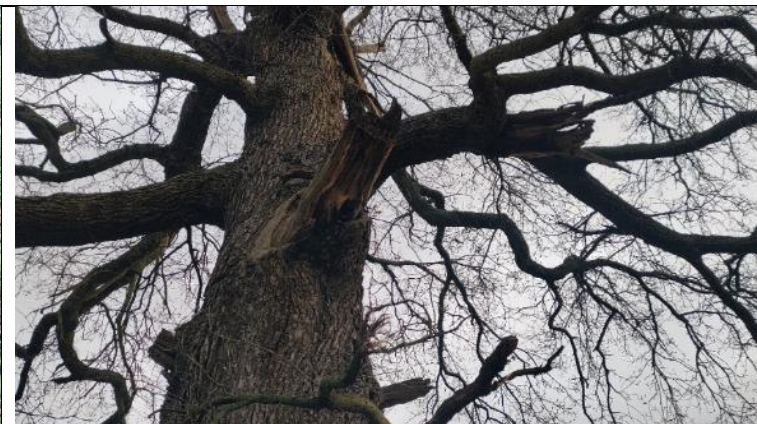
PRF 1

| BT195 | Tree Description: | <p>Pedunculate oak</p> <p>PRF 1: Butt-rot on the stem oriented south. The rot faced south and was at a height of 0m. There was no evidence of bat use. There was potential for maternity/satellite/night/mating/swarming bat roost use.</p> <p>Potential Bat Roost Suitability: PRF-M</p> <p>H&amp;S Considerations: None.</p> <p>Further Survey Requirements: Presence/likely absence surveys - dusk emergence.</p> <p>PRF 2: Dead limb (starting to form knot hole but dead splintered wood has associated cavities too) on the stem oriented south. The limb faced south and was at a height of 6m. There was no evidence of bat use. There was potential for maternity/satellite/night/mating/swarming bat roost use.</p> | | | |

| | <p>Potential Bat Roost Suitability: PRF-M<br/>H&amp;S Considerations: Unstable dead/diseased wood throughout.<br/>Further Survey Requirements: PRF inspection survey – ropes. If the tree is unsafe to climb due to the dead/diseased wood, then nocturnal surveys will be required.</p> <p>PRF 3: A dead limb becoming an upwards facing knot-hole on the stem oriented east. The limb faced east and was at a height of 5m. There was no evidence of bat use. There was potential for day/night/feeding/transitional occasional bat roost use.</p> <p>Potential Bat Roost Suitability: PRF-I<br/>H&amp;S Considerations: Unstable dead/diseased wood throughout.<br/>Further Survey Requirements: PRF inspection survey – ropes. If the tree is unsafe to climb due to the dead/diseased wood, then nocturnal surveys will be required.</p> <p>PRF 4: Tear-out on the stem oriented south. The tear-out faced south and was at a height of 10m. There was no evidence of bat use. There was potential for maternity/satellite/night/mating/swarming bat roost use.</p> <p>Potential Bat Roost Suitability: PRF-M<br/>H&amp;S Considerations: Unstable dead/diseased wood throughout.<br/>Further Survey Requirements: PRF inspection survey – ropes. If the tree is unsafe to climb due to the dead/diseased wood, then nocturnal surveys will be required.</p> |

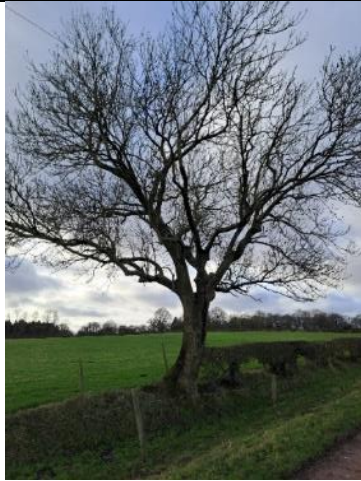
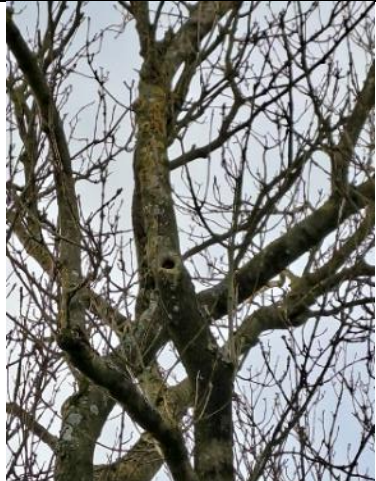
| BT196 | Tree Description: | Ash<br><br>PRF 1: Knot-hole on the stem oriented north-east. The hole faced north-east and was at a height of 7m. There was no evidence of bat use. There was potential for day/night/feeding/transitional occasional bat roost use.<br>H&S Considerations: Barbed wire.<br>Further Survey Requirements: PRF inspection survey – ropes. | | |

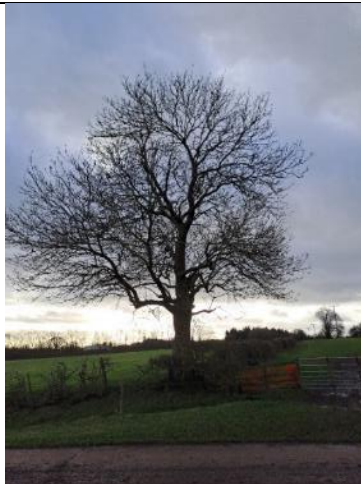
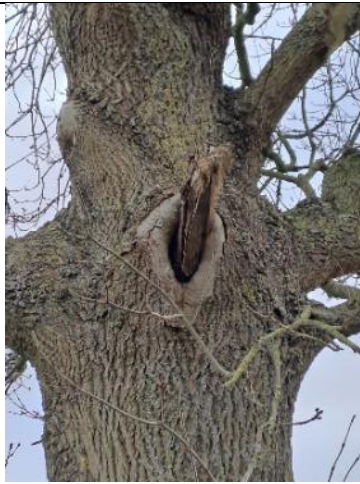
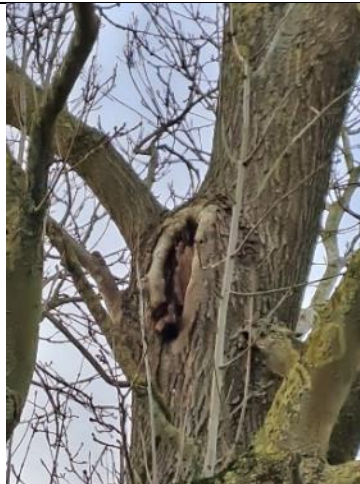
| BT197 | Tree Description: | <p>Ash</p> <p>PRF 1: Knot-hole on the stem oriented north. The hole faced north and was at a height of 3m. There was no evidence of bat use. There was potential for day/night/feeding/transitional occasional bat roost use.<br/>Potential Bat Roost Suitability: PRF-I<br/>H&amp;S Considerations: Barbed wire.<br/>Further Survey Requirements: PRF inspection survey - ropes.</p> <p>PRF 2: Knot-hole on the stem oriented east. The hole faced east and was at a height of 6m. There was no evidence of bat use. There was potential for maternity/satellite/night/mating/swarming bat roost use.<br/>Potential Bat Roost Suitability: PRF-M<br/>H&amp;S Considerations: Barbed wire.<br/>Further Survey Requirements: PRF inspection survey – ropes.</p> | | | |

| | | <p>PRF 3: Trunk cavity on the stem oriented west. The cavity faced west and was at a height of 6m. There was no evidence of bat use. There was potential for maternity/satellite/night/mating/swarming bat roost use.</p> <p>Potential Bat Roost Suitability: PRF-M</p> <p>H&amp;S Considerations: Unstable dead/diseased wood throughout.</p> <p>Further Survey Requirements: PRF inspection survey – ropes.</p> | | |

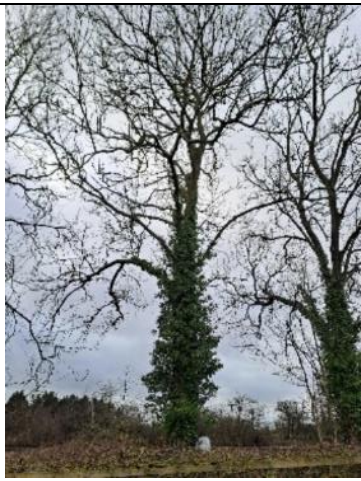
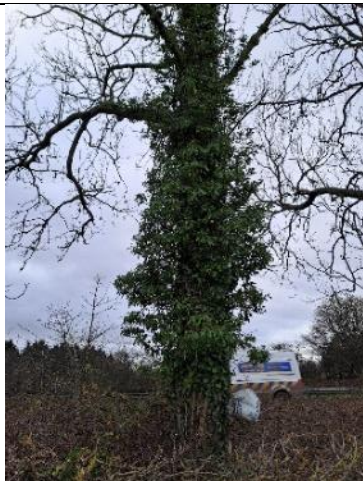
| | Tree Description: | <p>Ash</p> <p>PRF 1: Ivy cover (no PRF but may obscure other features) on the stem oriented all aspects. The ivy faced all aspects and was at a height of 2m. There was no evidence of bat use. There was potential for day/night/feeding/transitional occasional bat roost use.</p> <p>H&amp;S Considerations: Proximity to road.</p> | | |

| | Further Survey Requirements: Soft fell under supervision. | | | |

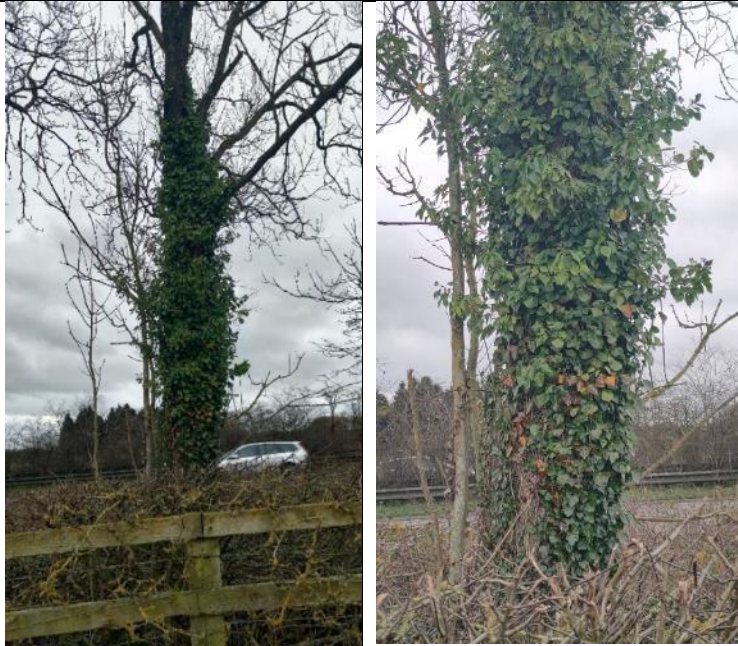
| BT199 | Tree Description: | <p>Ash</p> <p>PRF 1: Ivy cover mature (&gt;50mm diameter, lattice forming) on the stem oriented all aspects. The ivy creates a PRF. The ivy faced all aspects and was at a height of 0-7m. There was no evidence of bat use. There was potential for day/night/feeding/transitional occasional bat roost use.</p> <p>H&amp;S Considerations: Proximity to road.</p> <p>Further Survey Requirements: Soft fell under supervision.</p> | | |

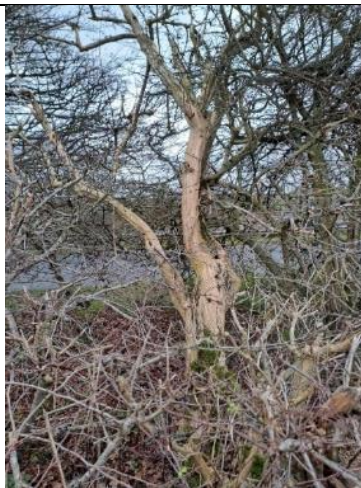
| | BT200 | Tree Description: | <p>Elder</p> <p>PRF 1: Trunk cavity on the stem oriented all aspects. The cavity faced south and was at a height of 1m. There was no evidence of bat use. There was potential for day/night/feeding/transitional occasional bat roost use.</p> <p>H&amp;S Considerations: Proximity to road.</p> <p>Further Survey Requirements: PRF inspection survey – ground-level.</p> | |

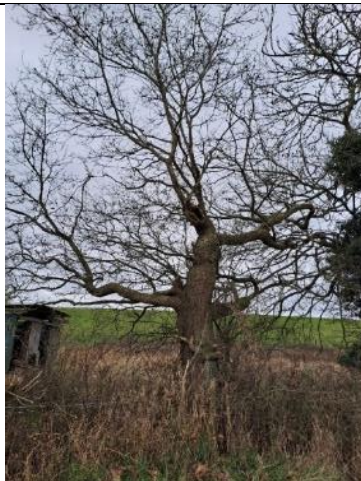
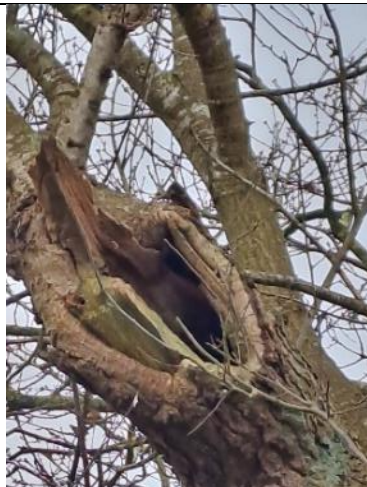
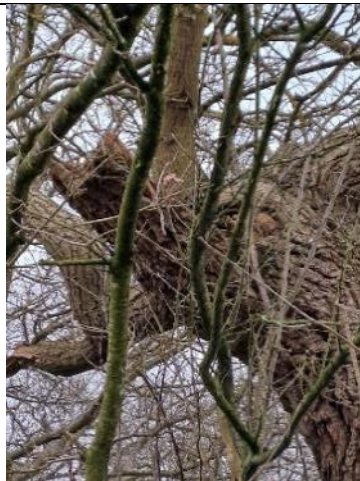
| BT201 | Tree<br>Description: | <p>Pedunculate oak</p> <p>PRF 1: Branch cavity located on the stem orientated north-east. The cavity faced east and was at a height of 3.5m. There was no evidence of bat use. There was potential for maternity/satellite/night/mating/swarming bat roost use.<br/>Potential Bat Roost Suitability: PRF-M<br/>H&amp;S Considerations: Barbed wire.<br/>Further Survey Requirements: PRF inspection survey – ropes.</p> <p>PRF 2: Branch cavity located on the stem orientated south-west. The cavity faced south and was at a height of 3.5m. There was no evidence of bat use. There was potential for maternity/satellite/night/mating/swarming bat roost use.<br/>Potential Bat Roost Suitability: PRF-M<br/>H&amp;S Considerations: Barbed wire.</p> | | | |

| | | Further Survey Requirements: PRF inspection survey – ropes. | | | |

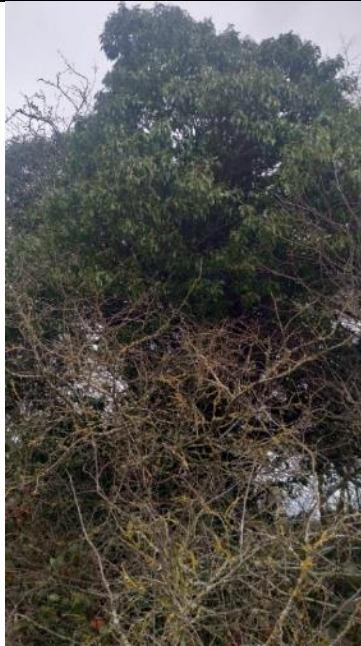
| BT202 | Tree Description: | <p>Hawthorn</p> <p>PRF 1: Ivy cover mature (&gt;50mm diameter, lattice forming) located on the stem orientated all aspects. The ivy creates a PRF but may also obscure other PRFs. The ivy faced all aspects and was at a height of 0-6m. There was no evidence of bat use. There was potential for day/night/feeding/transitional occasional bat roost use.</p> <p>H&amp;S Considerations: Impenetrable vegetation and proximity to water.</p> <p>Further Survey Requirements: Soft fell under supervision.</p> | | | |

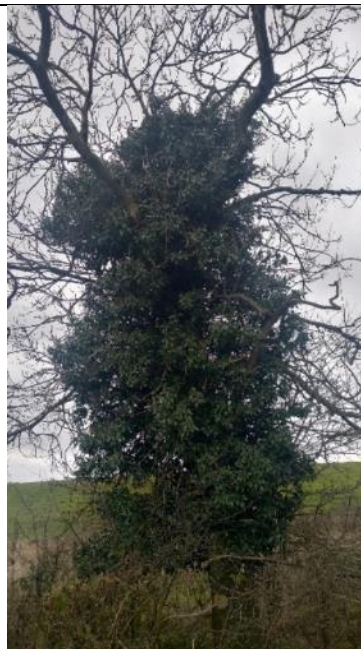
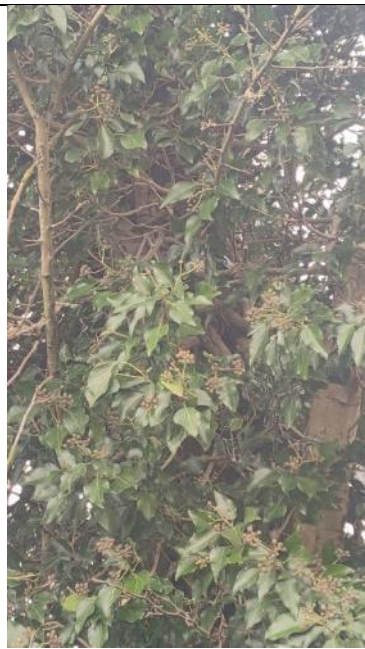
| BT203 | Tree Description: | <p>Pedunculate oak</p> <p>PRF 1: Ivy cover mature (&gt;50mm diameter, lattice forming) located on the stem orientated all aspects. The ivy creates a PRF but may also obscure other PRFs. The ivy faced all aspects and was at a height of 0-6m. There was no evidence of bat use. There was potential for day/night/feeding/transitional occasional bat roost use.</p> <p>Potential Bat Roost Suitability: PRF-I</p> <p>H&amp;S Considerations: Barbed wire.</p> <p>Further Survey Requirements: Soft fell under supervision.</p> | | | |

| | | PRF 2: Ivy cover (no PRF but may obscure other features) located on the stem orientated all aspects. The ivy faced all aspects and was at a height of 0-6m. There was no evidence of bat use. There was potential for maternity/satellite/night/mating/swarming bat roost use.<br>Potential Bat Roost Suitability: PRF-M<br>H&S Considerations: None.<br>Further Survey Requirements: Presence/likely absence surveys - dusk emergence. | | | |

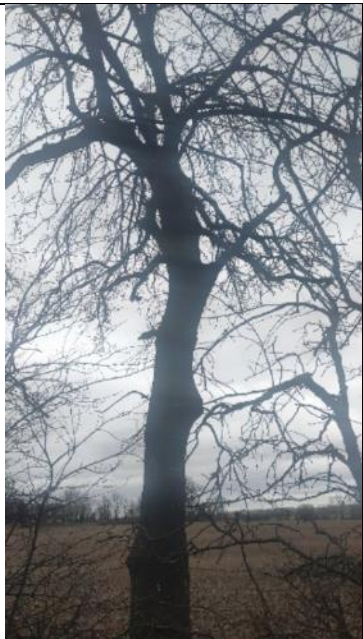
| | | <p>PRF 1: Knot-hole located on a minor limb orientated east. The hole faced west and was at a height of 5m. There was no evidence of bat use. There was potential for day/night/feeding/transitional occasional bat roost use.</p> <p>H&amp;S Considerations: Barbed wire.</p> <p>Further Survey Requirements: PRF inspection survey – ropes.</p> <p>Note: Multiple small knot-holes were present.</p> | | |

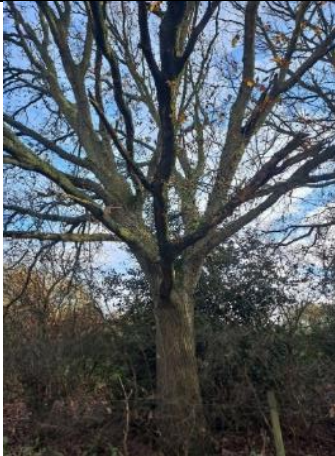
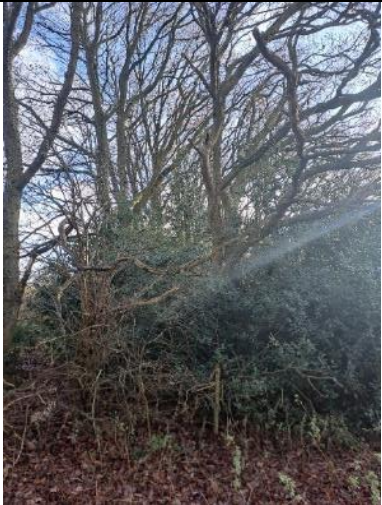
| BG1 | Tree Description: | Various trees on/next to the boundary. Very unlikely to be impacted so a detailed survey was not done. If the trees will be impacted, a more detailed survey will be needed. | | |

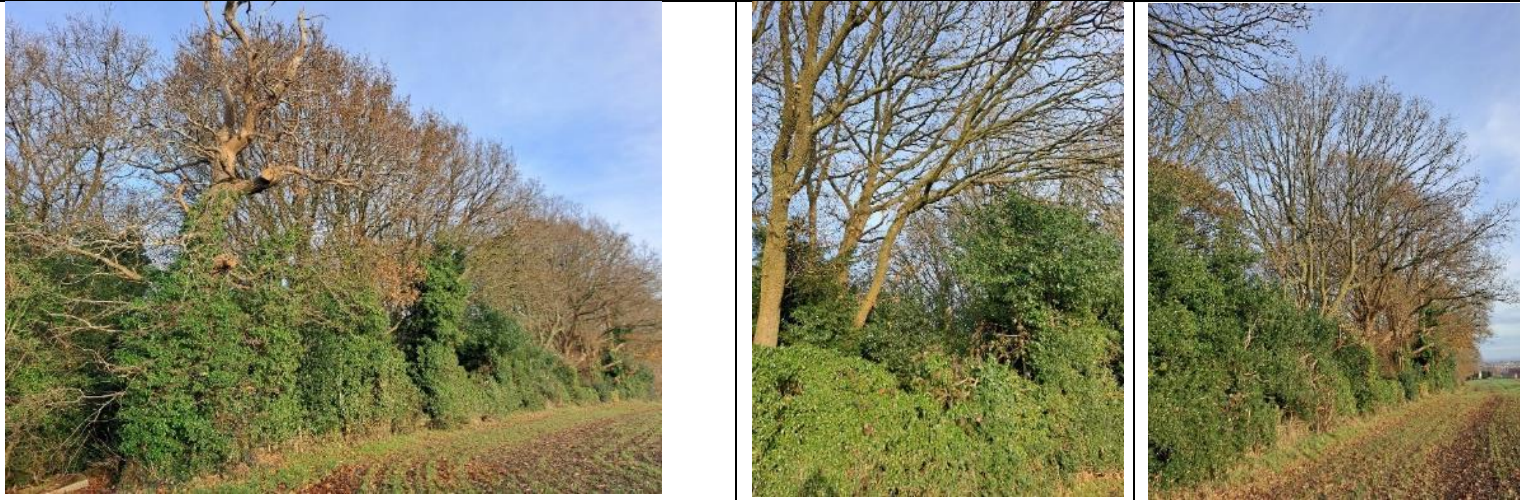
| | BG2 | Tree Description: | Various species that were blanket assessed as PRF-I due to numerous mature and ivy clad trees. No obvious PRF-M trees, but the trees were of sufficient size and age to provide features.<br>Further Survey Requirements: Soft fell under supervision. | | |
