## Oldbury to Meriden, Warwickshire

# Ground Level Tree Assessment Report

**Prepared For: Severn Trent Water**

Document Reference: 10408.04.001

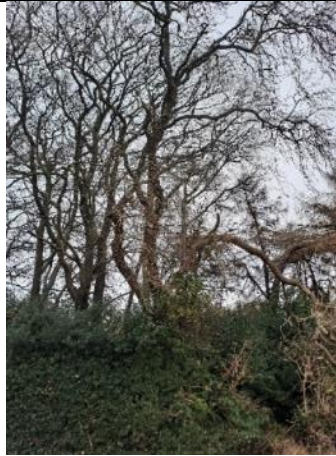
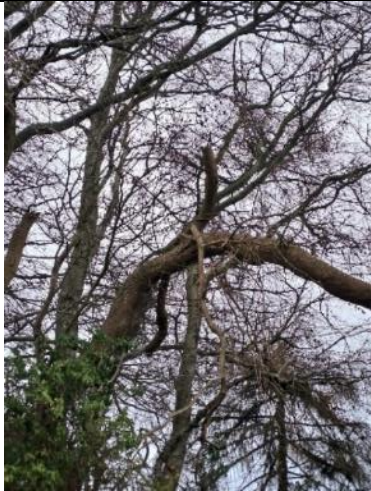
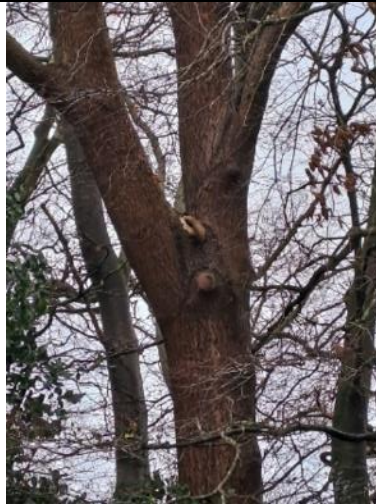
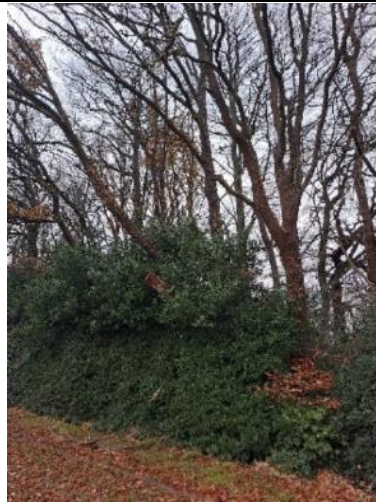
| | BG3 | Tree Description: | Various tree species in a woodland block adjacent to the working area. The trees are unlikely to be impacted and so weren't subject to a detailed survey. Trees with PRFs incidentally recorded and are assessed as PRF-M on a precautionary basis. | |

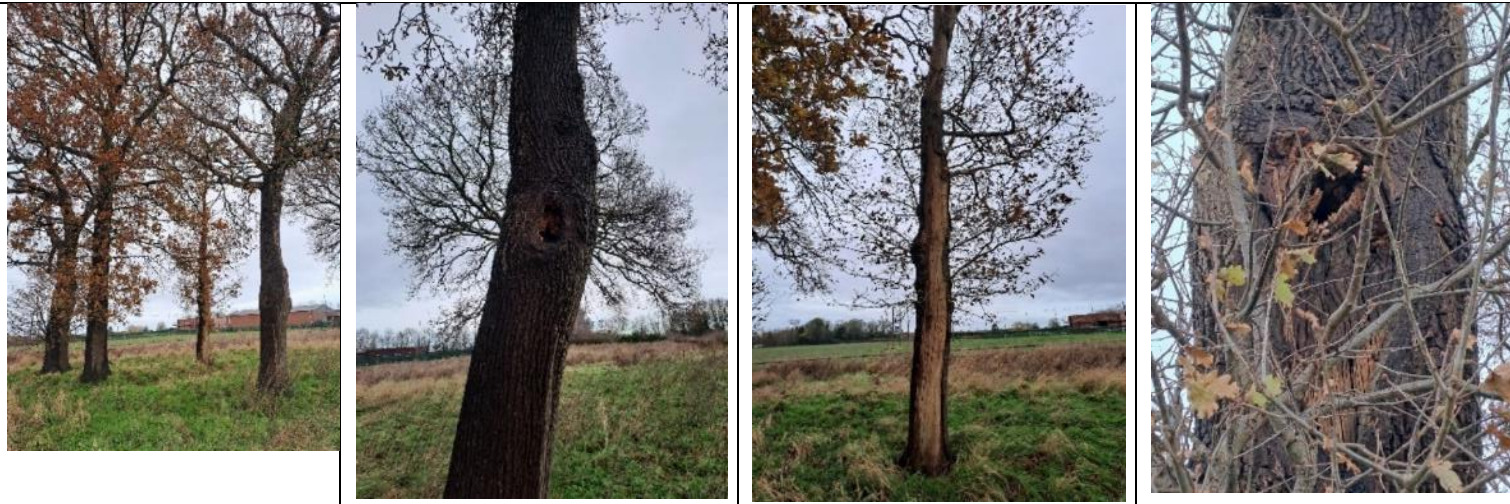
| | BG4 | Tree<br>Description: | A group of four oak trees. A detailed survey was not done as they were outside of the working area but PRFs incidentally recorded. PRF-M features were present. The trees are unlikely to be affected but a detailed survey will be needed should they be impacted. | | | |

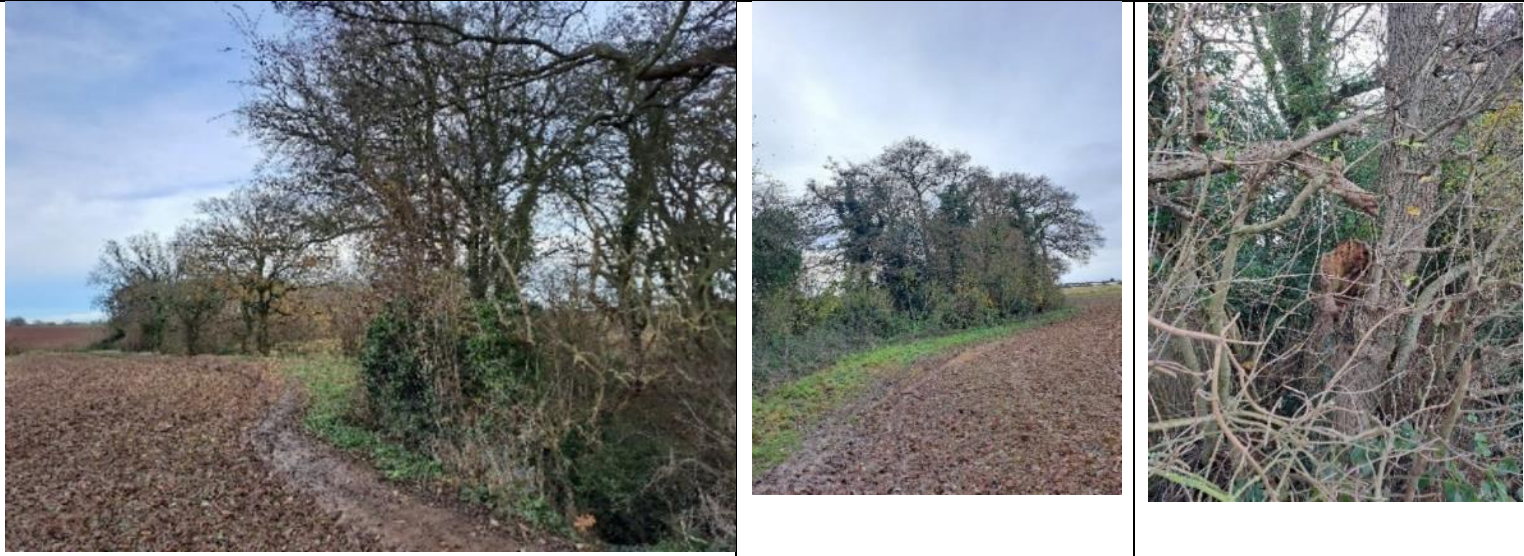
| BG5 | Tree Description: | A linear block of woodland with various species. The woodland was not surveyed in detail as it was outside of the working area. PRFs were incidentally recorded. There are likely numerous PRFs within the woodland. It is assumed that the woodland is being retained. The trees were bulk assessed as PRF-M on precautionary basis. | | | |

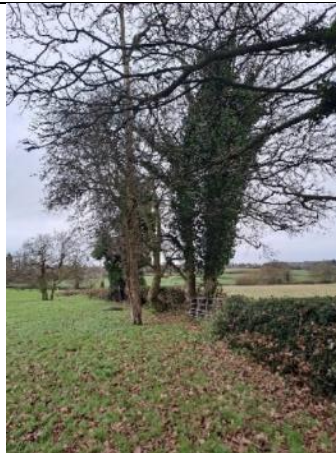
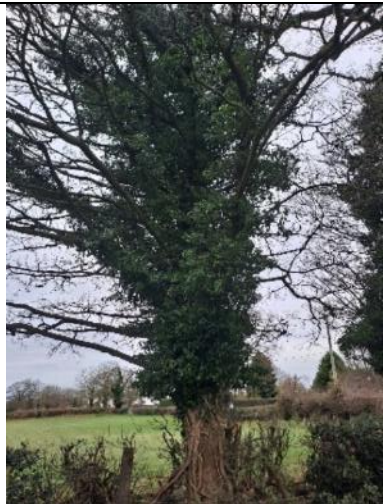
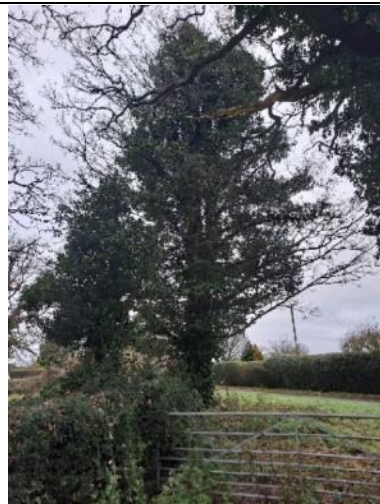
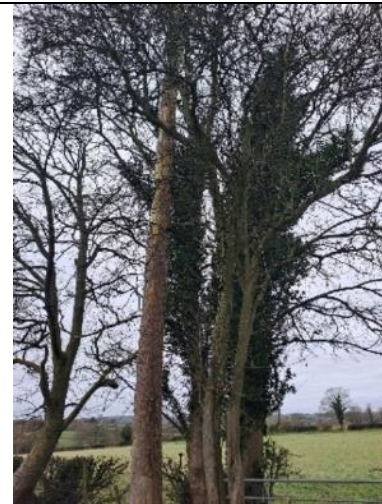
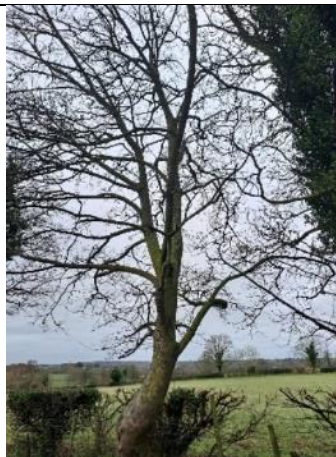
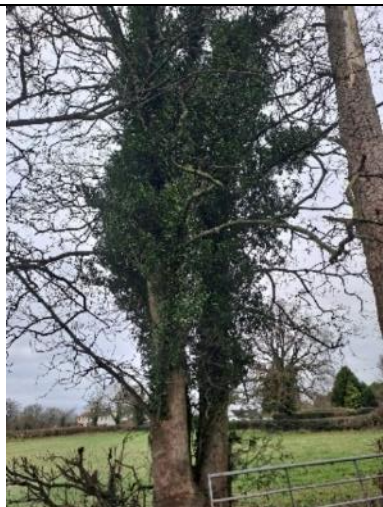
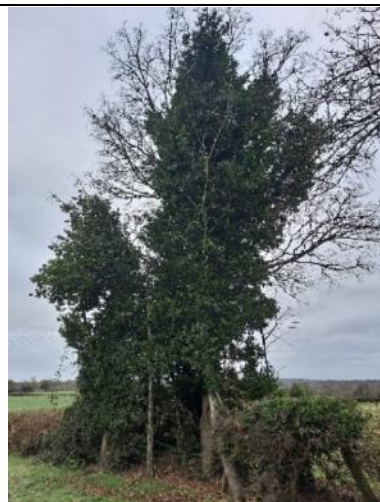
| | BG6 | Tree Description: | <p>Various tree species located on the boundary of the field and therefore unlikely to be impacted. A detailed survey was not done.</p> <p>PRF 1: Various potential PRFs on the stem oriented all aspects. The PRFs faced all aspects and were at a height of 0-10m. There was no evidence of bat use. There was potential for day/night/feeding/transitional occasional bat roost use.</p> <p>H&amp;S Considerations: Livestock risk.</p> <p>Further Survey Requirements: A further detailed assessment will be needed if the trees will be impacted.</p> | |

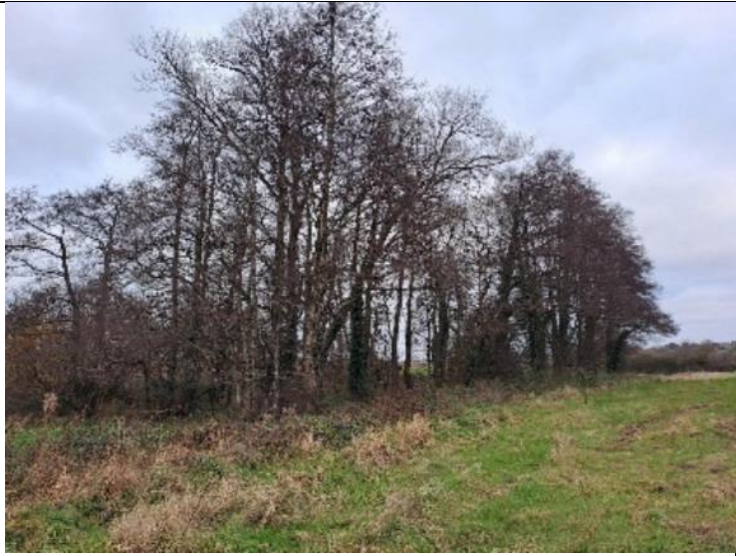
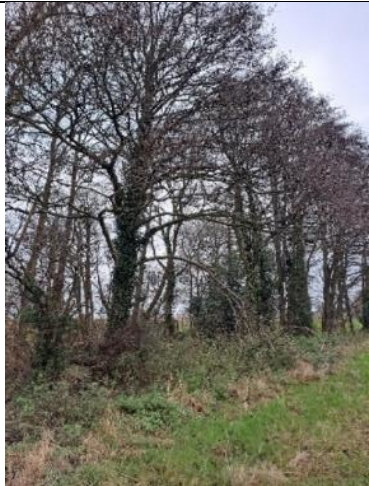
| BG7 | Tree Description: | The trees were not surveyed in detail as they were directly on the boundary and unlikely to be impacted. The trees were of the sufficient size and age that could have features. A further detailed assessment will be needed if the trees will be impacted. | | |

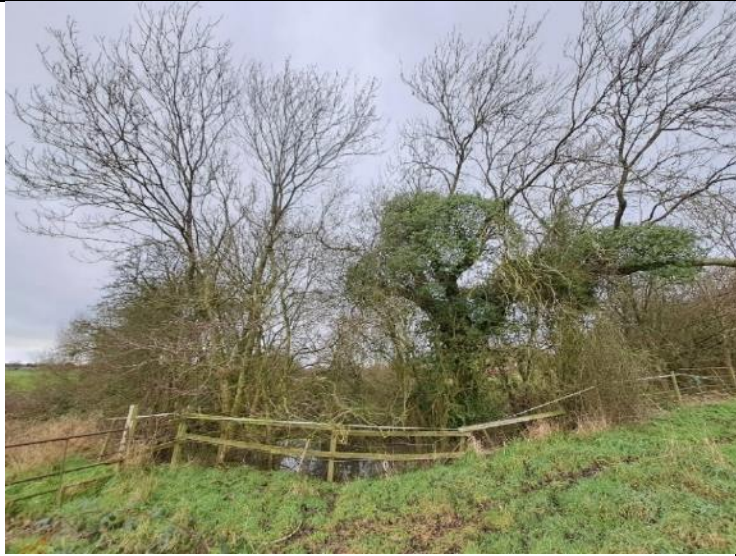
| BG8 | Tree Description: | <p>Ash</p> <p>PRF 1: No obvious features but access is restricted due to the pond. There was no evidence of bat use. There was potential for day/night/feeding/transitional occasional bat roost use.</p> <p>H&amp;S Considerations: Proximity to water and uneven ground surrounding.</p> <p>Further Survey Requirements: Likely to be retained but if not, soft fell under supervision.</p> | | |

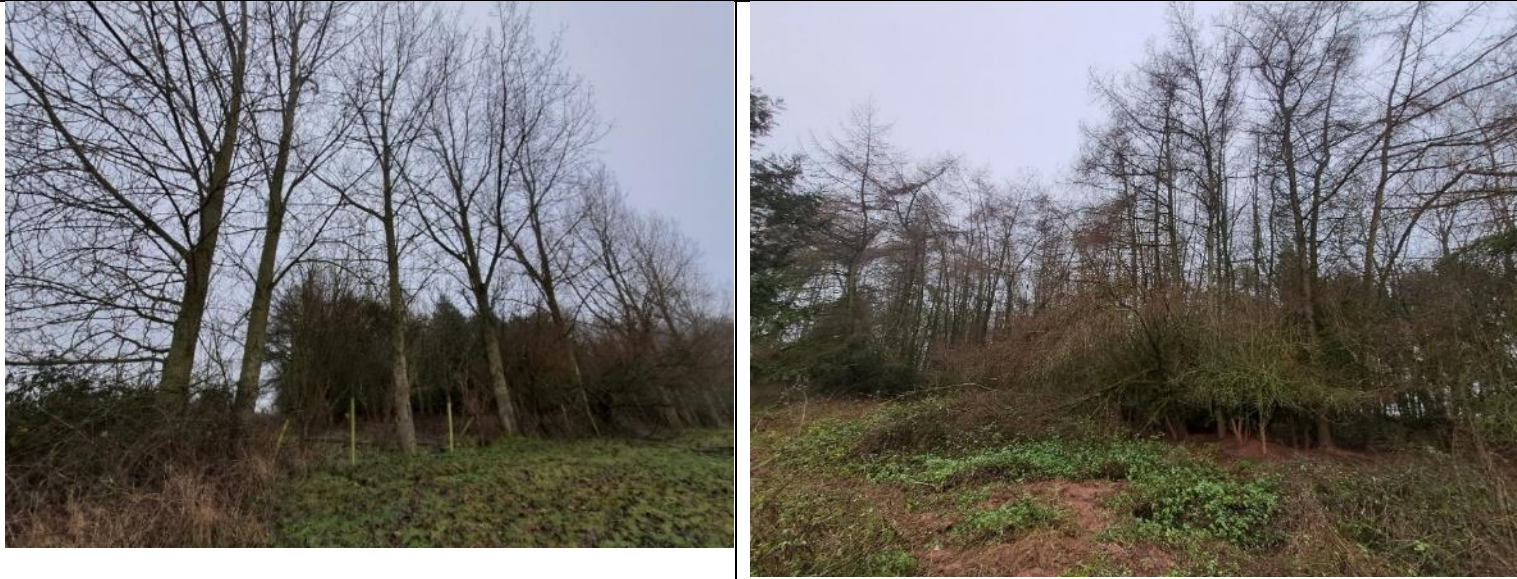
| | BG9 | Tree Description: | <p>Assessed as block of woodland as the trees lie just outside of the working area. Further detailed survey required if impacted.</p> <p>PRF 1: Lifting-bark located on the stem oriented all aspects. The bark faced all aspects. There was no evidence of bat use. There was potential for day/night/feeding/transitional occasional bat roost use.</p> <p>H&amp;S Considerations: Uneven ground surrounding and badger sett(s) present.</p> <p>Further Survey Requirements: PRF inspection survey – ropes.</p> | |

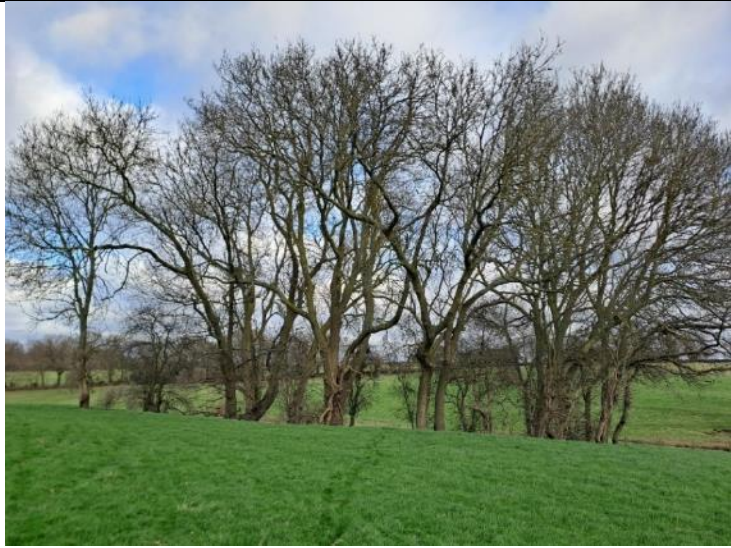
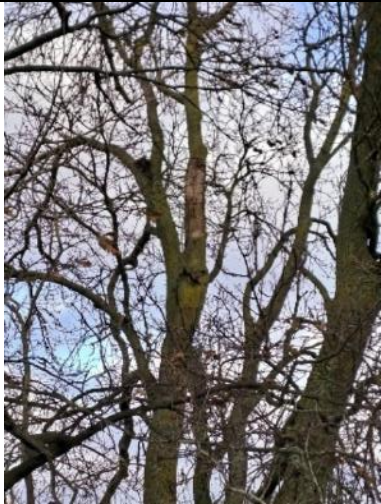
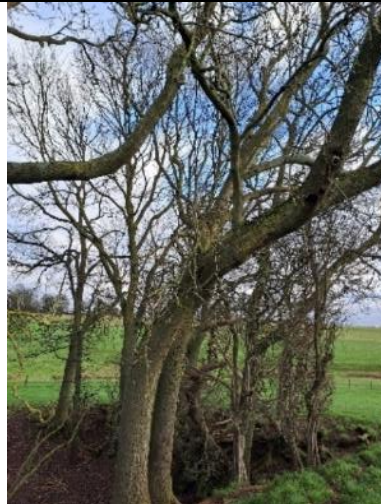
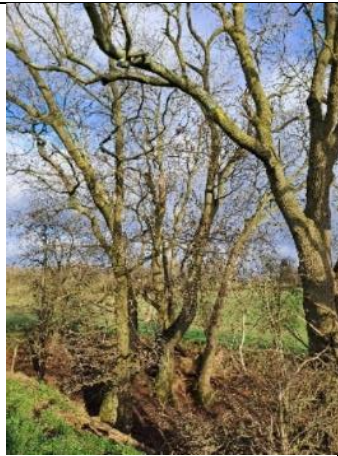
| BG12<br>and<br>BG13 | Tree<br>Description: | <p>Ash – Two groups with multiple PRFs including knot-holes, canker and dead, hollow limbs.</p> <p>PRF 1: Canker located on a stem oriented all aspects. The canker faced all aspects and was at a height of 8m. There was no evidence of bat use. There was potential for maternity/satellite/night/mating/swarming bat roost use.</p> <p>H&amp;S Considerations: Unstable dead/diseased wood throughout.</p> <p>Further Survey Requirements: Presence/likely absence surveys – dusk emergence.</p> | |

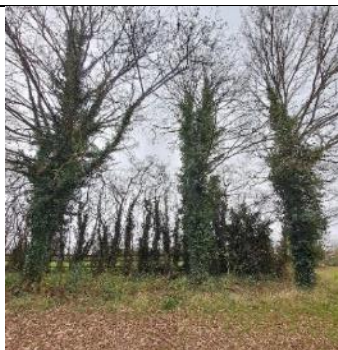
| BG14 | Tree Description: | <p>Sycamore</p> <p>PRF 1: A group of three trees with dense ivy cover and the potential to conceal PRFs. The ivy was on the stems and faced all aspects at a height of 1-7m. There was no evidence of bat use. There was potential for day/night/feeding/transitional occasional bat roost use.</p> <p>H&amp;S Considerations: Proximity to road and uneven ground surrounding.</p> <p>Further Survey Requirements: PRF inspection survey – ropes.</p> | | | |
